## Reserve Study

**Cheesman Tower West**  
1200 Humboldt Street  
Denver, CO 80218

July 16, 2008

Re: Cheesman Tower West Condominium Association, Denver, Colorado  
Reserve Study – Project No. 07183.1

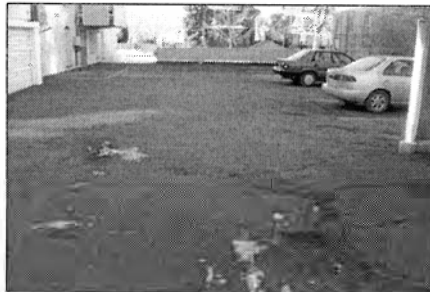
**Description:** Asphalt mat over the Humboldt Street subsurface parking garage.

**Condition:** Poor condition. We noted signs of significant deterioration and cracking.

We recommend that the association consult with a professional engineering firm to determine if the depth of the existing asphalt mat does not exceed the loading or code requirements for the parking structure.

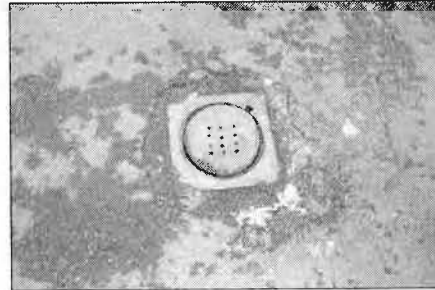
The drain located at the north east side of the parking deck is in poor condition and is causing severe deterioration to the concrete twin tees below.

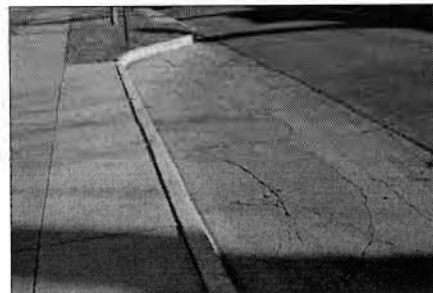
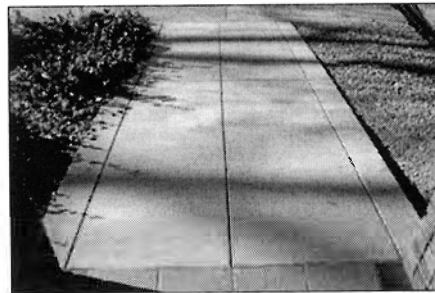
**Condition:** Good condition with no major

cracking or deterioration noted.

The sidewalk on the west side of the main entrance was removed and replaced in 2007.

- Cyclically remove and replace damaged sections of the concrete walkways every eight years, starting in 2009.

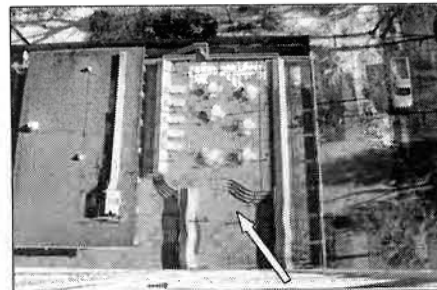
**Description:** 2' x 2' x 2-1/2" concrete pavers set on adjustable pedestals over a waterproof membrane.

**Condition:** Good condition.

- Cyclically remove and replace damaged concrete pavers every five years, starting in 2012.

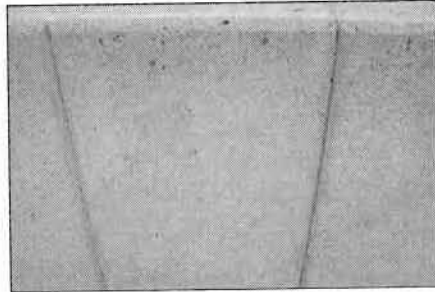
**Description:** Reinforced, cast-in-place, concrete retaining wall.

**Condition:** Good condition with no visual signs of failure. The control joints in the retaining wall on the east side of the property were caulked in 2006. Typically cracks that are 1/8" or larger should be routed and crack filled with an epoxy injected to prevent any further damage to the structure.

- Remove and replace the sealant in the control joints every 10 years, starting in 2016.
- Cyclically inspect, maintain and repair the concrete retaining wall every three years starting in 2011.

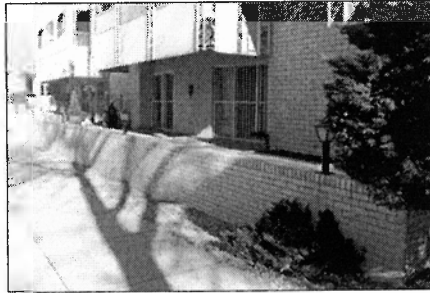
**Description:** Brick wall separating the first floor patio decks and Humboldt Street sidewalk. There are pole lighting units mounted on the top of the wall.

**Condition:** The brick wall is in good condition with no visual signs of deterioration or missing brick.

- Cyclically inspect, tuck point the mortar joints and replace damaged bricks every six years, starting in 2014.

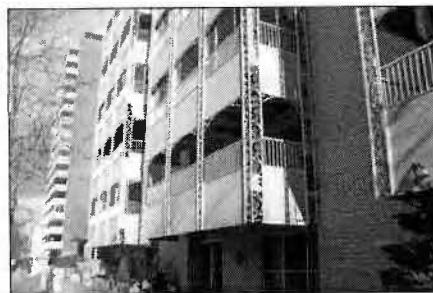
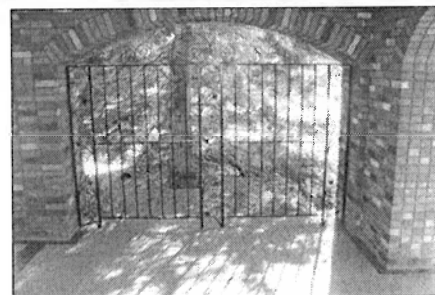
**Condition:** Fair to poor condition.

The balcony railings are in poor condition with signs of corrosion on the horizontal and vertical members.

As noted in a report from Bornengineering dated May 11, 2005; The paint on the existing wrought iron and steel framing for the balcony railing system is in poor condition. The paint condition is worse as the bottom of the panels and along the top of the hand rail. At these locations, there are many areas

where the paint has completely flaked off of the surface, exposing the underlying metal, which is rusting. Paint in better condition is beginning to crack and peel. The bottom steel of the railing panels is severely rusted and deteriorated. It is not uncommon to find spots that have rusted through the metal. The deterioration has affected the structural integrity of the steel frame, some of which are sagging under their own weight. Significant surface preparation will be required simply to apply a new coat of paint. Products exist that can stop the rust and help consolidate the rust to improve the structural integrity of the deteriorated steel component; however, the repair will not fully restore the steel to its original condition.

The May 11, 2005 report from Bornengineering provides the Cheesman Tower West Homeowners Association with general recommendations for repair. We recommend that the Cheesman Tower Homeowners Association consult with a professional engineering company to develop repair specifications and details to paint the wrought iron and steel framing for the balcony railing system.

- Remove and replace the metal railings in 2009.
- Cyclically scrape, rust proof and paint the metal railings every six years, starting in 2014.

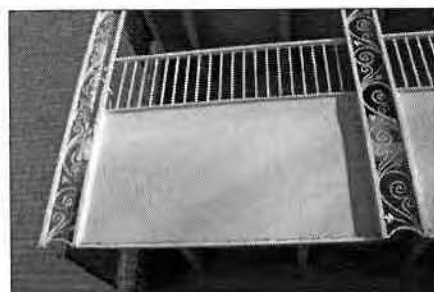
For a building of this age, it has been our experience that these panels could potentially be made of an asbestos material. Special care and environmental testing should be taken when these panels are removed and replaced. Typically an industrial hygienist and abatement contractor contract directly with the owner so we really do not have a cost basis to project from.

**Condition:** Poor condition, we noted signs of deterioration by weathering beneath the paint on the lower level panels. We were informed the exterior of the building was last painted in 1997.

The May 11, 2005 report from Bornengineering provides the Cheesman Tower West Homeowners Association with general recommendations for repair. We recommend that the Cheesman Tower Homeowners Association consult with a professional engineering company to develop repair specifications and details to paint the composite panels.

- Remove and replace the composite paneling at the building exterior in 2009. This expense includes required scaffolding.
- Cyclically power wash and paint the composite paneling at the building exterior every seven years, starting in 2014. This expense includes required scaffolding.

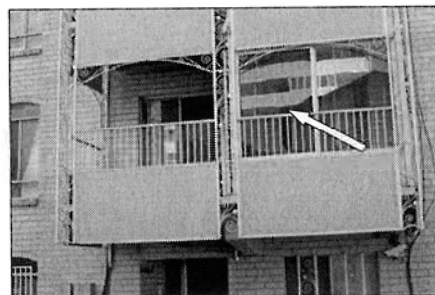
**Description:** The balconies have bare concrete topping slab over twin tees with framed divider walls between units.

**Condition:** Good condition.

- Cyclically inspect and repair twin tees and topping slab every eight years, starting in 2009.

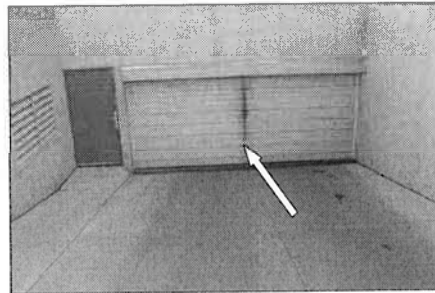
**Condition:** Good to fair condition.

The metal garage door on the Humboldt street entrance to the subsurface parking garage is in fair condition with surface rusting in the center of the door.

The metal garage door to the south side parking garage is in good condition with no visual signs of deterioration.

The garage doors on the upper level parking garages are in good condition with no visual signs of deterioration.

- Replace a portion of the metal panel garage doors every 16 years starting in 2010.

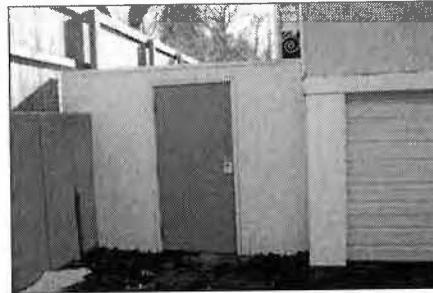
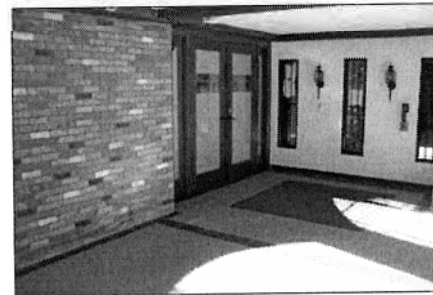
**Condition:** The common doors are in good condition. The common doors were replaced during the remodel.

The entry doors to the parking garages are in fair to poor condition showing signs of rusting.

The store front windows surrounding the interior pool are in fair to poor condition with many of the seals and gaskets missing or failing.

- Cyclically remove and replace the sealant and gasket joints in the store front windows around the indoor pool area every three years, starting in 2009.
- Remove and replace the garage man door and manager's office doors 2015.
- Replace the common windows in 2015.

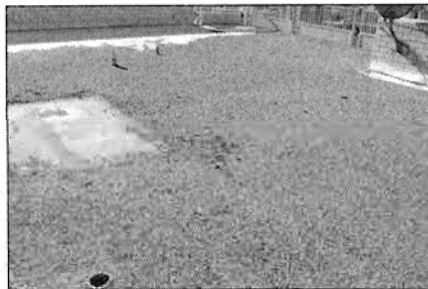
**Description:** Built up roof. Appeared to be a modified bitumen system with a granulated cap sheet.

**Condition:** The built up roof system is in poor condition with multiple patched areas and areas that continue to leak.

- Remove and replace the low sloped roof areas in 2010.

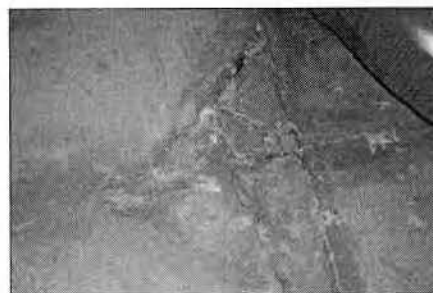
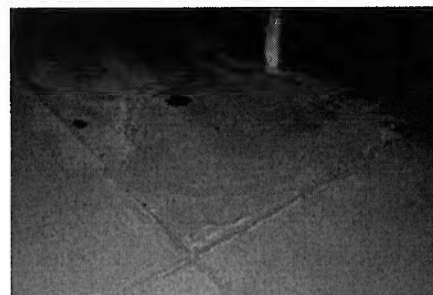
**G1. Concrete Parking Surface****Location:** Subsurface parking garage 12<sup>th</sup> Avenue garage.**Description:** Presumed to be on-grade, reinforced concrete slab.**Condition:** Good to fair condition with no major visual signs of failure or deterioration. We noted some minor cracking.**Age:** 11 years.**Expected Useful Life:** 50+ years with sectional replacement and maintenance.**Effective Useful Life:** 40+ years with sectional replacement and maintenance.

- Cyclically remove and replace damaged sections of the concrete surface in the subsurface parking garage every eight years, starting in 2008.

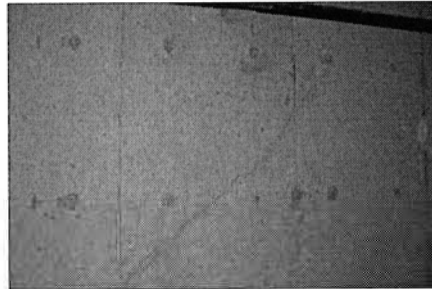
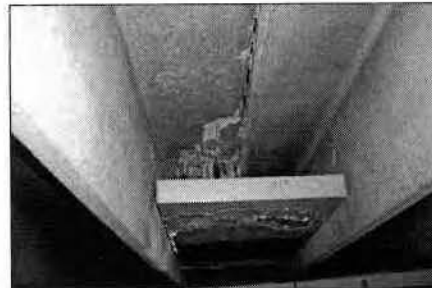
**Condition:** Fair condition.

Two support beams on the east side of the garage were recently repaired as a result of severe moisture intrusion from the concrete deck above. The moisture intrusion from the concrete deck above has been stopped.

We noted some large cracks in the foundation wall south of the recently repaired concrete support beams. The cracks should be addressed and monitored for further movement.

We noted severe deterioration of the concrete flange of the double tee in the center drive lane where the drain for the upper surface parking structure is located. We recommend that the Homeowners Association contract with a professional engineer to evaluate and provide repair specifications.

The 12<sup>th</sup> Avenue parking garage leaks and gutters have been installed at every joint between the twin tees. The gutters are holding water and some of the beam seats are showing signs of deterioration.

- Remove the metal pan under the drain at the end of the ramp and repair the flange of the double tee in the Humboldt street garage in 2008.
- Remove the metal pans between the double tees in the 12<sup>th</sup> Avenue garage and repair the waterproof membrane above in 2008. 350,000
- Cyclically inspect the concrete walls and ceilings at the subsurface parking garage for any cracking or damage and perform any required maintenance every five years, starting in 2008.
- Anticipated Engineering fees for the 12<sup>th</sup> Avenue and Humboldt Street parking garage. Estimate cost: \$75,000

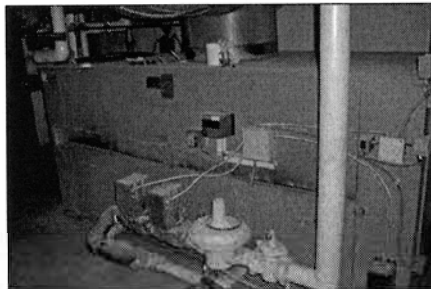
**Description:** There are three boilers that provide space heat, hot water and heat the pool. Parker Industrial Boiler model T-5670, 5,760,000 BTU, natural gas boiler; Raytherm Raypak Type H, model WH1-0962 and a Teledyne Laars Series 2 pool boiler.

**Condition:** The Parker Industrial Boiler has passed its expected service life. As a result of exceptional maintenance, the boiler is still operational however, obtaining replacement parts, especially during catastrophic failure, and continuing to provide such maintenance will become increasingly difficult if not impossible.

A report provided to the Homeowners Association by EG Power Engineering dated September 2, 2004 recommended that the boiler be removed and replaced with three new Patterson Kelly Thermific Boilers with input ratings of 2,000,000 BTU/H each.

**Expected Useful Life:** As noted in the above mentioned report, according to the American Society of Heating, Refrigeration and Air Conditioning Engineers (ASHRAE), the expected service life of a boiler is 25 to 35 years depending upon the type of boiler and the service and maintenance performed over time.

- Remove and replace the Parker Industrial Boiler with three new Patterson Kelly Thermific Boilers in 2009.
  - Remove and replace the Teledyne Laars Series 2 boiler in 2018.
-
