October 6, 2008

Re: Parking Structure Evaluation for Parkway Towers Condominium Association  
Project No.: 08103

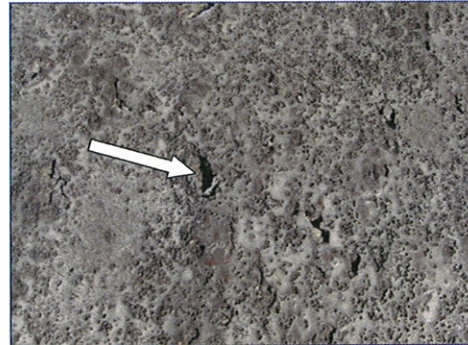
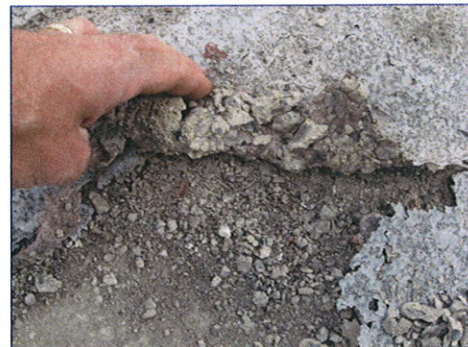
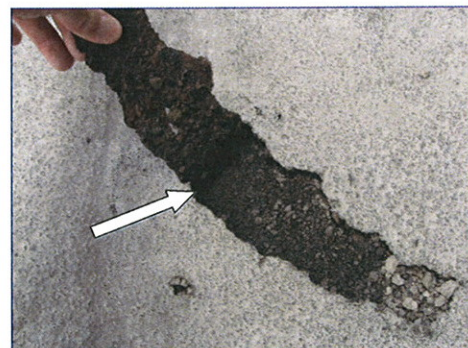
#### A1. Upper Surface Wear Slab

**Comments:** We observed a significant amount of deterioration of the elastomeric waterproof membrane that has been applied to the concrete wear slab.

We observed a significant amount of concrete deterioration of the upper surface wear slab below the elastomeric waterproof coating. The elastomeric waterproof coating at many locations is easily removed by hand.

We observed approximately 85% of the upper surface of the concrete topping slab to be affected by severe surface deterioration of the elastomeric waterproof coating. As a result of the severe waterproof coating deterioration observed and subsequent concrete topping slab deterioration, we estimate approximately 15% of the concrete topping slab to be sound.

**Recommendations:** We recommend that the existing waterproof membrane and topping slab be removed. A new topping slab should be poured and a traffic grade overlay system should be installed. These systems provide protection from water intrusion as well as impeding the absorption of deicing salts and deicing compounds. These products are very hard wearing in vehicular traffic conditions. They also provide excellent slip resistance under wet and icy conditions.

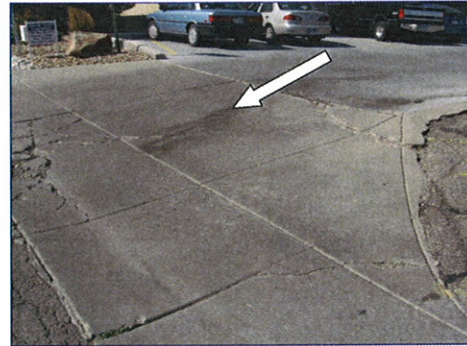
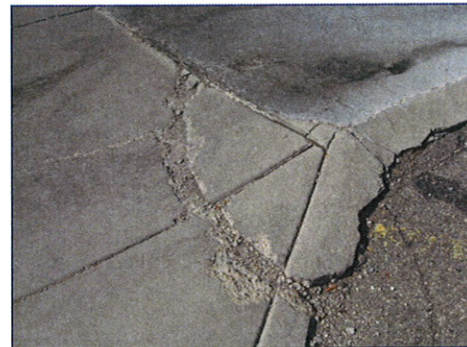
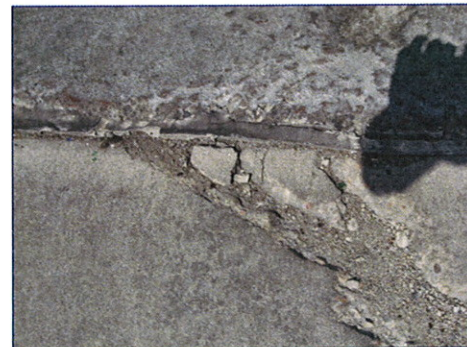
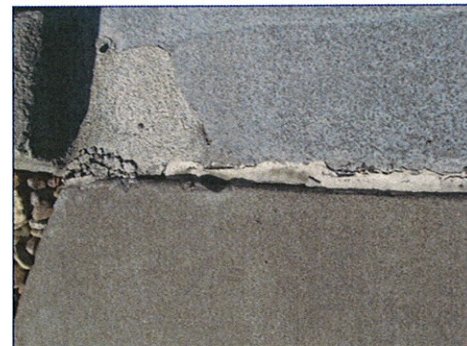
## A2. Concrete Aprons and Concrete Drain Pans

**Comments:** The concrete drain pans are severely deteriorated. We observed the concrete aprons to be approximately 1/2" to 2" below the upper surface parking wear slab on the north entrance and 1" to 3" below the upper surface parking wear slab on the south entrance.

Due to the significant amount of movement between the concrete topping slab and the east foundation wall, and the fact that commercial grade urethane sealants do not have the movement capability to handle the shear movement observed, the following are two repair options to affectively remediate this damage.

**Recommendations:** We recommend that the concrete aprons and concrete drain pans be removed and replaced. The movement, and subsequent damages observed, indicates that the soils beneath the concrete aprons and concrete drain pans have settled. We recommend removing a minimum 12" of existing soils and importing compacted structural fill prior to the placement of the new concrete aprons and drain pans.

### Option 1 – Preformed Sanoprene Expansion Joint

Saw cut the concrete topping slab to accommodate a preformed, sanoprene expansion joint, designed to perform under compression, tension and shear movements. A concrete block-out shall be formed and poured to receive the expansion joint materials. Repair option #1 will provide a long term solution to the movement issue observed at this location.

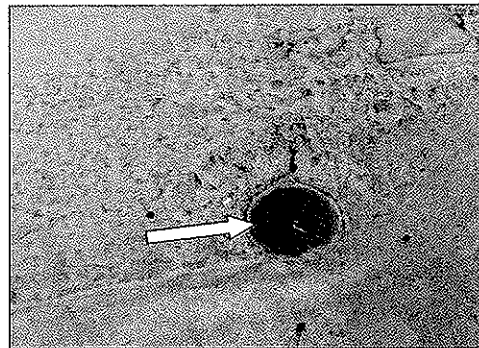
### A3. Upper Surface Drains

**Comments:** There were seven deck drains visible during our observations of the upper surface of the parking structure.

The deck drains are located at various locations on the west and south side of the building. The deck drains appear to be functioning properly however; due to the large amounts of runoff from areas to the south and west of the property, the drains appear to be undersized and/or more drains are needed.

**Recommendations:** The deck drains appear to be undersized or more drains are needed to adequately capture the runoff directed toward the structure. While we did not observe any areas of standing water, the metal screen covers appear to limit the potential flow capability from surface drainage. By increasing the number and size of the drains and modifying the screen covers it will increase the flow potential and reduce the maintenance required to keep the drains functioning at a maximum efficiency.

A video scope inspection shall be performed on the existing storm sewer system, at which time Bornengineering can recommend any modification required for the storm sewer system.

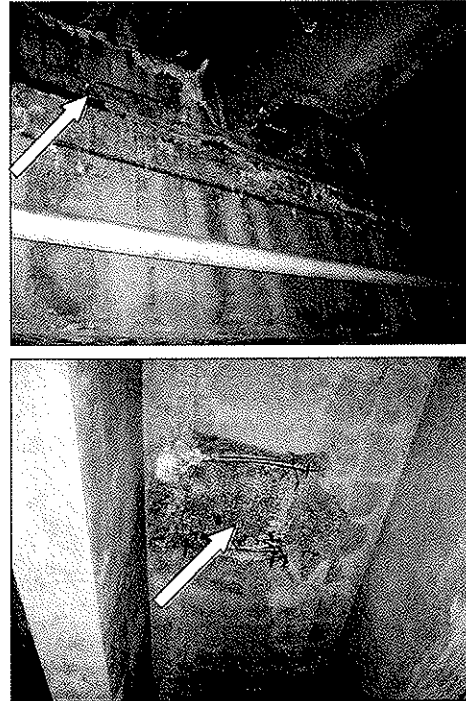
#### A4. Structural Twin Tees

We observed active water leaks between gridlines E and F and the west foundation wall and gridline 5. Water leaks were also observed along gridline 3 between gridlines A and the south foundation wall.

We observed damage to double tee flanges and/or webs in the following locations.

- The first double tee located east of gridlines 5 and 6 on gridline G.
- The third leg to the east from gridlines 4 and G.
- There are several delaminated areas including exposed reinforcing steel in the flanges of the double tees at gridlines E, C and 4.
- We observed a repair that appears to be failing between gridlines D and E above parking stall #27.
- There is a spall in the flange of the double tee at gridlines B and C west of the concrete beam directly below the building footprint.
- We observed a crack in the flange of the third double tee to the east of gridline 5 between gridline A and the south foundation wall that extends the length of the double tee.
- The third and fifth legs of the double tees between the west foundation wall gridline 5 are spalled where the double tees intersect the inverted tee beam.

**Recommendations:** Upon completion of the upper surface wear slab and traffic grade overlay system and sealant installation, clean surface rust from the exposed portions of the steel bearing plates and apply a penetrating, migrating corrosion inhibitor.

Remove deteriorated concrete, clean the existing reinforcing steel and apply a penetrating, migrating corrosion inhibitor and repair the deteriorated areas with a polymer modified, shrinkage compensated, vertical and overhead repair mortar with integral corrosion inhibitor.

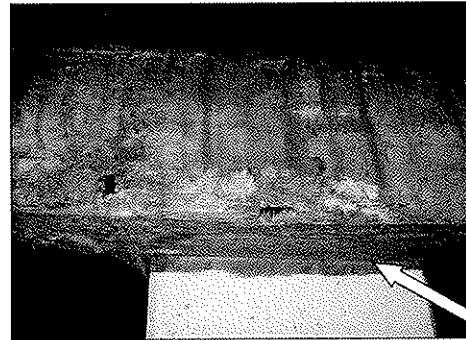
## A5. Inverted Tee Beam and Concrete Columns

We observed delaminations in the inverted tee beams at the following locations.

- Along gridlines G and 5 between the west foundation wall and gridline 5.
- Above the column at gridlines G and 5.
- We observed a large spall along the bottom of the inverted tee beam at gridline 4.

- Corroded steel embed plates along the inverted tee beam at gridline C between gridlines 4 and 5.
- There is delamination in the inverted tee beam C between gridlines 4 and 5.

- Corroded steel embed plates along the inverted tee beam at gridline A between the west foundation wall and gridline 5. We also observed a significant amount of dirt and debris on the top of the inverted tee beam.

- There is delamination in the face of the inverted tee beam below the second and third double tee legs west of the concrete beam directly below the building footprint.

- We observed a significant delamination in the inverted tee beam between gridlines 2 and 3 and A. The steel embed plates are corroded and in one 10'-0" section along gridline 3, the steel embed plate is completely corroded.

**Recommendations:** Upon completion of the upper surface wear slab and traffic grade overlay system and sealant installation, clean surface rusting from the exposed portions of the steel bearing plates and apply a penetrating, migrating corrosion inhibitor.

Remove deteriorated concrete, clean the existing reinforcing steel and apply a penetrating, migrating corrosion inhibitor and repair the deteriorated areas with a polymer modified, shrinkage compensated, vertical and overhead repair mortar with integral corrosion inhibitor.
