November 5, 2008

Re: Roof Deck Evaluation for Parkway Towers Condominium Association  
Project No.: 08103

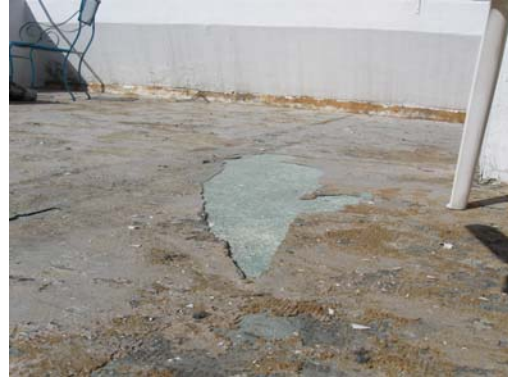
**Comments:** We observed a significant amount of deterioration of the waterproof membrane that was applied to the surface of the concrete deck.

**Recommendations:** We recommend that the existing waterproof membrane be completely removed. The areas of spalled concrete should be cleaned and patched with a repair mortar with integral corrosion inhibitor.

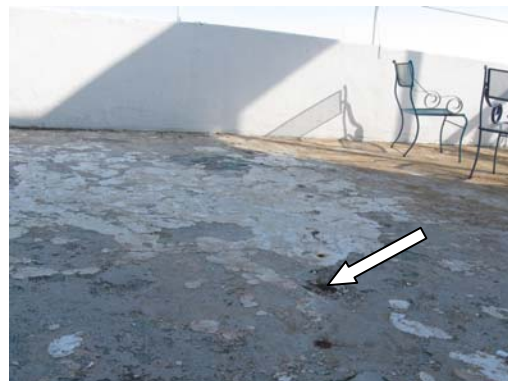
There was very little distress in the concrete deck slab. Minor exposed aggregate was visible on the east side of the deck near the parapet wall. In addition, there appears to have been previously embedded steel anchors in a circular pattern on the east elevation. The cut anchors are visibly rusted.

The cut, rusted bolts shall be removed, the surrounding concrete cleaned and patched with a repair mortar with integral corrosion inhibitor. The entire concrete surface shall be cleaned and a pedestrian grade waterproof coating shall be installed.

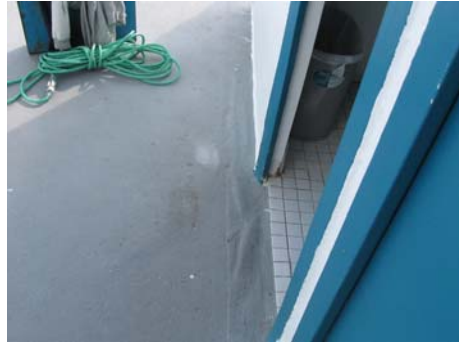
**Comments:** We observed deterioration and delamination of the waterproof membrane that was applied to the surface of the concrete deck.

The delamination of the membrane has occurred at the following locations:

1. At the deck/wall transition around the three sides (east, south and west) of the mechanical room.
2. At the deck/wall transition along the east edge of the building for approximately 40 lineal feet.
3. At the steel embed plate located at the east end of the south building wall.
4. Around the drain located at the west end of the deck along the south side of the pool.

**Recommendations:** We recommend that the existing waterproof membrane be completely removed. Any areas of spalled concrete should be removed and the affected area cleaned and patched with a repair mortar with integral corrosion inhibitor. The entire concrete surface shall be cleaned and a fluid-applied polyurethane waterproofing coating shall be installed. Because of the chemical and greater need for performance, the waterproof system used for the pool area will be slightly more costly than the open air deck coating.

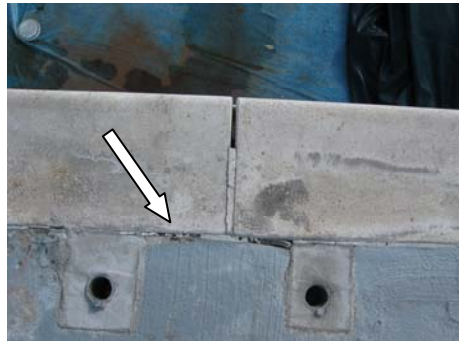
Approximately 80% of the coping stones surrounding the pool deck give an acoustic response indicating a detachment from the structure. The membrane approximately 6" – 8" outward from the coping stones has also delaminated.

The sealant joint between the coping stone and the pool deck has also failed around the majority of the pool perimeter.

The coping stones around the perimeter of the pool shall be removed and reset prior to the installation of the new waterproof membrane.

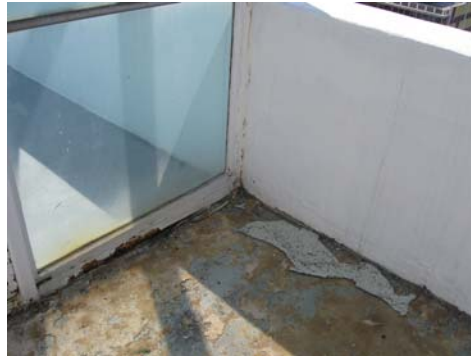
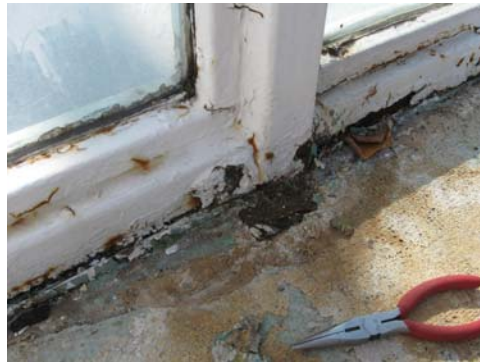
**Comments:** The attachment of the curtain wall to the deck is severely deteriorated, with the damage worse on the west elevation. Although not visible, it is assumed that the deterioration at this location has damaged the concrete deck to some extent.

**Recommendations:** The curtain wall that separates the pool area from the remainder of the roof area shall be removed. The concrete shall be observed at this time for deterioration. It is assumed that a portion of the deck will need to be removed and replaced. The concrete shall be removed in such a manner as to salvage the reinforcing steel. If salvageable, the steel shall be cleaned to bare steel prior to the install of a repair mortar. A new curtain wall shall be installed. The waterproof membrane will need to be incorporated with the new curtain wall.
