**Sorrel Ranch HOA**  
**Aurora Parkway & Alexander Drive**  
**Aurora, CO 80016**

**Level 1 Reserve Analysis**

**Report Period – 01/01/09 – 12/31/09**

**Date of Property Inspection – February 12, 2009**  
**Report Prepared by – G. Michael Kelsen**  
**Property Inspected by - G. Michael Kelsen & Curtis Karkoski**  
**Main Contact Person - Mr. Scott Ryan, Community Manager**

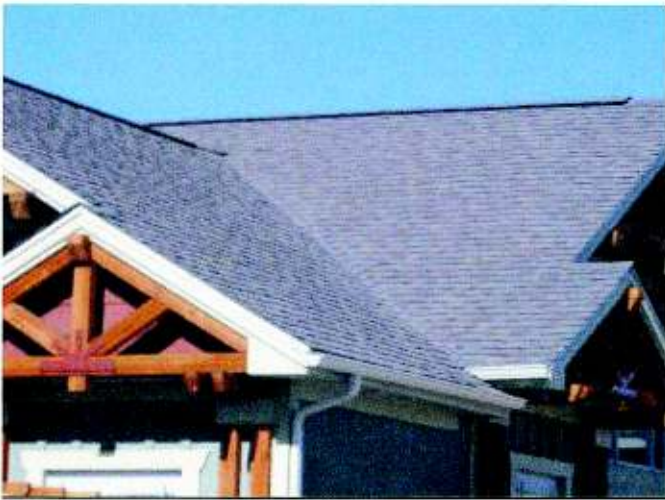
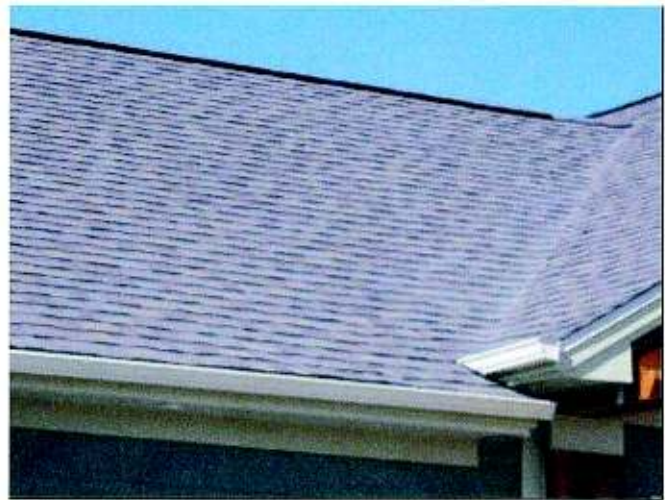
Comp #: 105 Comp Shingle Roof - Replace

No unusual conditions observed at time of inspection, such as loose or missing shingles. This roof appears to be a "30-year" rated shingle. Despite this rating, replacement typically needs to occur within 15 - 20 years due to weather elements such as hail, wind, and temperature fluctuations. It is not recommended that an overlay is applied when a roof needs to be replaced. With overlays, it may cause further damage from hailstones due to being a softer surface and wind due to uneven surfaces. Therefore, Reserve funding includes complete tearoff and replacement.

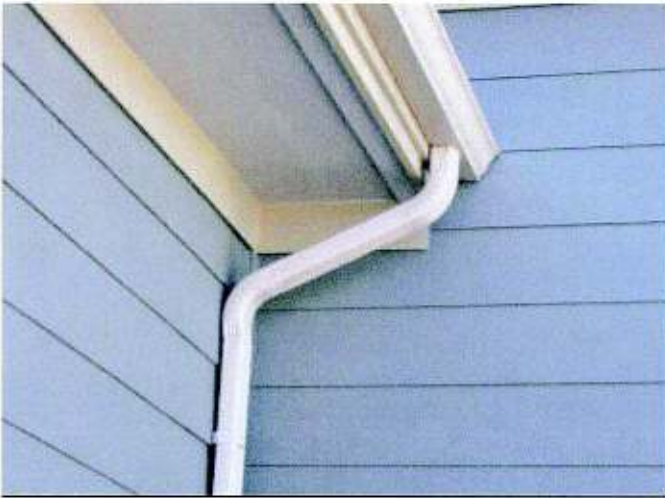
Comp #: 120 Gutters/Downspouts - Replace

No unusual conditions of the rain gutters or downspouts were observed during inspection. Some of the tip down extensions for the downspouts were smashed on the ends and should be repaired. Typically, properties replace rain gutters and downspouts at the same time as roofing materials to ensure proper size for drainage. Due to the small amount of gutters and downspouts, we suggest including the cost of the lines with the roof cost. Repair on an as needed basis with general operating funds.

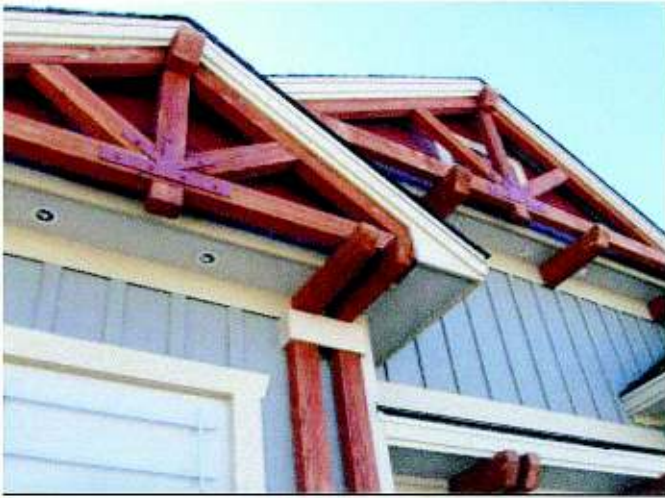
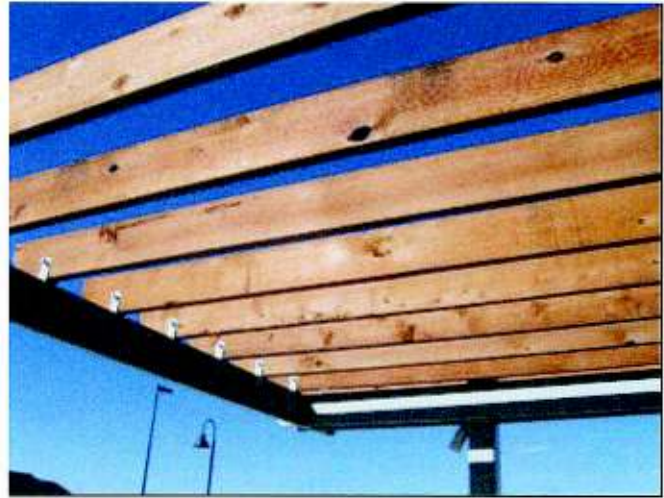
Comp #: 202 Wood Trim - Stain

Exterior wood trim surfaces are generally in good condition, no drying or deterioration noted. Restain and seal these surfaces approximately every 3 to 5 years to maintain appearance and protect wood. Remaining life based on current age and condition.

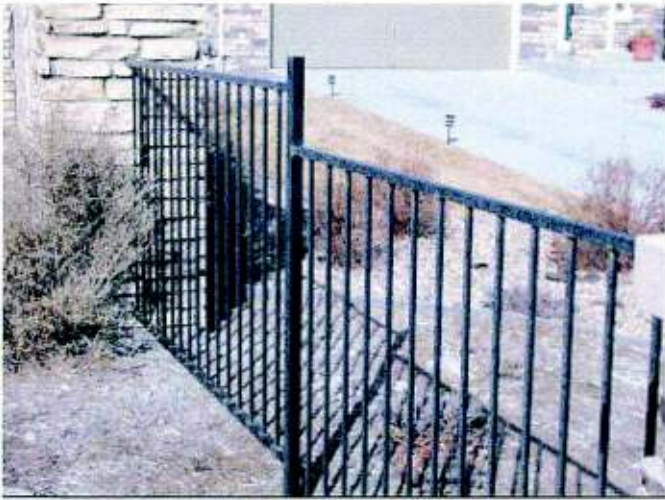
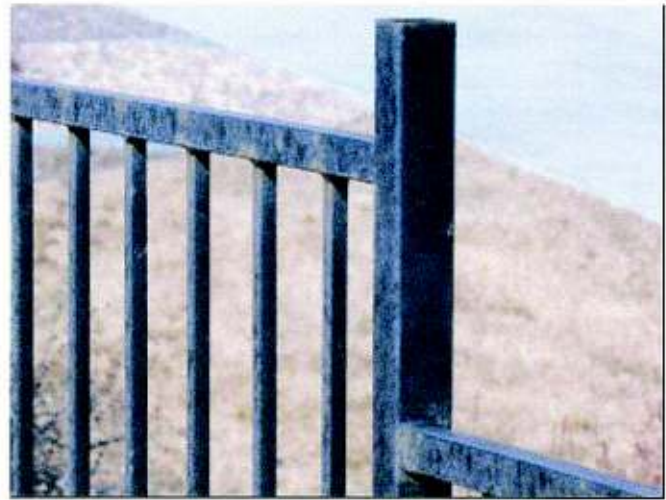
Comp #: 207 Iron Fencing - Repaint

There were some signs of rusting and corrosion noted at welds and connections, as well as faded paint and thin areas. Iron fencing in filing 1 needs coat of paint lots of rusting at welds. Based on the observed conditions, we recommend painting these surfaces this next year to protect the materials against further deterioration. In this climate, we recommend repainting this component every 3 - 4 years to maintain appearance and protect metal surfaces. Remaining life based on current condition.

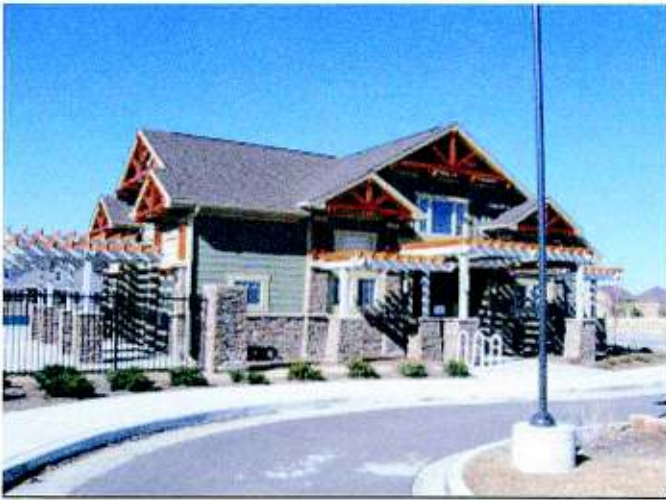
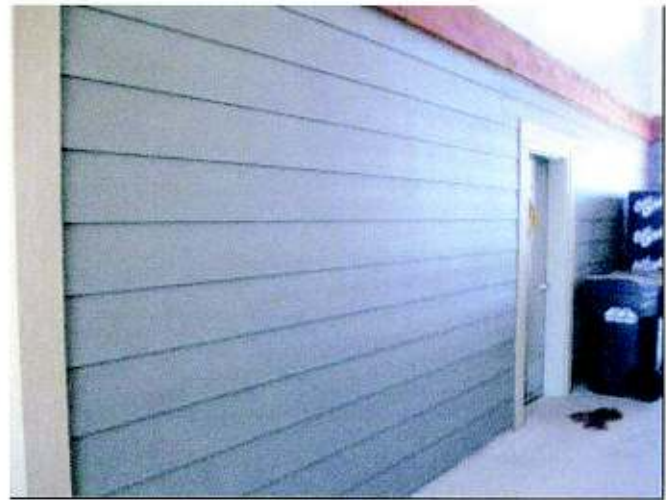
Comp #: 215 Exterior Surfaces - Repaint

Siding and paint is in good condition at time of inspection. There was no evidence of fading or discoloration noted. In this climate, we recommend repainting exterior surfaces every 5 - 7 years to maintain an appropriate appearance and protect the materials from exposure to elements. We suggest coordinating wood trim staining at the same time as painting for best cost estimate.

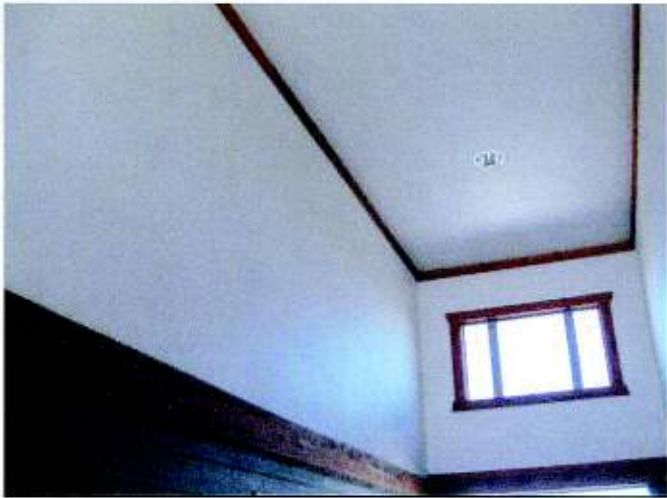
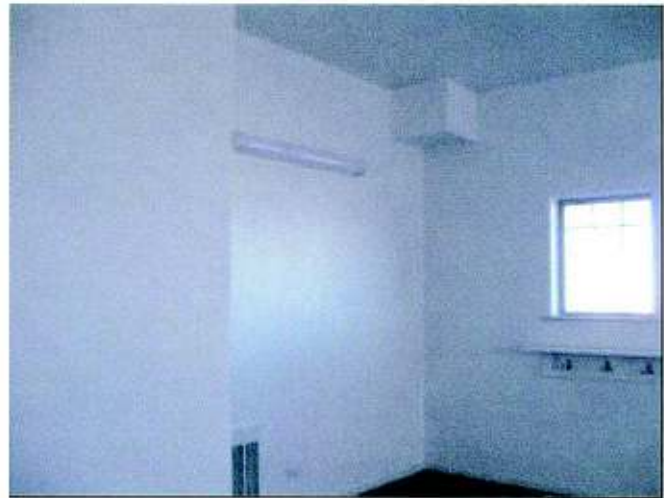
Comp #: 216 Interior Surfaces - Repaint

Painted surfaces are generally in good condition with no major signs of wear or marks. Drywall seams are visible and some cracking has occurred. Based on observed conditions, we suggest waiting until the next time exterior surfaces are scheduled to be painted. By scheduling the interiors at the same time as the exteriors, the association will be able to obtain the best painting cost possible. In between painting cycles, we recommend touching up areas on an as needed basis with general operating funds.

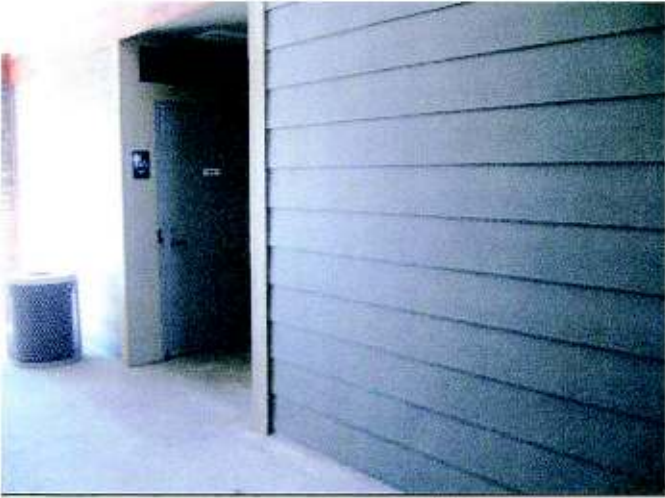
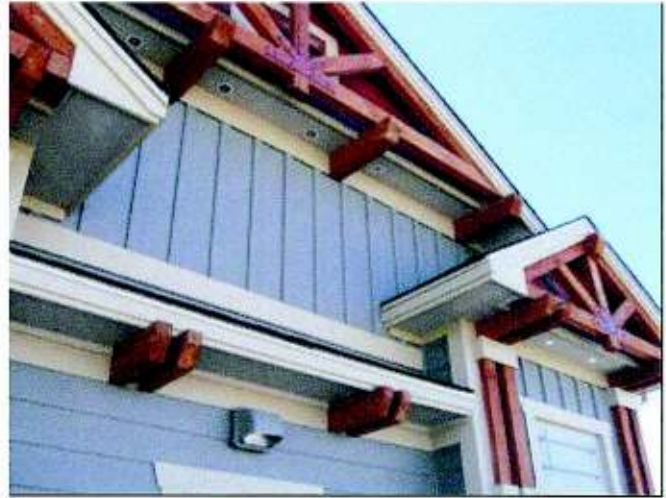
Comp #: 304 Fiber Cement Siding - Replace

There were no major problems noted at time of inspection. Any minor repairs can be performed as a maintenance issue as part of prep work before painting. According to the manufacturer of this product, this material has a 50+ year warranty against defects that will require replacement. Therefore, at this time, we do not suggest Reserving for replacement of siding or trim materials. If deterioration is observed in future years, there is plenty of time available to add to Reserves without substantially affecting the contribution rate. If replacement was needed, expect to spend approximately \$12.00/GSF or approximately \$42,000 at today's dollars (2009).

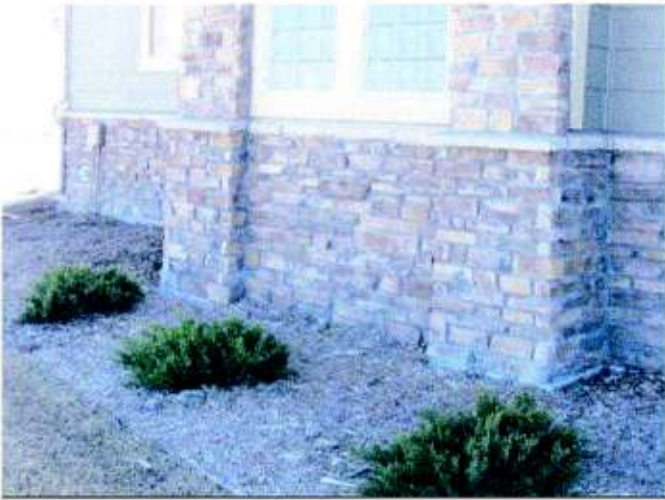
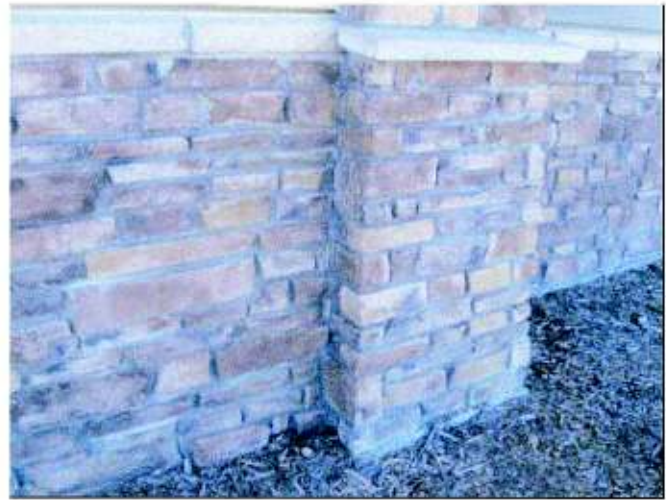
Comp #: 306 Manufactured Stone - Replace

Stones appeared to be adhered to the sides well with no loose or missing stone noted. These are cultured stones with a flat backing to ensure proper attachment to the buildings. Typically, these stones have an extended life expectancy and complete replacement is unlikely. There are times where some stones will loosen and fall off, but this is unpredictable when and how much would occur. Repairs should be handled as a maintenance issue on an as needed basis. No reserve funding is required for this component at this time. If it later turns out that frequent repairs are necessary, then funding could be added in future Reserve Study updates.

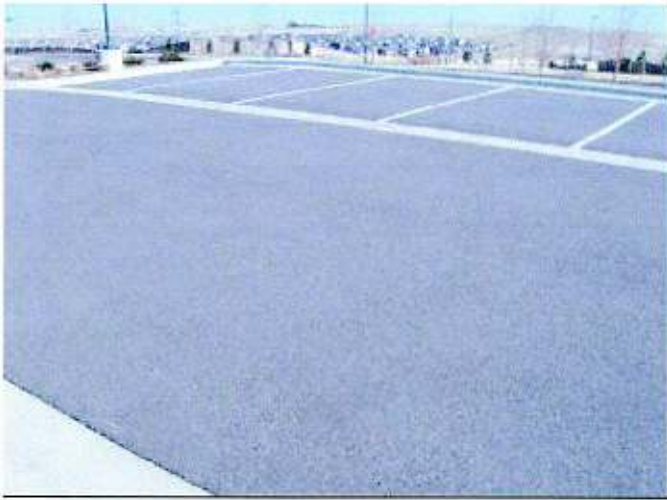
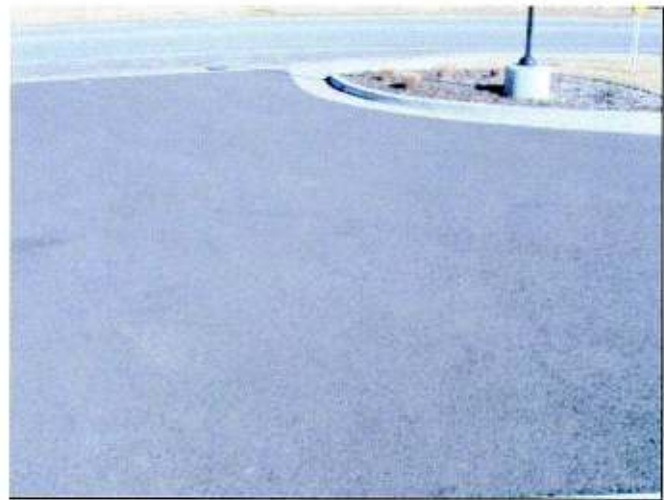
**Comp #: 401 Asphalt - Overlay**

In general, the asphalt is in good condition with no signs of major cracking, or any other signs of deterioration. The parking lot is fairly new and the integrity has remained intact. The average life expectancy for asphalt surfaces ranges between 20 - 27 years for surfaces that are maintained on a regular schedule. Maintenance includes crack fill and repairing small potholes annually as an operating expense. In addition, asphalt should be seal coated every 3 - 4 years, depending on the level of traffic and snow removing techniques.

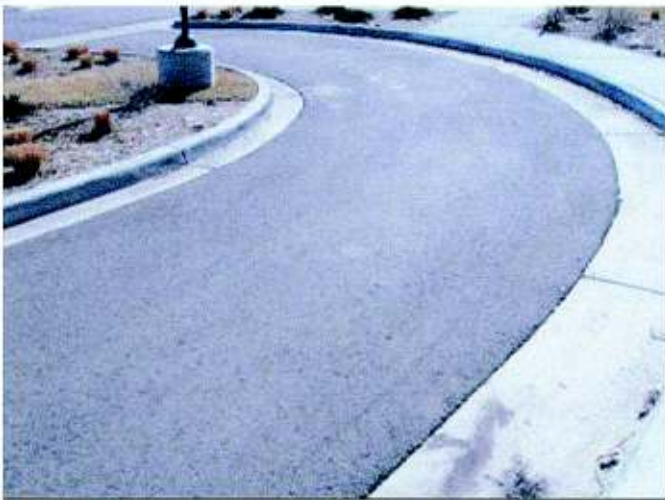
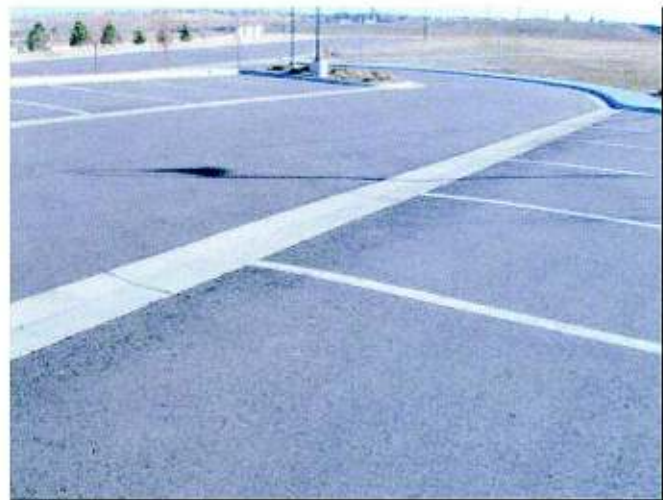
Comp #: 402 Asphalt - Seal Coat/crack fill

Surface has not been seal coated since it was installed. Industry professionals recommend sealing within 12 months of final application. Current conditions are good with some dryness and minor cracks. In this environment, expect to seal asphalt every 3 - 4 years, depending on traffic levels and effects from weather. Sealcoating is applied to protect the asphalt from ultra-violet rays and water. This helps in slowing the process of oxidation, cracking, and raveling. While acting as a protective barrier, it also maintains the appearance of the community to maintain or improve property values.

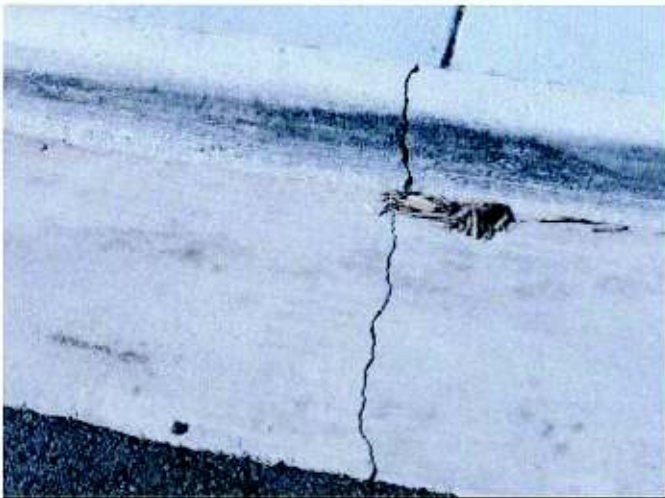
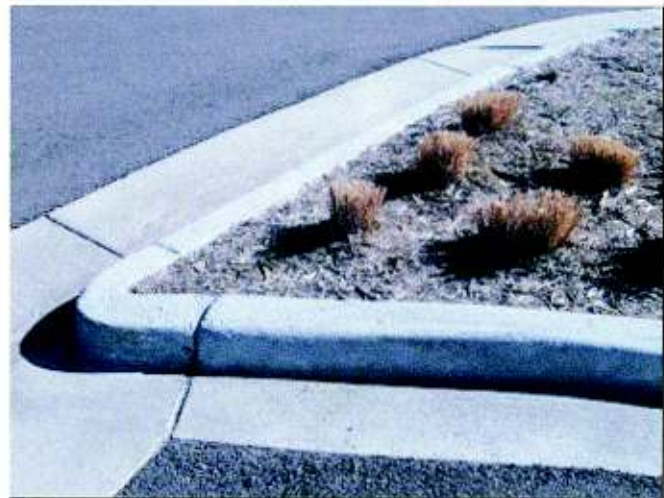
Comp #: 406 Drain Pans/Curb/Gutters - Repair

There were no major signs of problems noted at time of inspection other than a few minor cracks. It appeared that drainage was adequate as there were no signs of water stains or standing water at time of inspection. In this environment, concrete is subject to settling, cracking, and spalling. As a result, periodic repairs and replacements will be necessary. Similar to other concrete surfaces, we suggest establishing a Reserve fund to repair and replace approximately 10% of total area (345 GSF) every 4 years. Remaining life based on average condition.

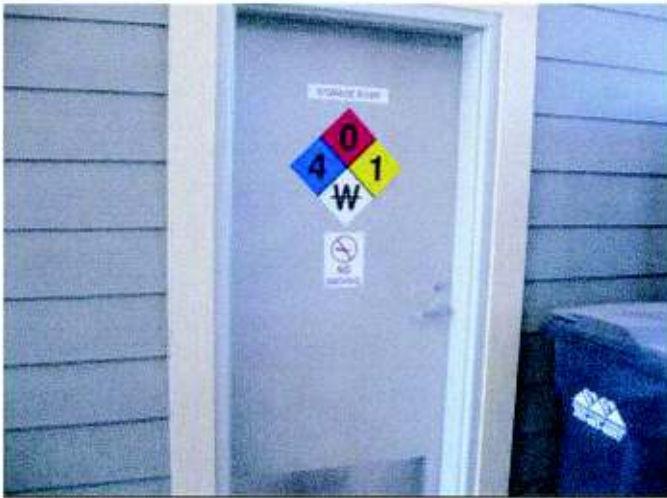
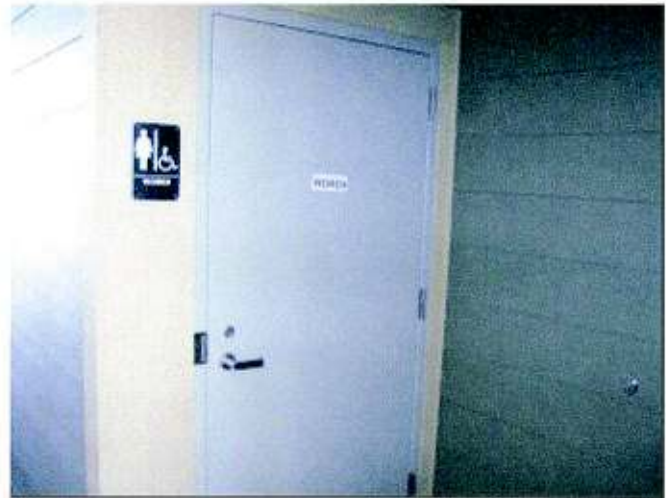
Comp #: 503 Utility Doors - Replace

No problems noted at the time of inspection. The life expectancy of these doors is indefinite due to the quality and the minimal amount of use on an annual basis. Therefore, Reserve funding for complete replacement is not necessary at this time.

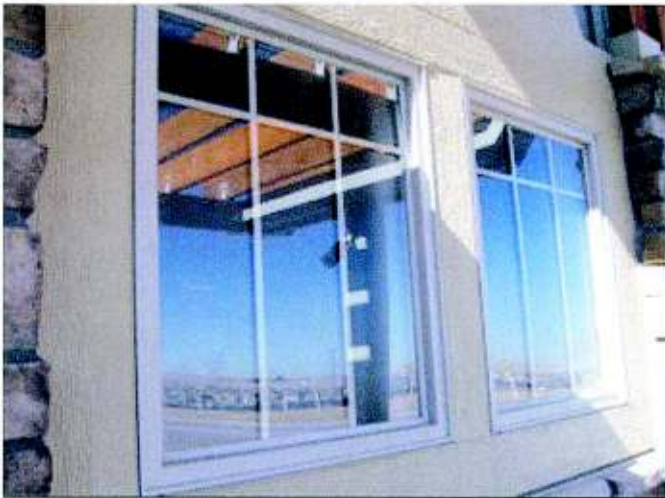
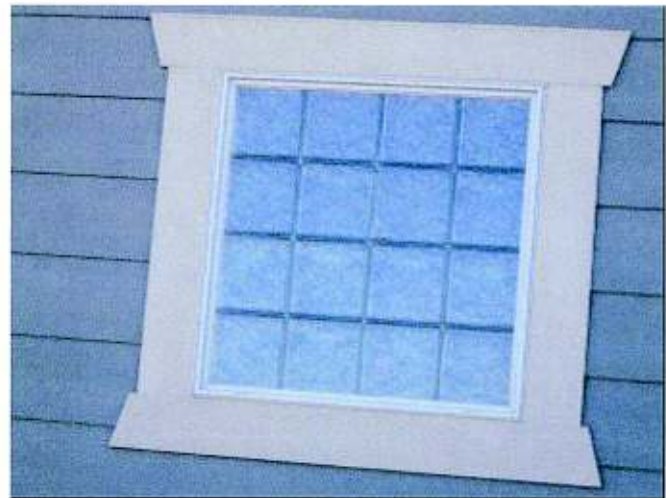
Comp #: 506 Windows - Replace

All doors and windows were functioning normally with no unusual conditions observed at time of inspection. Since these windows are non-habitable rooms, then collective replacement will not be necessary to maintain efficiency. We suggest replacing on an as needed basis with general operating funds, not Reserves.

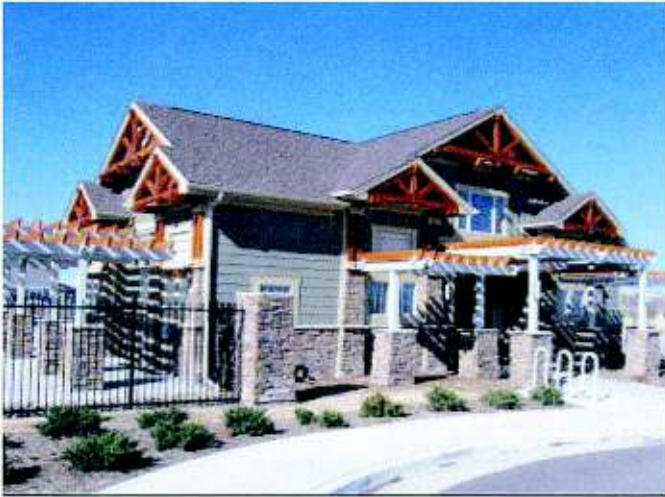
Comp #: 601 Concrete Sidewalks/Decks - Repair

All of the concrete surfaces are new and in good condition with only minor areas of cracking noted. Similar to other concrete surfaces, it is unlikely that all concrete surfaces will fail and need to be replaced at the same time. Therefore, we suggest establishing a Reserve fund for frequent repairs and replacement to a percentage of the area (5% or 2310 GSF) every 5 years. Coordinate repairs with other concrete surfaces for best cost estimate. As the property ages, the percentage of replacement may need to be increased in future Reserve Study updates.

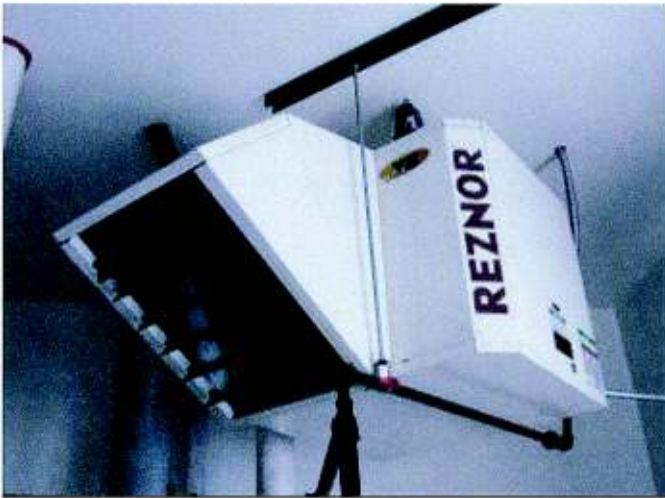
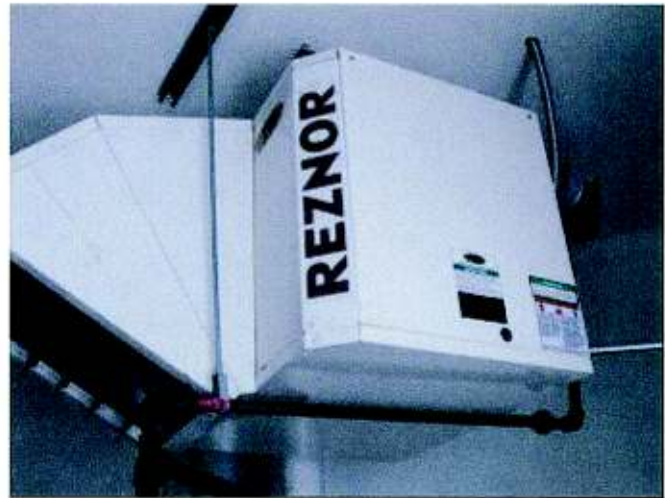
Comp #: 706 Space Heater - Replace

Heater is in good condition with no observed or reported problems noted at the time of inspection. Heater is used to maintain an adequate temperature for the equipment room. Depending on the level of use, expect a useful life of approximately 15 - 20 years from this component.

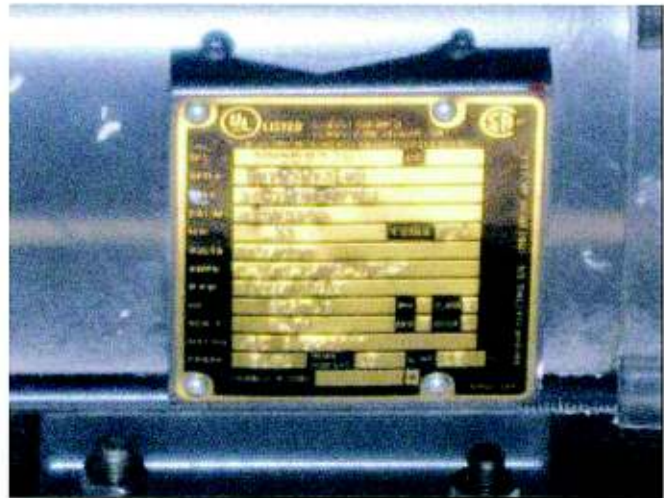
Comp #: 714 Chemical Room Exhaust Fan - Replace

Unit was in working order when inspected and appeared to be new and in good condition. Due to the low replacement cost of this unit, we suggest treating replacement on an as needed basis with general operating funds. Therefore, separate Reserve funding is not required for this component.

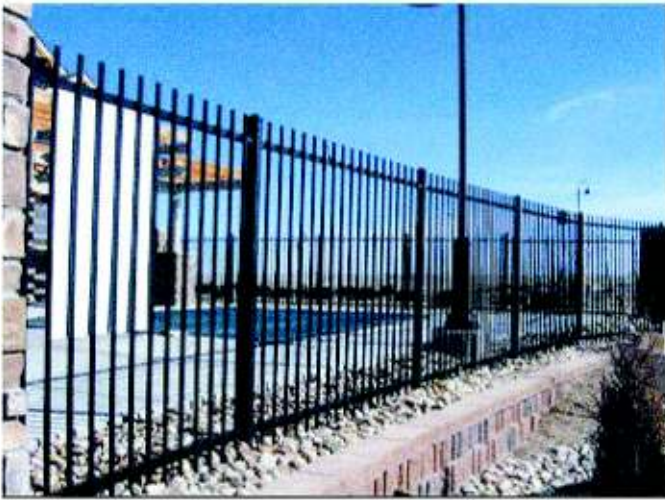
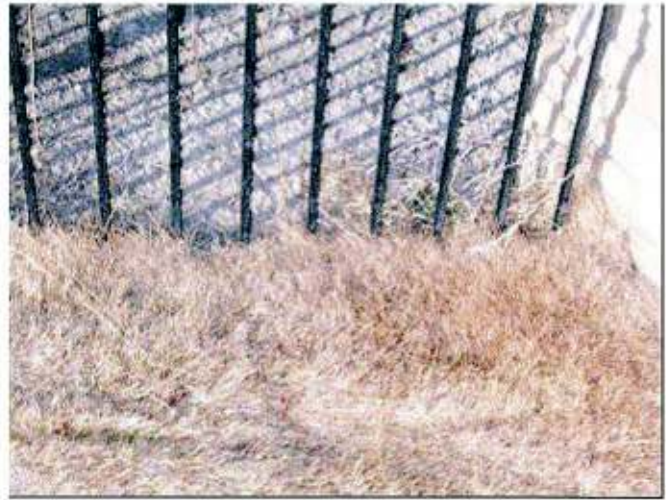
Comp #: 1002 Ironwork Fencing - Replace

In general, the gate and lock set for the pool area is in good condition with no structural problems observed. The majority of the fences are in good condition with no structural problems observed. However, the fencing in filing is installed flush with grass with no room for soil expansion and has direct contact with soil/grass which will increase rusting and deterioration. The fence in filing 1 needs coat of paint as it exhibited extensive signs of rusting at welds. The fence at S. Buchanan cul de sac iron was not attached at north side of column. The average replacement cycle for this type of fencing and gate typically ranges between 20 - 30 years, depending on maintenance levels and exposure to elements.

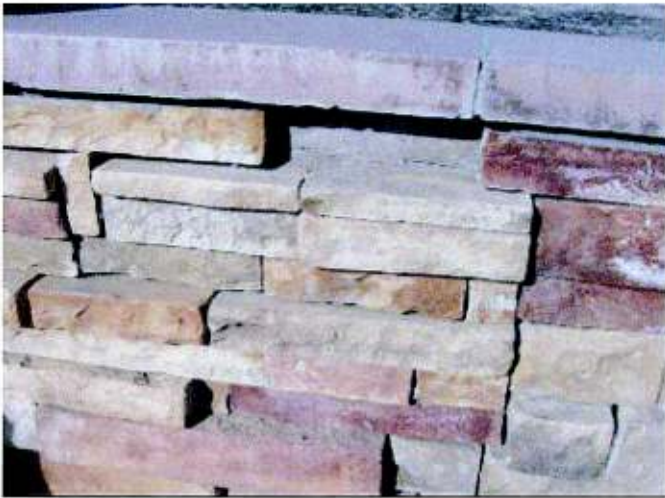
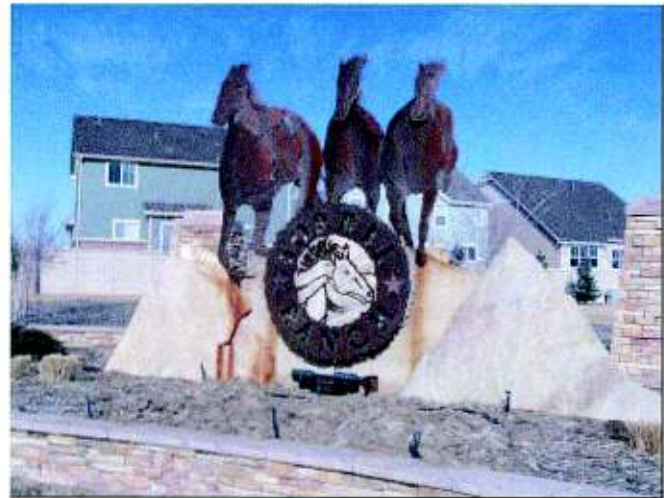
Comp #: 801 Monuments - Refurbish

Monument areas are primarily made up of flagstone rocks and rusted steel designs. The main monument has a flagstone wall where some pieces have fallen off and will require periodic repairs. While the materials used should have an indefinite life expectancy, we recommend planning on renovating monument every 10 - 12 years to maintain current trends and an appropriate appearance for the entrances to the community. It is expected that as other areas are constructed, more monuments will be installed and these numbers may need to be adjusted in future Reserve Study updates. Lighting should be replaced as needed with general operating funds.

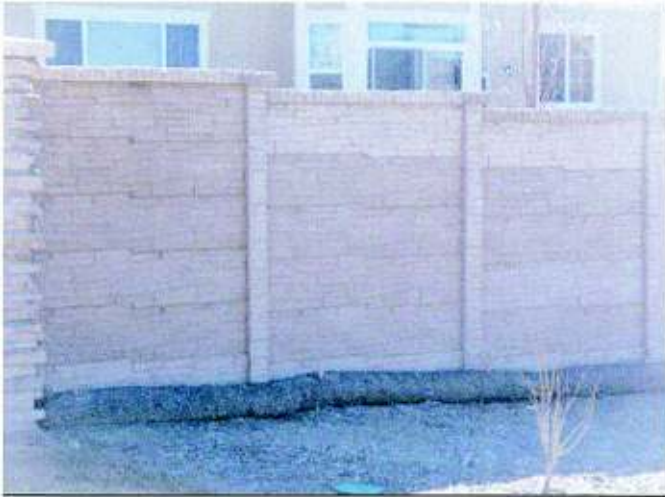
Comp #: 1003 Concrete Fence - Replace

Pre-Cast concrete perimeter wall appeared in good condition. We observed one section that was missing the top cap in filing 6 at the intersection of E Garden Dr and E Alexander Dr. Also observed another area in filing 6 along Aurora Parkway near the fire hydrant at the backyard of the 3rd house west of the intersection of Catawaba Way and Duquesne Ct that appeared more unstable than any other areas of the wall. According to the vendor, this material has a 10 year warranty against manufacturer defects. If moisture enters these cracks and with the temperature fluctuations, frequent cracking can be expected. While these panels can be replaced as needed, gradual replacement will result in a patch quilt appearance, which will lead to complete replacement.

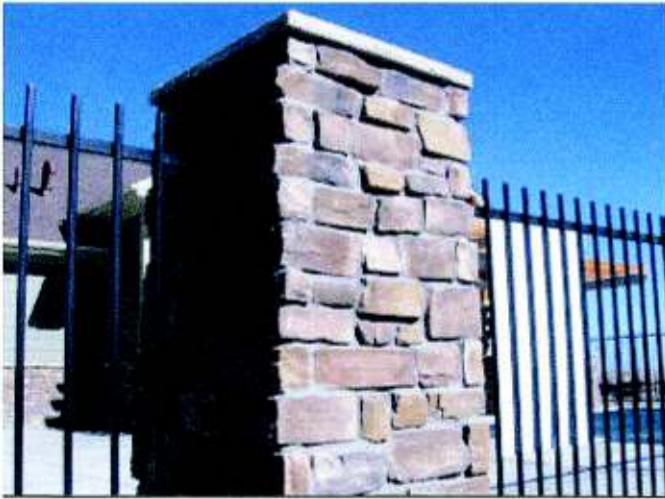
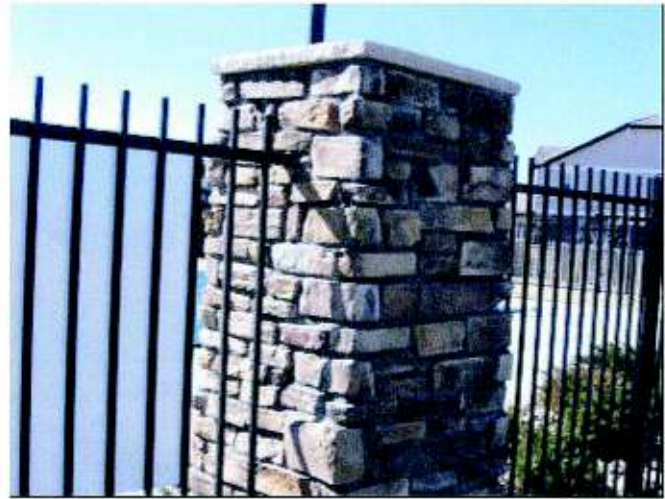
Comp #: 1005 Stone Columns- Major Repairs

All columns were in very good condition with no signs of loose stones at time of inspection. While it is unlikely that the entire column will need to be replaced, it is likely that major repairs will be necessary to replace loose or missing stones. Depending on the effects from weather and potential vandalism, we suggest establishing a Reserve fund for periodic repairs to the pillars every 10 years.

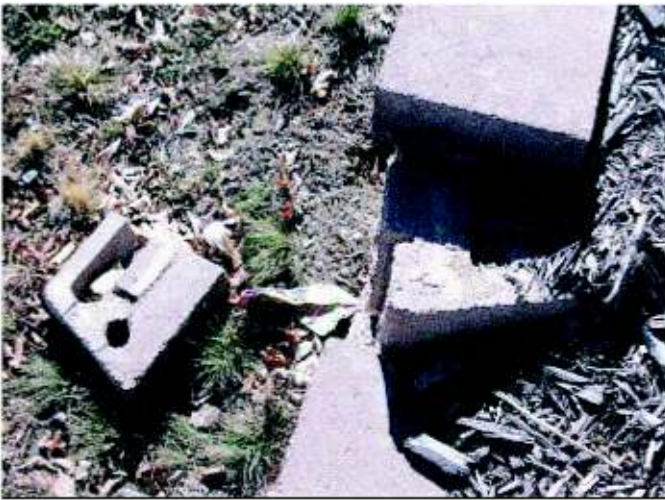
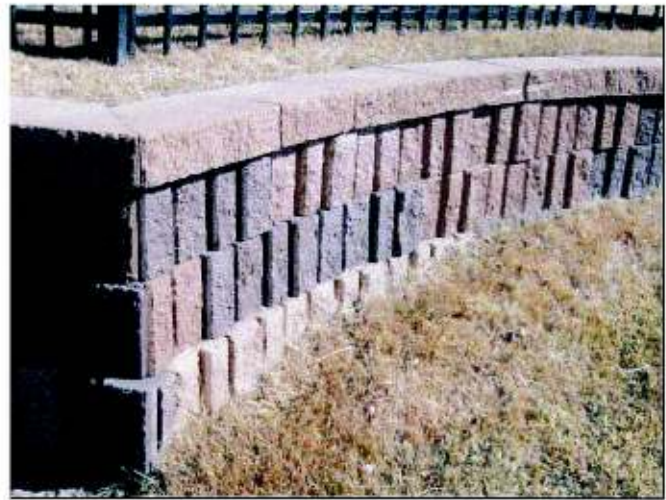
Comp #: 1011 Retaining Wall - Replace

We observed some loose cap stones at the wall in filing 1. The rest of the walls exhibited no significant cracking or structural problems at the time of inspection. As long as block wall was installed conforming to county code requirements this wall should have an extended useful life. This type of material has an indefinite life expectancy and complete replacement is unlikely. Therefore, Reserve funding is not required for this component.

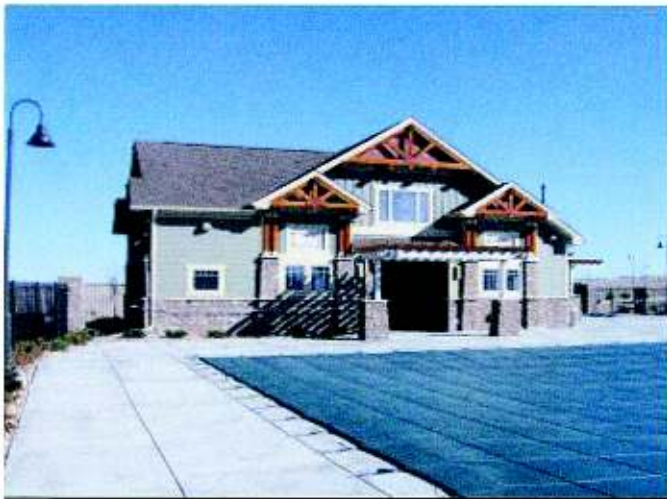
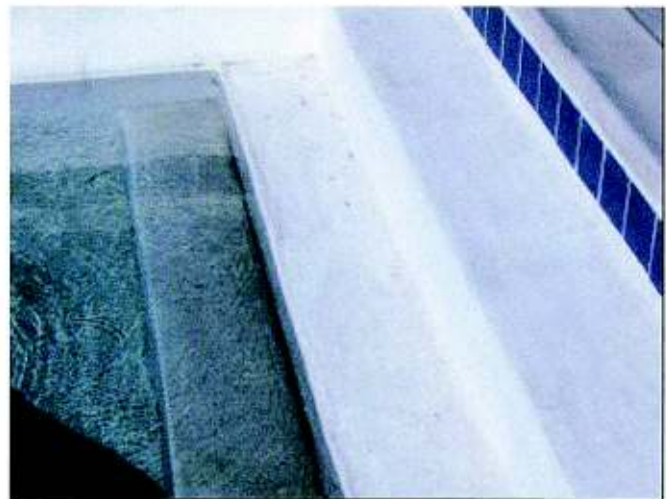
Comp #: 1101 Pool - Resurface

Pools were winterized and covered at time of inspection, so it was difficult to inspect the entire surface. Of the areas we were able to inspect, the plaster was smooth and in good condition with no cracks noted. The average resurfacing cycle for pool surfaces ranges from 8 - 10 years, depending on the quality of the water and the chemical levels in the water. In this climate, frequent acid washes are required to clean the surface after being winterized for 9 months a year. These acid washes gradually "eat" away the plaster and the surface becomes rough. The useful life and remaining life is based on the condition and age of property.

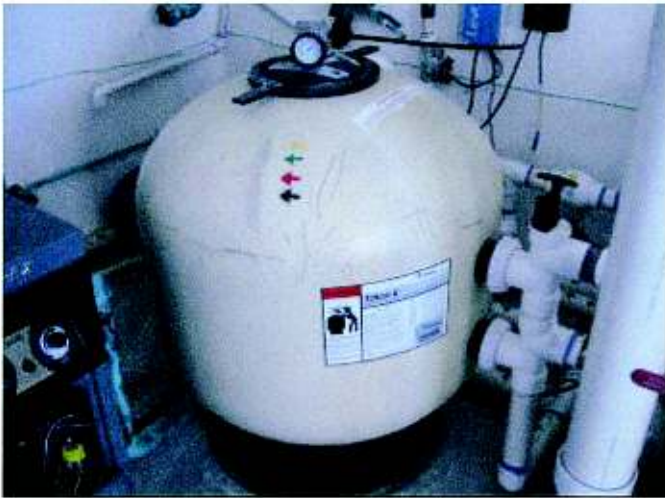
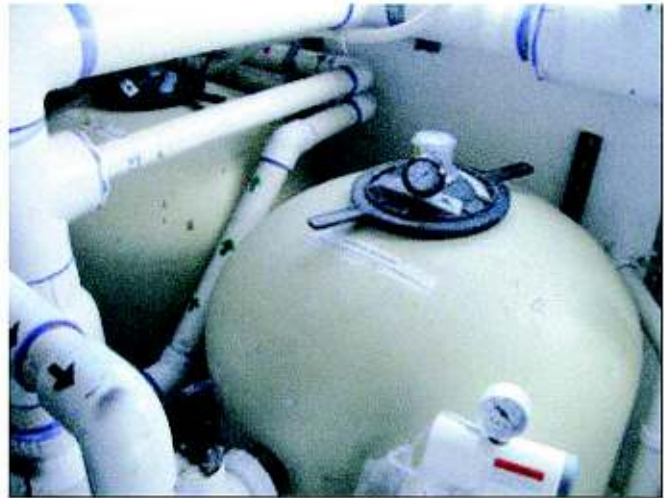
Comp #: 1108 Pool/Wader Filters - Replace

No unusual conditions observed at time of inspection. Pool and filtration system was shut down and winterized at time of inspection, so unable to inspect for current leaks. Typical replacement cycle ranges from 15 - 20 years, depending on maintenance and water quality.

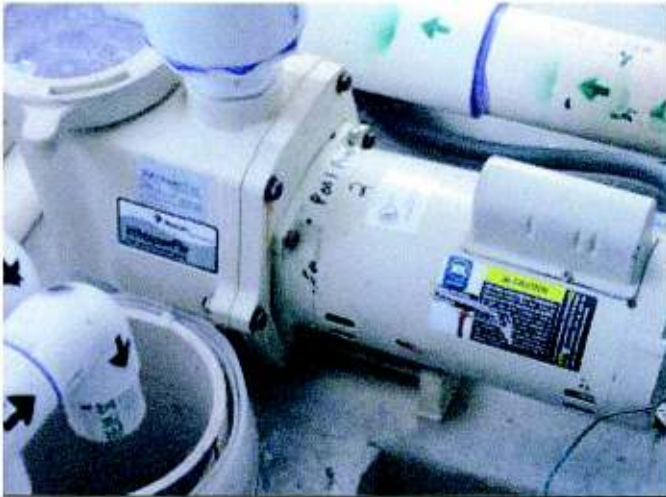
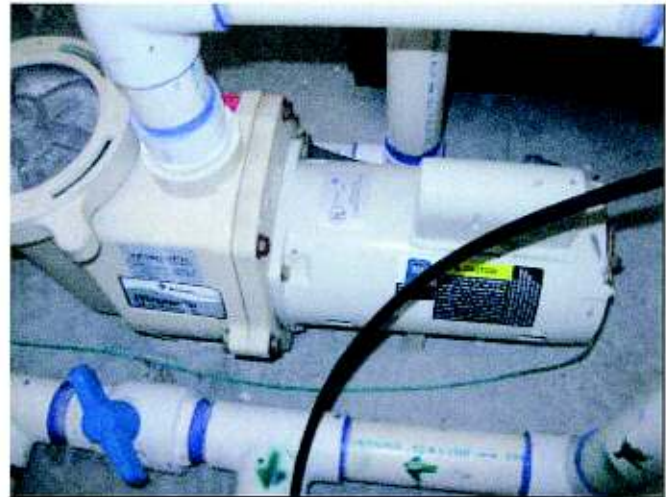
Comp #: 1111 Pool/Wader Pumps - Replace

No unusual conditions were observed or reported at time of report preparation. The life expectancy for this equipment can differ depending on the level of use and maintenance, as well as the quality of the equipment. Therefore, we suggest establishing an allowance for periodic replacement of the equipment. Meaning, this is just an allowance to provide the association some funds to replace equipment when required.

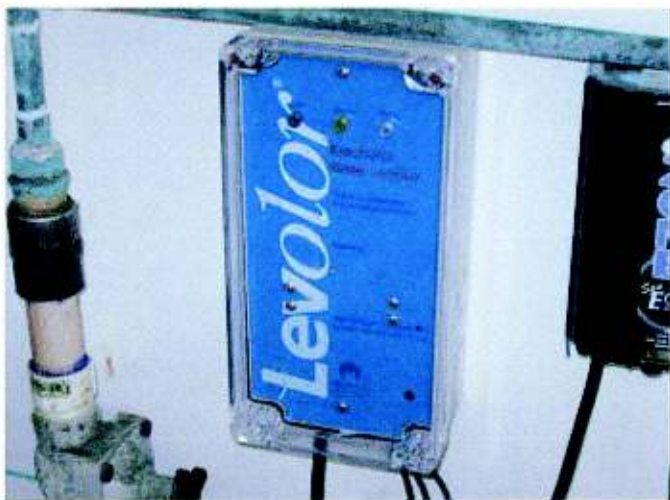
Comp #: 1112 Pool/Wader Levelers - Replace

No unusual conditions observed during inspection. Pools were winterized at time of inspection so operation could not be verified. The replacement cost of these units (less than \$400 each) is too small for separate Reserve designation. Therefore, at this time, we suggest treating replacement on an as needed basis with operating funds.

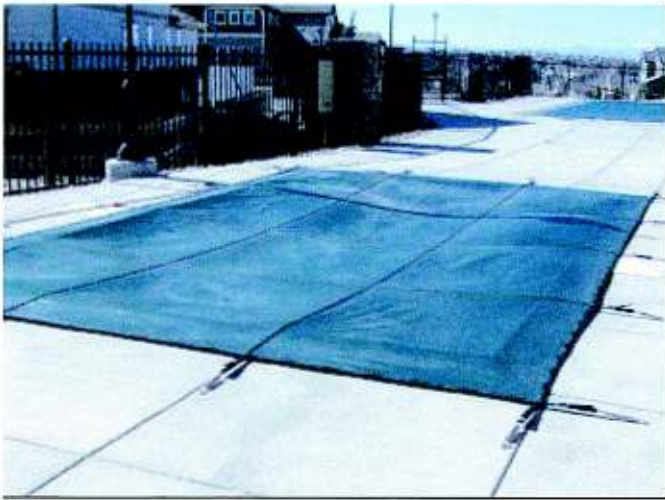
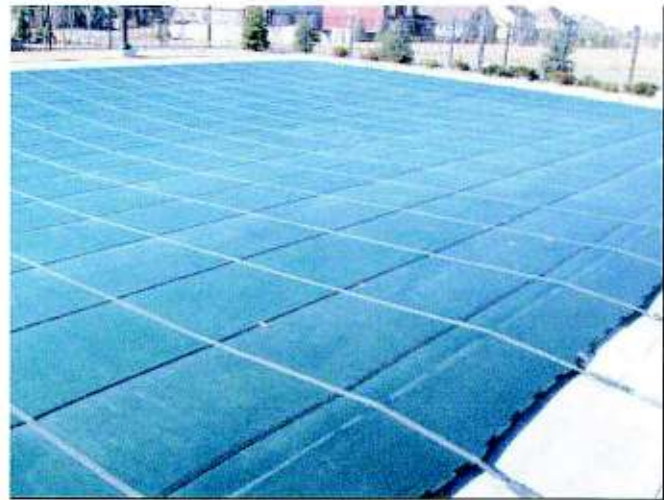
Comp #: 1113 Pool/Wader Covers - Replace

Covers were in good condition at time of inspection with no signs of tears, fading or fraying around edges. While most cover manufacturers carry a 10 year warranty against defects, there are strict storage requirements to adhere to the warranty. In this environment, the cover fabric typically has a life expectancy of 6 - 10 years. The replacement cost is a little higher than normal for the pool cover due to the need for a custom design.

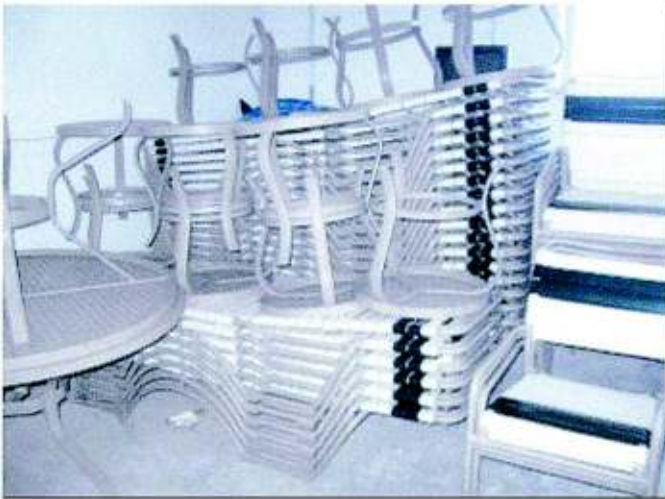
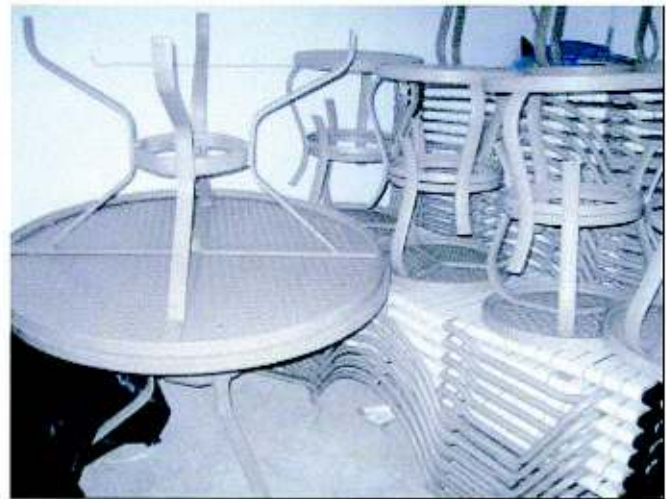
Comp #: 1121 Pool Furniture - Replace

It was difficult to inspect all pieces because they were still stacked upon each other. From what we were able to inspect, the furniture is in fair condition with no major signs of broken straps or significant sun damage noted at the time of inspection. The replacement cycle depends on the level of use and care. Remaining life based on current age and condition. These are stored during winter months, so expect a longer replacement cycle. The association is planning on buying new umbrellas before the 2009 swim season begins.

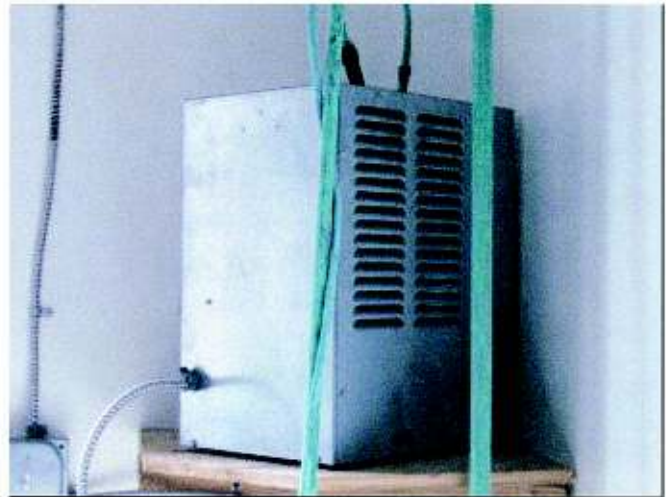
Comp #: 1304 Drinking Fountain - Replace

No problems noted with drinking fountain at the time of inspection. System was winterized. Due to the minimal replacement cost associated with this component, Reserve funding is not appropriate. Repair and replace as necessary as an operating expense.

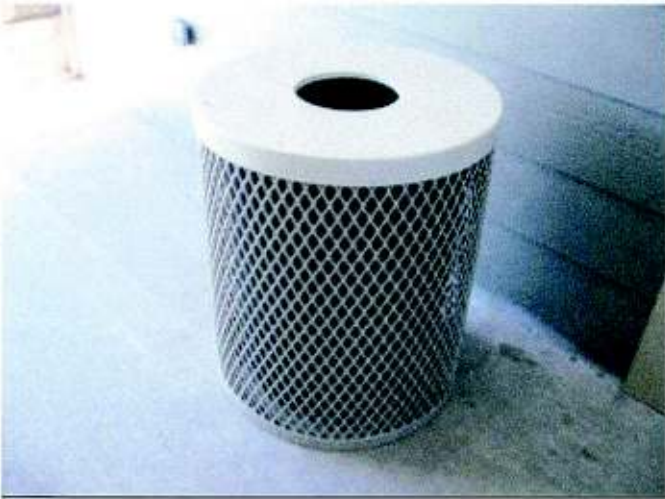
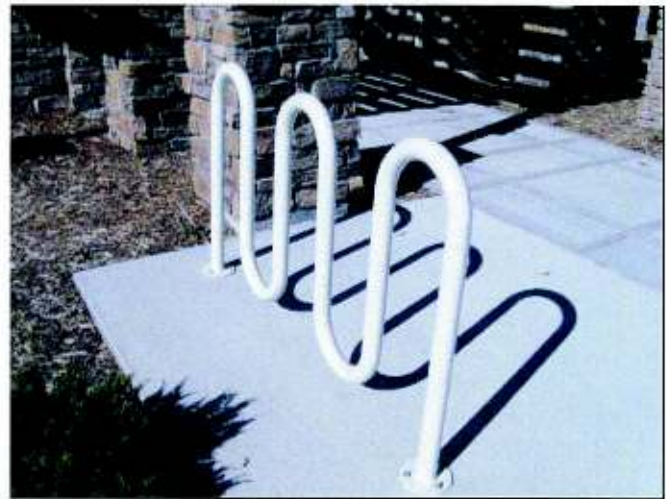
Comp #: 1308 Park Equipment - Replace

All found to be in good condition with no unusual conditions observed during inspection. The individual cost (less than \$400 each) of the bike rack is too small for separate Reserve designation. However, the trash receptacles will eventually need to be replaced and the cost of these warrant funding when combined to be replaced at the same time. We suggest replacing all at same time to maintain a consistent appearance.

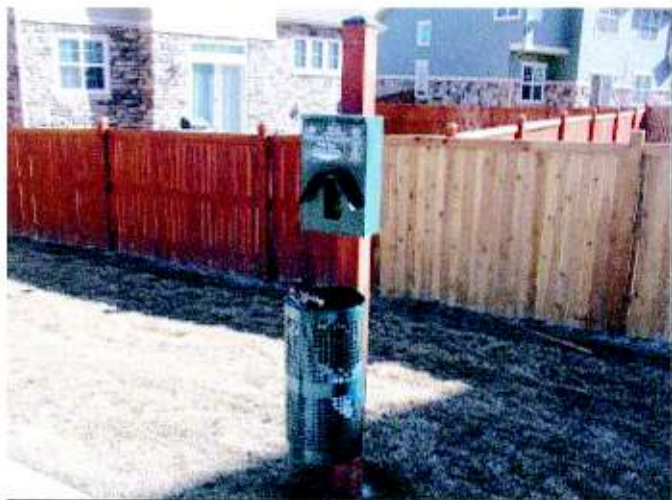
Comp #: 1311 Pet Waste Pick Up Stations - Replace

No unusual conditions observed during inspection. The individual replacement cost of these stations (less than \$400 each) is too small for Reserve consideration. Therefore, we recommend replacing these on an as needed basis with general operating funds.

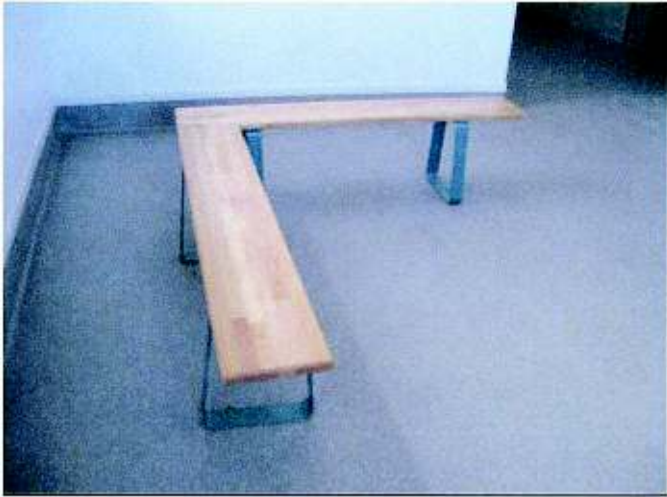
Comp #: 1405 Furnishings - Replace

No problems noted with benches at the time of inspection. Due to the minimal replacement cost and long life associated with wood benches of this type, Reserve funding is not appropriate. Make repairs or replacements as necessary as an operating expense.
