**Sorrel Ranch HOA**  
**Aurora Parkway & Alexander Drive**  
**Aurora, CO 80016**

**Level 1 Reserve Analysis**

**Report Period – 01/01/09 – 12/31/09**

**Date of Property Inspection – February 12, 2009**  
**Report Prepared by – G. Michael Kelsen**  
**Property Inspected by - G. Michael Kelsen & Curtis Karkoski**  
**Main Contact Person - Mr. Scott Ryan, Community Manager**

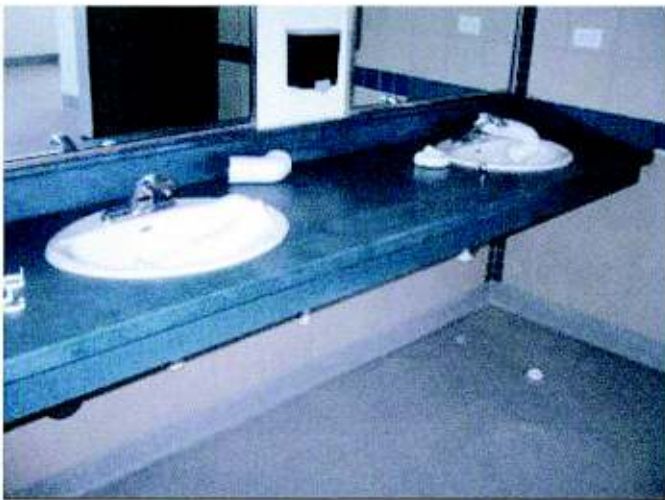
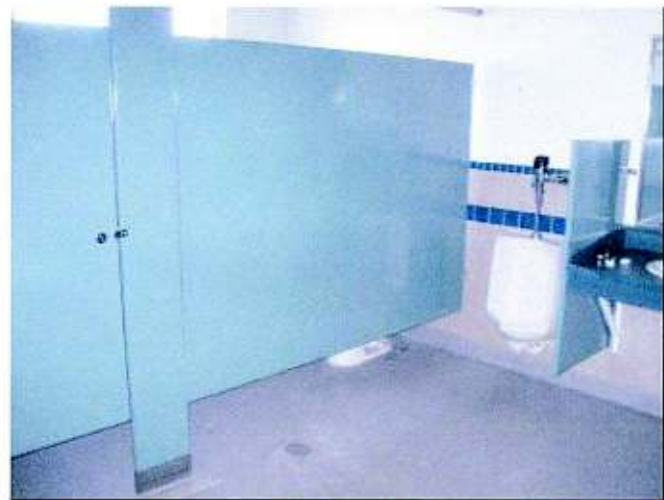
Comp #: 1413 Restrooms - Remodel

In general, restrooms are in good condition with no significant signs of wear or deterioration. These rooms are used only 3 months a year, so expect a longer life expectancy than most applications. Most associations perform a general remodel of the restroom/locker room interiors every 15 - 20 years to maintain appearance and keep up with current decorative trends. The final decision is up to the community members in deciding when to spend the money to perform this project since it is considered cosmetic and discretionary.

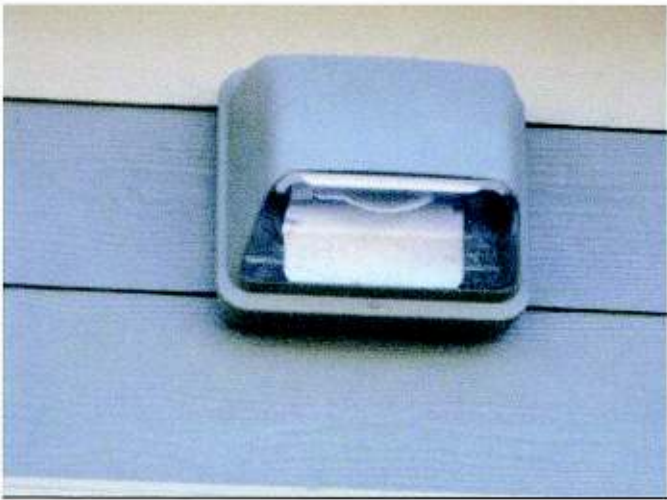
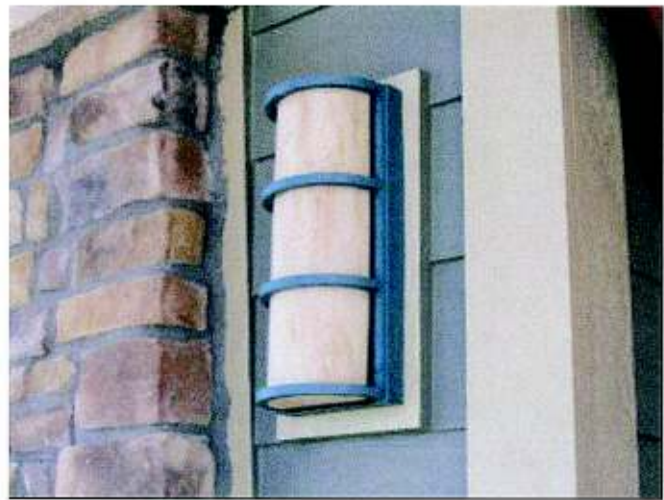
Comp #: 1602 Exterior Wall Mount - Replace

No unusual conditions were observed or reported at time of inspection. While replacement can occur on an as needed basis, it is our opinion and recommendation to replace all lights at the same time every 15 - 20 years to maintain a consistent appearance throughout the property. In addition, by replacing multiple fixtures, the association will be able to obtain a quantity discount for the fixtures. Estimated replacement cost includes labor for installation.

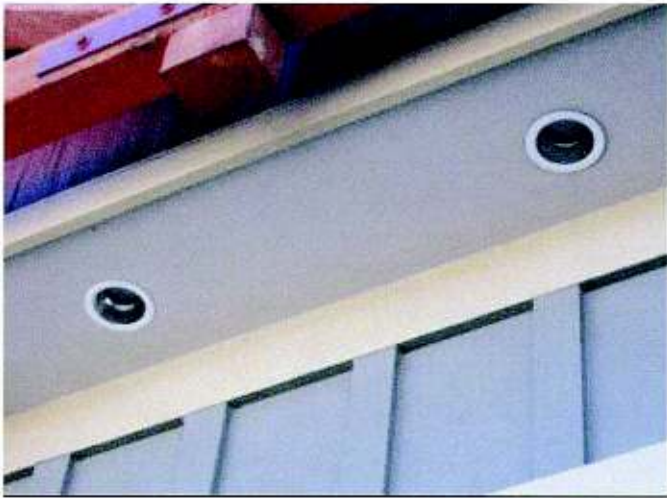
Comp #: 1608 Can Lights - Replace

No unusual conditions observed during inspection. The individual replacement cost (less than \$60 each) is too small for separate Reserve designation. Also, these are not considered to be decorative lights, so periodic replacement should not effect the consistent appearance of the clubhouse. Therefore, we suggest replacing these on an as needed basis with general operating funds.

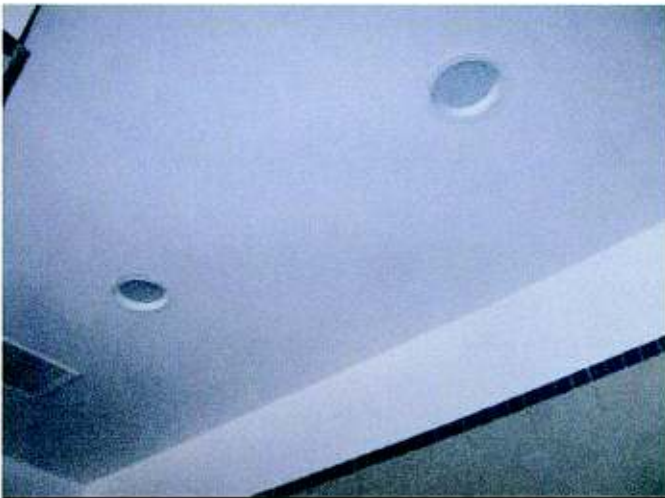
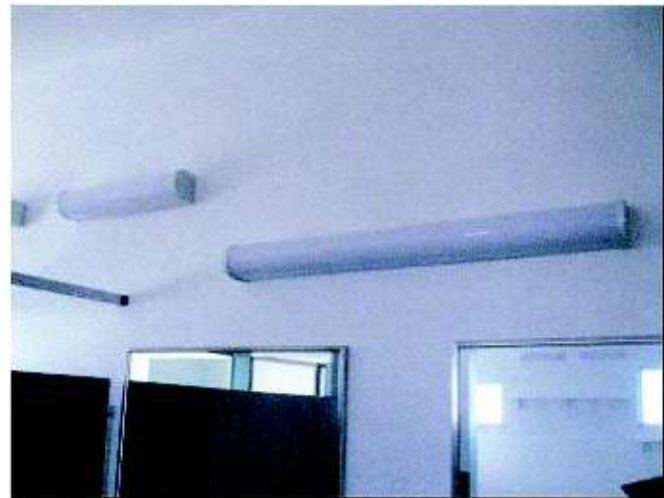
Comp #: 1608 Interior Lights - Replace

No unusual conditions observed during inspection. The individual replacement cost (less than \$100 each) is too small for separate Reserve designation. Therefore, we suggest replacing or repairing these on an as needed basis with general operating funds, or include replacement as part of the restroom remodel costs.

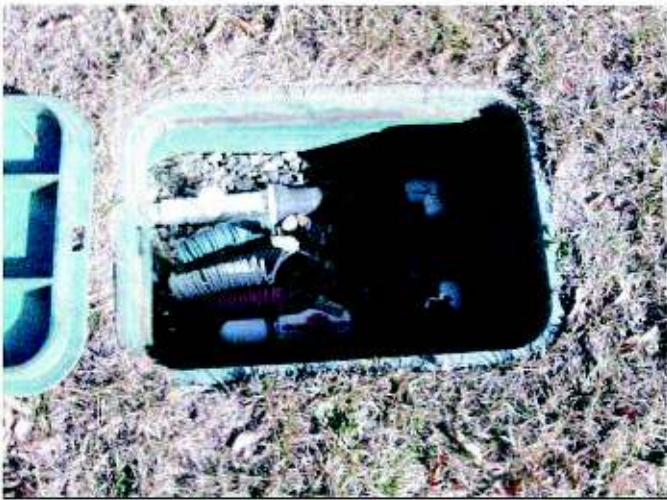
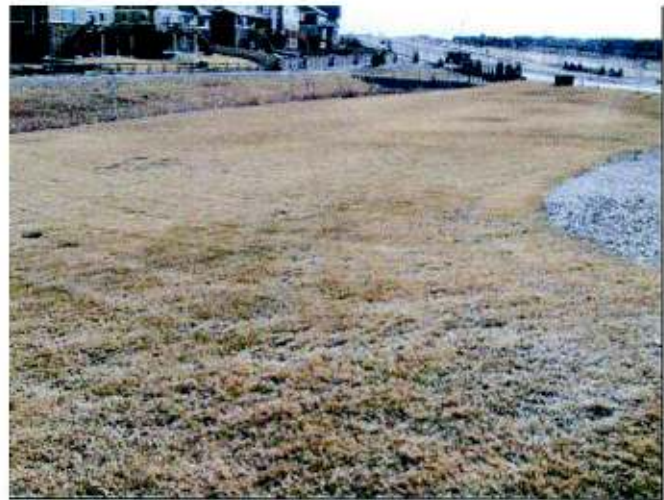
Comp #: 1701 Irrigation System - Rebuild

Irrigation system appears to be functional and in good condition with no visible problems noted during inspection. The materials used during construction should have a long life expectancy with proper maintenance. At this time, there is no expectancy to completely replace the system and Reserve funding is not recommended. We recommend the association establish a line item in the general operating budget for annual repairs to necessary components of the system (broken lines, sprinkler heads, valves, backflow preventers, etc). If it later turns out that complete replacement will be necessary, expect to spend approximately \$1,000,000 (\$3,000 per zone) for a new system, plus landscaping.

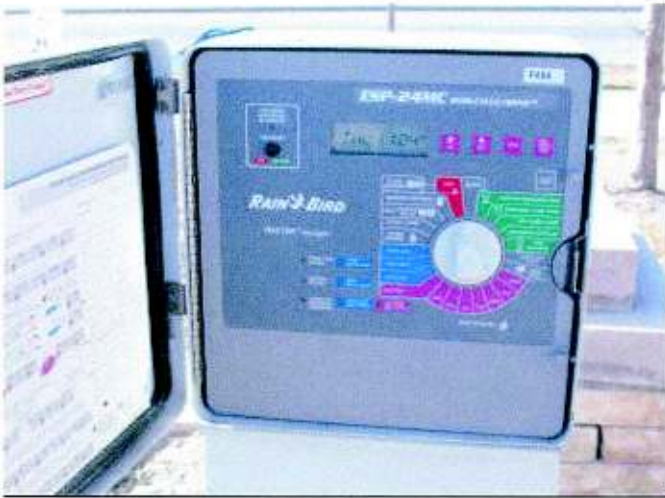
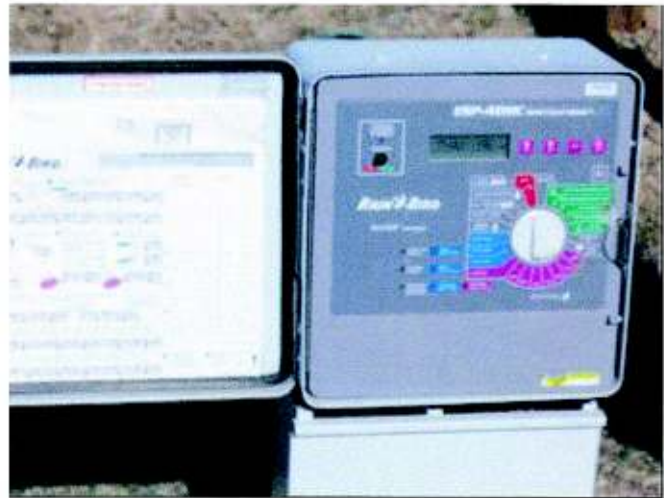
Comp #: 1703 Irrigation Timeclocks - Replace

System was winterized at time of inspection, so we were unable to test the function of the clocks. The base of the clock at E. Brandt place was very unstable and should be repaired. Also, both enclosures were exhibiting signs of rust and corrosion at the E. Berry Ave. location. Ages of clocks vary between 1 and 6 years old. Under normal conditions (not including Acts of God, vandalism, etc.) these clocks should last 10 - 12 years with proper maintenance. Due to the varying ages of the clocks, we suggest establishing a Reserve allowance to replace 3 clocks every 4 years. As the property ages and grows, it is expected more areas will be brought on and more clocks may be added. These numbers can be adjusted in future Reserve Study updates.

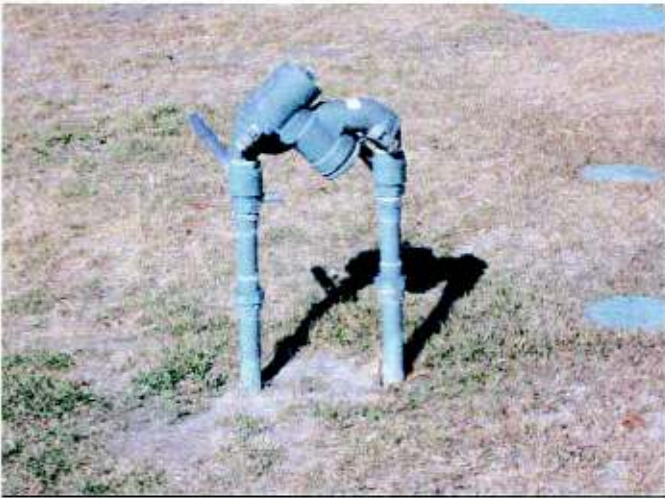
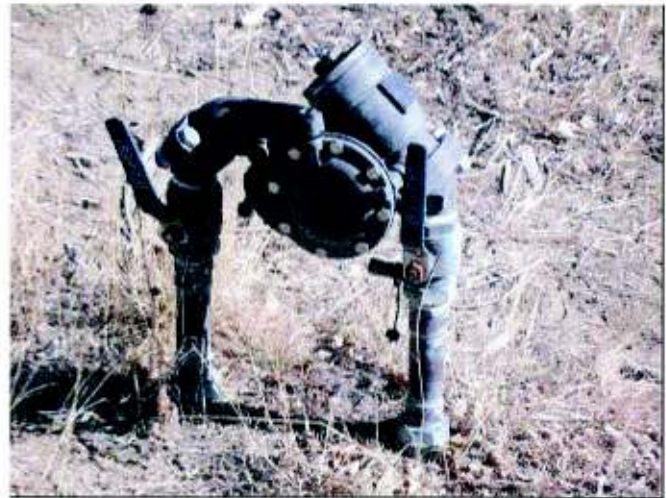
Comp #: 1706 Backflow Devices - Replace

No problems noted at the time of inspection. Due to the minimal replacement cost (\$500 - \$800 each) and unpredictable useful life associated with this component, reserve funding is not appropriate. Make repairs and replacements as necessary as an operating expense.

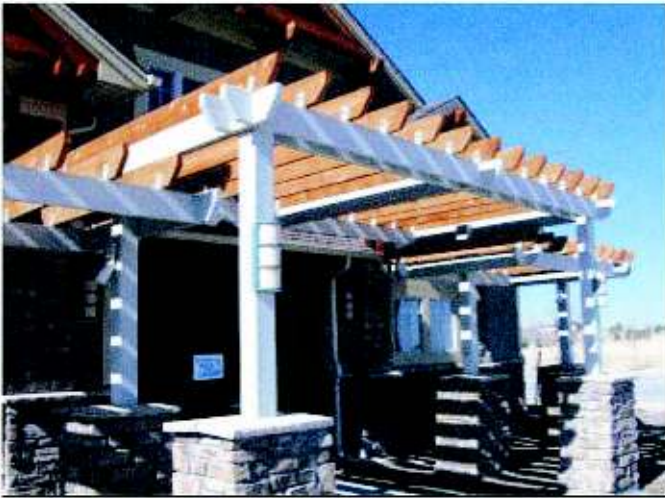
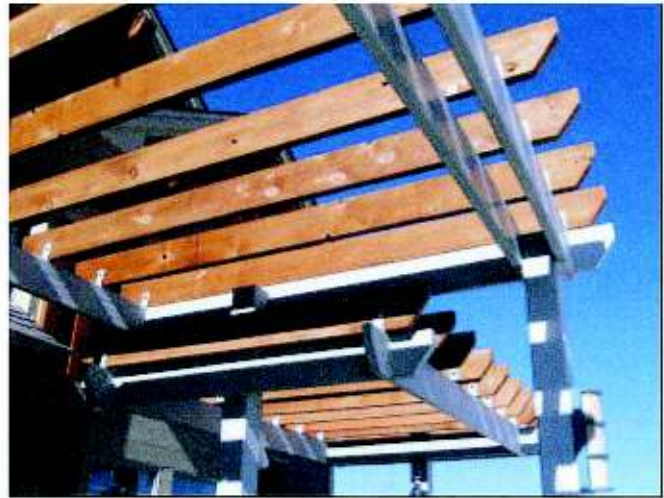
Comp #: 2001 Trellis System - Refurbish

All steel post and beams are in good condition with no rust showing through the paint. Re-painting should be coordinated every 3 - 4 years along with the wood beam restaining. The steel posts and beams are heavy duty and should have an extended life expectancy with proper maintenance. We suggest replacing the wood cross members on an as needed basis with general operating funds before staining occurs.
