## **“Full” Reserve Study**

### **Stapleton Filing #2 Denver, Colorado**

Report #: 16891-0  
For Period Beginning: January 1, 2008  
Ending: December 31, 2008

Date Prepared: August 22, 2008

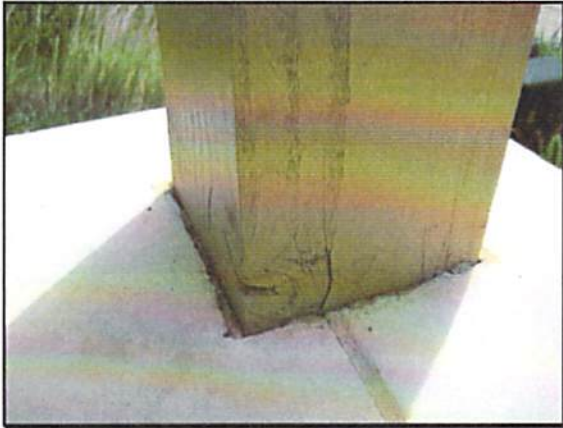
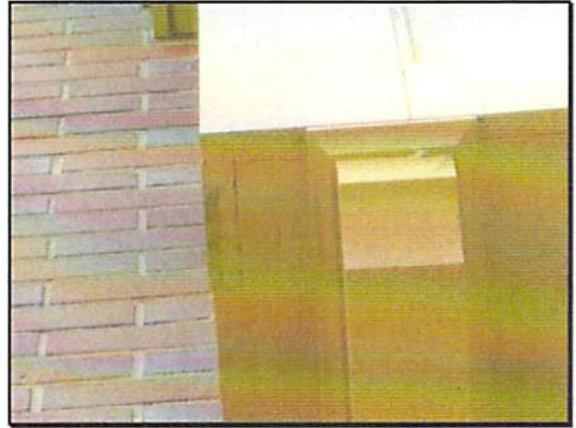
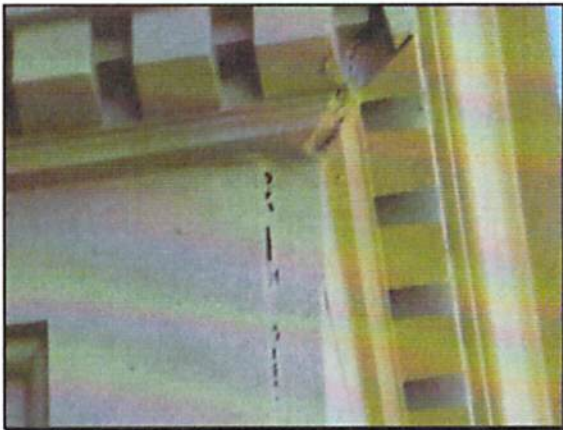
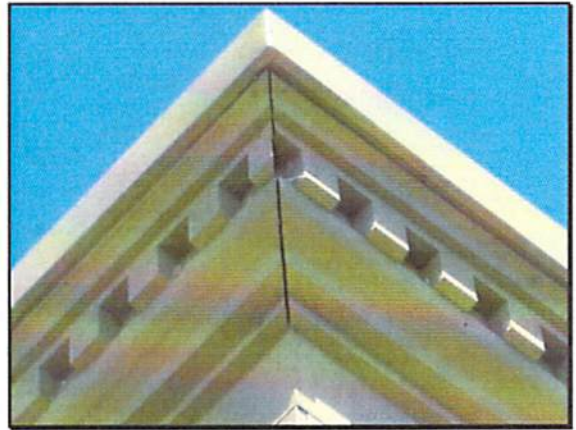
We also observed several areas of caulking separation, dry and splitting wood and a lack of paint coverage. We recommend those areas be addressed to ensure a proper maintenance, appearance and full useful life of the exterior siding and wood components. Also, areas where wood abuts a different material, e.g., where a wood post is surrounded by concrete decorative cap, we recommend caulking between the two components, which will mitigate any subsurface moisture and potential future damage.

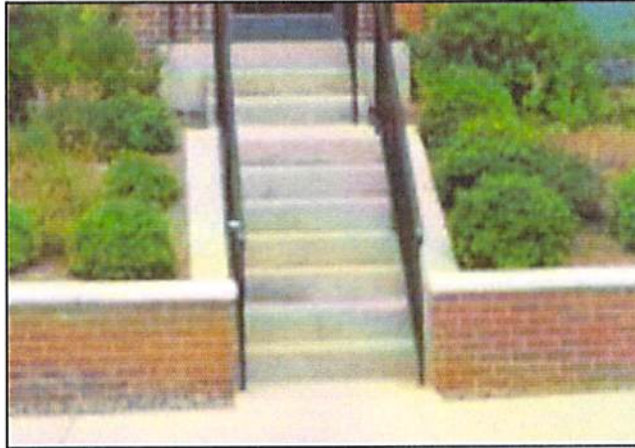
**Comp #:** 103 Concrete Deck/Walk - Replace/Repair

Remaining Life:

3 years

Best Case: \$4,000.00

Worst Case: \$6,000.00

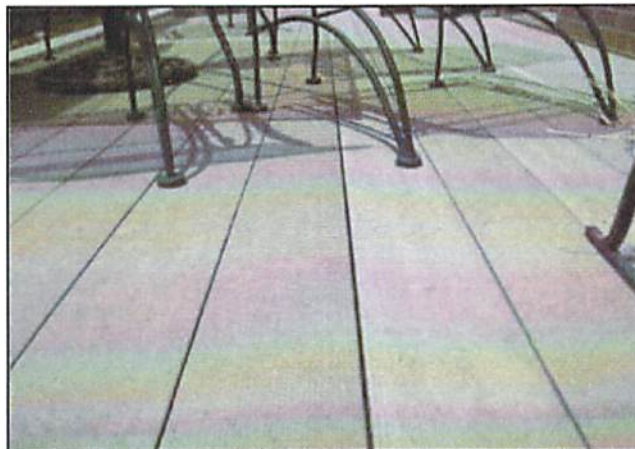
Remaining Life:

5 years

Best Case: \$4,000.00

Worst Case: \$5,000.00

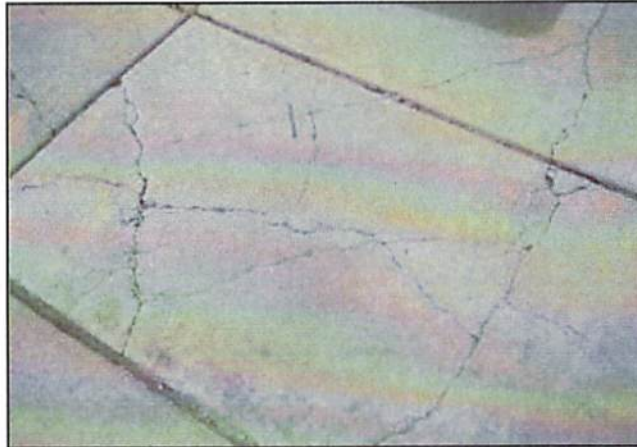
Remaining Life:

0 years

Best Case: \$5,000.00

Lower allowance to replace

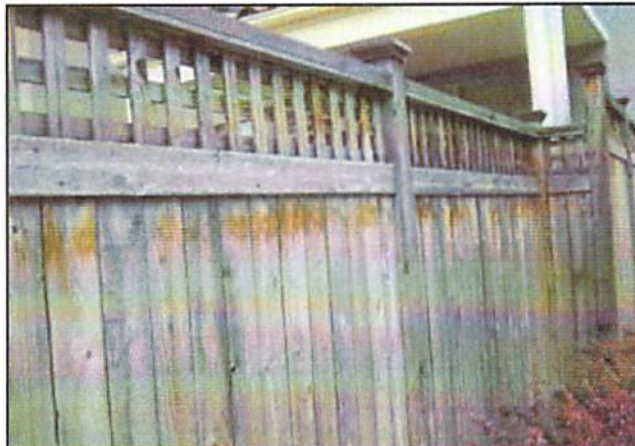
Remaining Life:

3 years

Best Case: \$10,000.00

\$25/LF - Lower estimate to replace

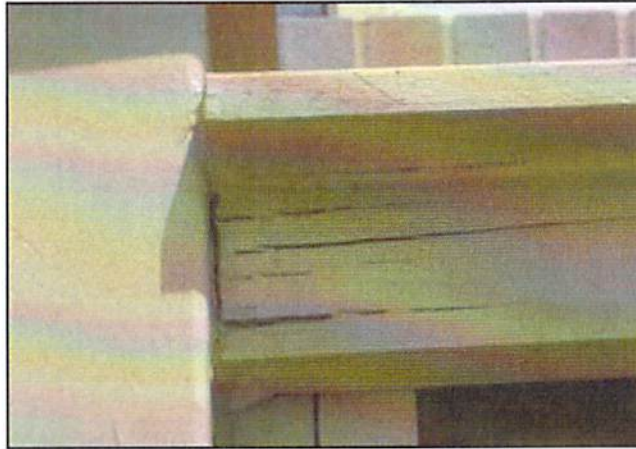
**Remaining Life:**

5 years

**Best Case:** \$10,500.00

\$20/LF - Lower estimate to replace with wood - 30%

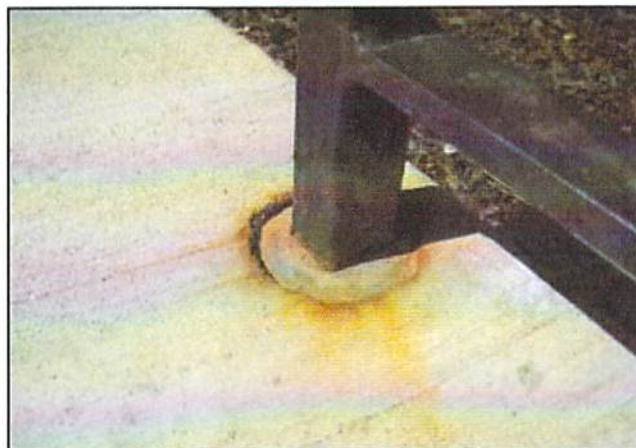
**Remaining Life:**

15 years

**Best Case:** \$16,800.00

\$70/LF - Lower estimate to replace - 10%

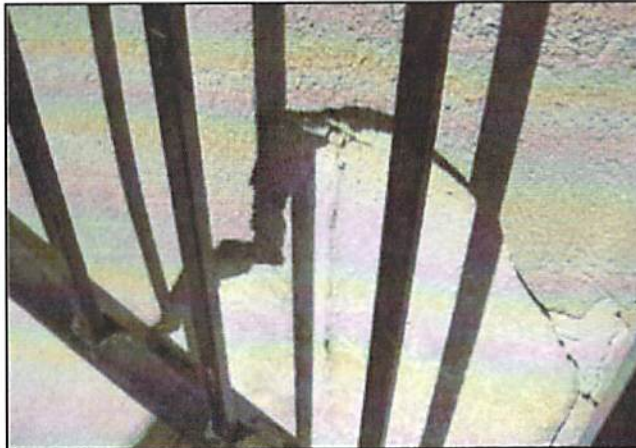
Useful Life:  
5 years

Remaining Life:  
0 years

Best Case: \$3,000.00  
Lower allowance to repair

Worst Case: \$5,000.00  
Higher allowance to repair

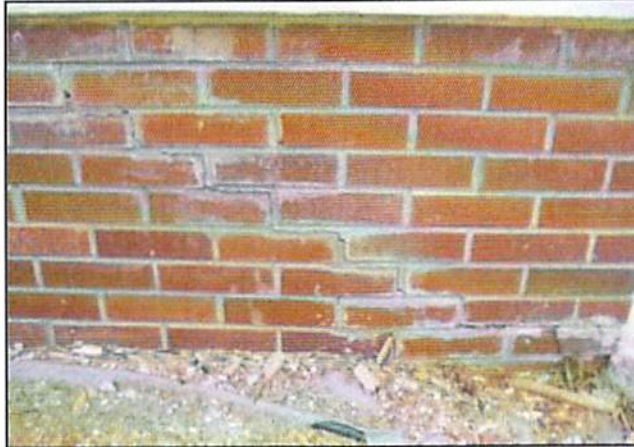
**Remaining Life:**

4 years

**Best Case:** \$2,500.00

Lower allowance for repairs

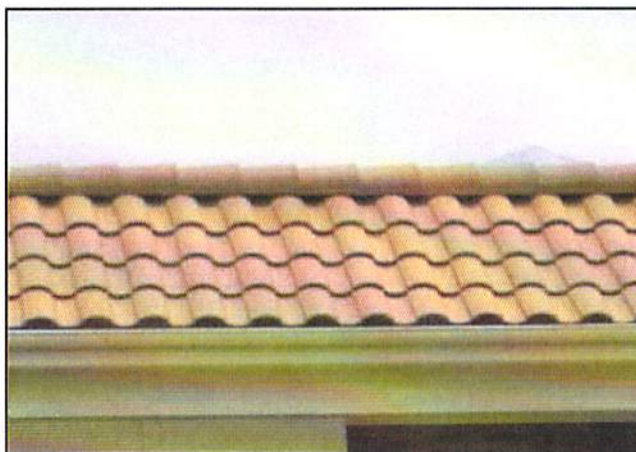
Useful Life:  
30 years

Remaining Life:  
15 years

Best Case: \$12,600.00

\$6/GSF - Lower estimate to replace

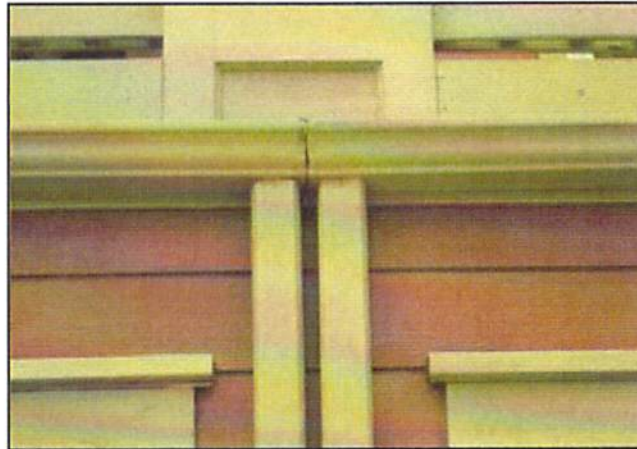
Remaining Life:

10 years

Best Case: \$4,000.00

Lower allowance for repair
