# **Stapleton Filing 2 Townhome Association**

**2810 – 2880 Syracuse Ct. & 7750 – 8490 E. 29<sup>th</sup> Avenue  
Denver, CO 80238**

## **Level 2 Reserve Analysis**

**Final  
Report**

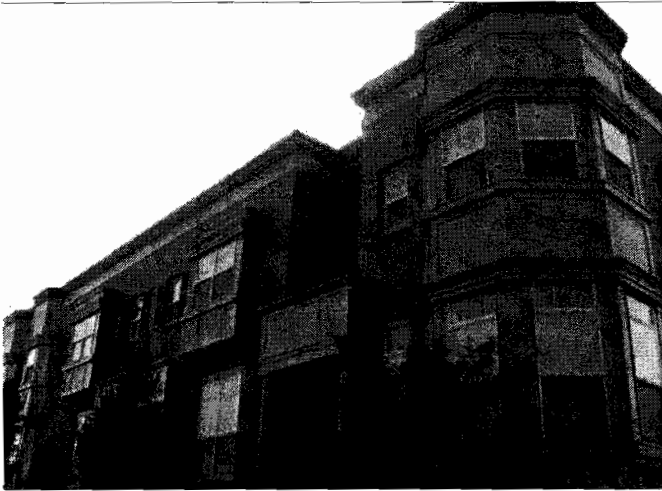
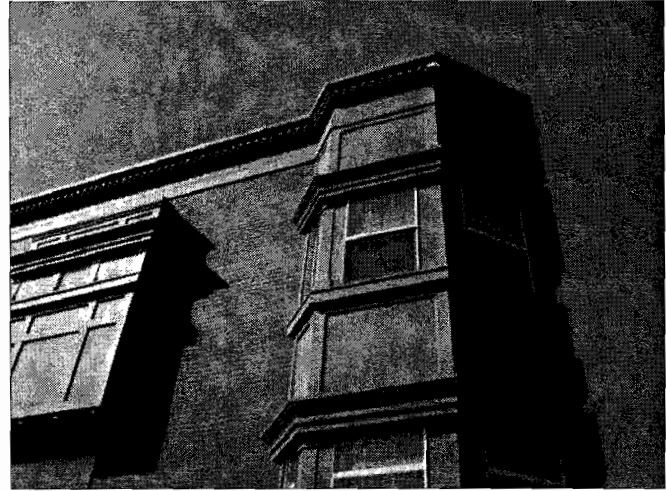
Comp #: 103 EPDM Flat Roof - Replace 1

We were not able to access roof to inspect these roofs. It was previously reported that the roofs are in good to fair condition with good slopes for drainage. At this time, continue to expect a full useful life of this component. We would recommend inspections to occur every 1 - 2 years by a roofing contractor to ensure proper maintenance and whether or not deterioration is consistent with estimated remaining useful life.

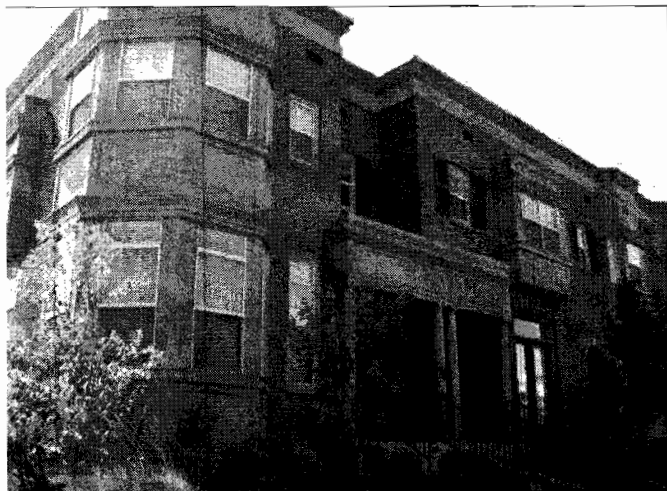
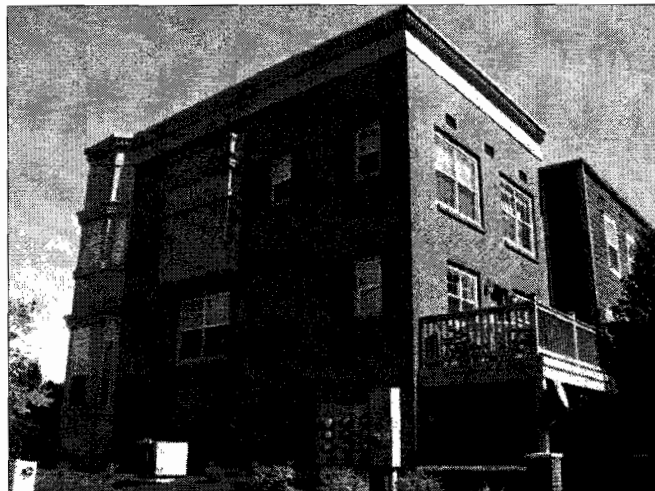
Comp #: 103 EPDM Flat Roof - Replace 2

We were not able to access roof to inspect these roofs. It was previously reported that the roofs are in good to fair condition with good slopes for drainage. At this time, continue to expect a full useful life of this component. We would recommend inspections to occur every 1 - 2 years by a roofing contractor to ensure proper maintenance and whether or not deterioration is consistent with estimated remaining useful life.

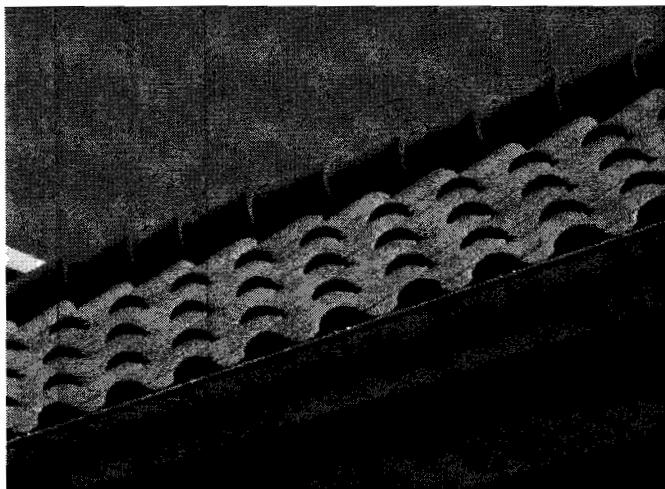
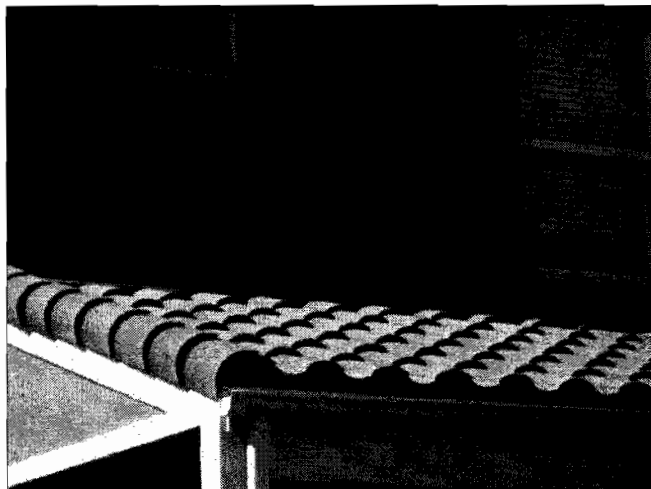
Comp #: 106 Tile Roof - Replace

The Spanish tile roofs appear to be in good condition with no broken or missing tile noted during the inspection. However, we were not able to closely inspect the roofs due to not wanting to cause any damage to the roof material. This material cracks very easily from the weight of a person walking around on the roof. While the tiles act as the primary water barrier from intrusion into the building, the underlayment (usually a 40 lb felt fabric) also is very important in protecting the building from water intrusion. This underlayment will typically require replacement every 20 - 30 years in this environment. Replacement of underlayment involves removal of roof tiles, replacing the underlayment and reapplying the tiles. Reserve to replace the underlayment and replace some tiles every 25 years.

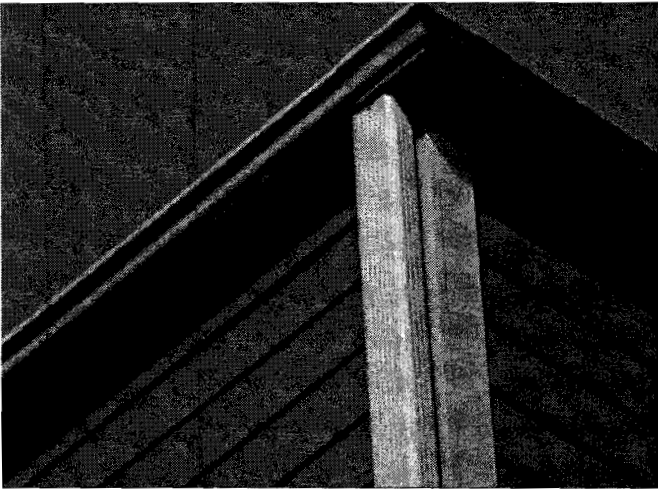
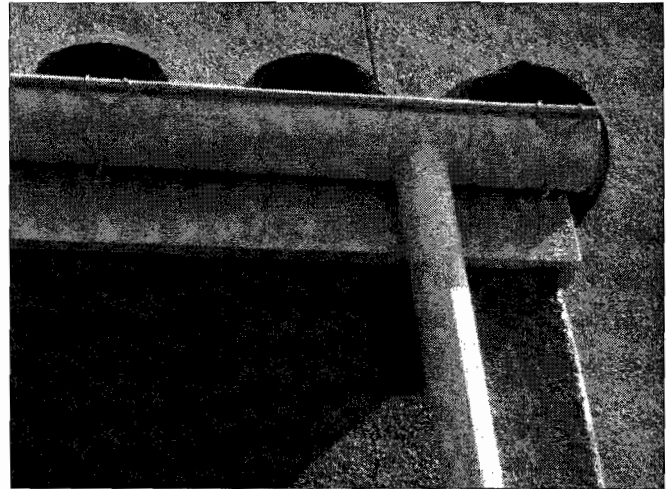
Comp #: 120 Gutters/Downspouts - Replace

There were no unusual conditions with the installation of the lines or any evidence of damage. It is typical for debris, such as roof granules and dirt, to build up in the lines. When debris remains in the rain gutters, it will stay wet after rains and snow melt which will cause premature deterioration of the materials. Therefore, we recommend cleaning out the lines at least once a year as a maintenance expense to ensure full life expectancy. It is typical to replace rain gutters and downspouts at the same time as roof materials for best cost estimate. As long as the gutters are maintained, Reserve to replace these lines every other roofing cycle along with the tile roofs.

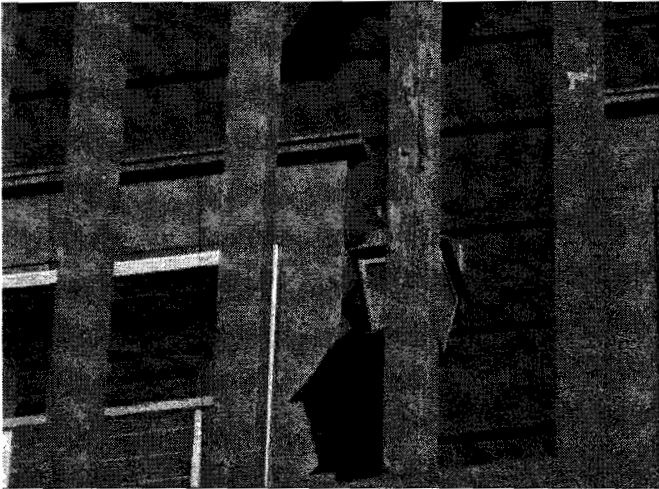
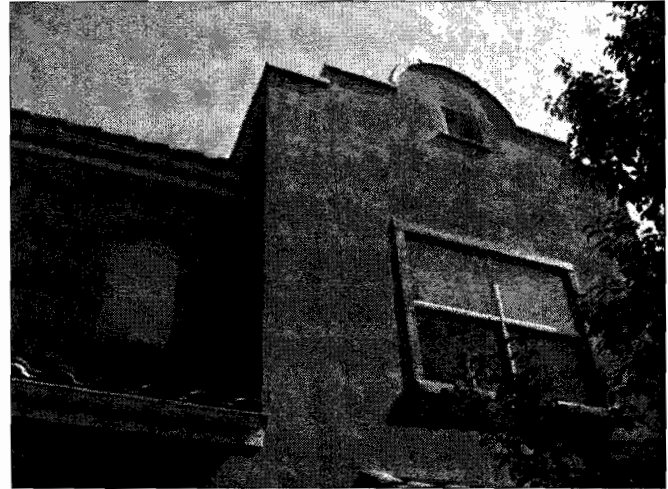
Comp #: 202 Wood Trim - Repaint 3

The wood siding, panels, cornice and wood railings on these buildings appear to be faded and will be in need of paint in by 2012. During the inspection, we also observed several isolated areas of caulking separation and peeling paint on the metal flashing. On the Spanish style buildings, the garage siding and stucco all appear to be in good to fair condition. It was previously reported that the exterior was painted in 2007, including the stucco on the Spanish style units. Maintaining exterior with a proper application of painting and caulking will ensure a full useful life. Because of orientation and exposure some areas may need periodic maintenance between painting cycles. Remaining life is based on the reported time until the next painting cycle for these buildings.

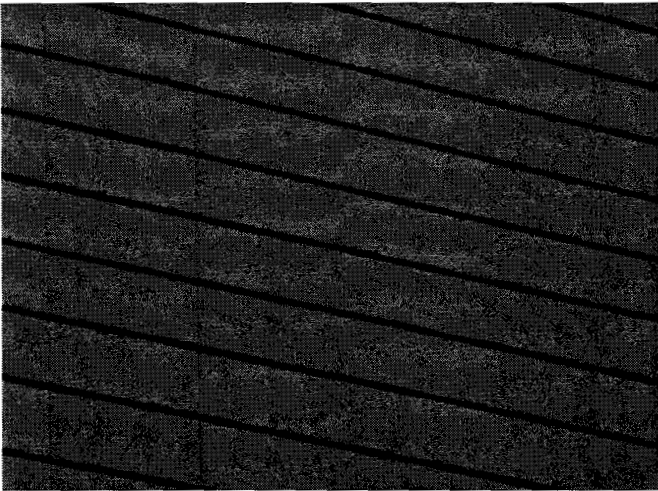
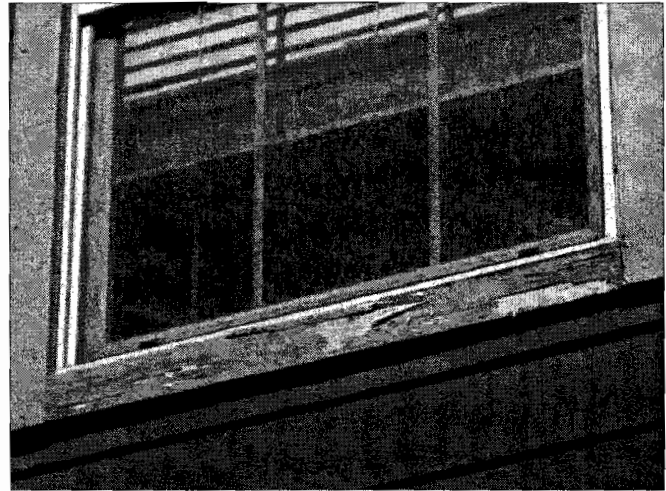
Comp #: 202 Wood Trim - Repaint 1

The wood siding, panels, cornice and wood railings on these buildings appear to be faded and will be in need of paint in the next fiscal year (2011). During the inspection, we also observed several isolated areas of caulking separation, cracked or dry wood and peeling paint on the metal flashing. Maintaining exterior with a proper application of painting and caulking will ensure a full useful life. Because of orientation and exposure (especially on the south facing sides) some areas may need periodic maintenance between painting cycles. Remaining life is based on observed conditions and the reported time until the next painting cycle for these buildings.

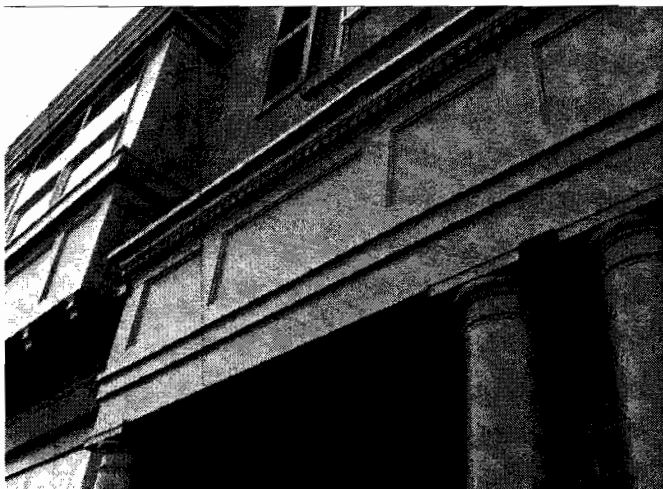
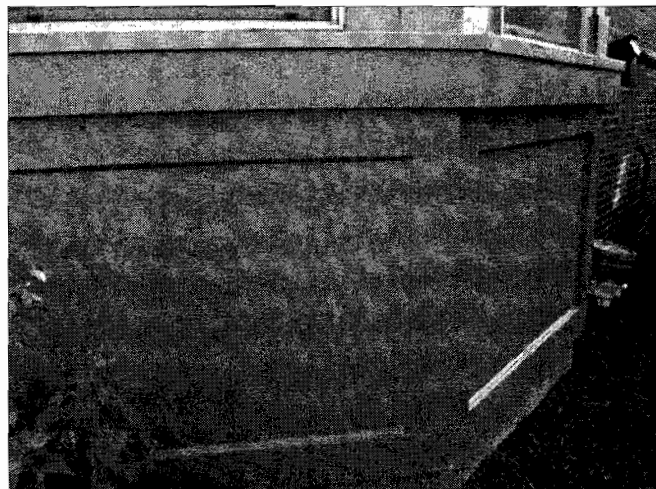
Comp #: 202 Wood Trim - Repaint 2

The wood siding, panels, cornice and wood railings on these buildings appear to be good condition since they were in process of being painted during the property inspection. Maintaining exterior with a proper application of painting and caulking will ensure a full useful life. Because of orientation and exposure (especially on the south facing sides) some areas may need periodic maintenance between painting cycles. Remaining life based on the time since the last painting cycle (2010).

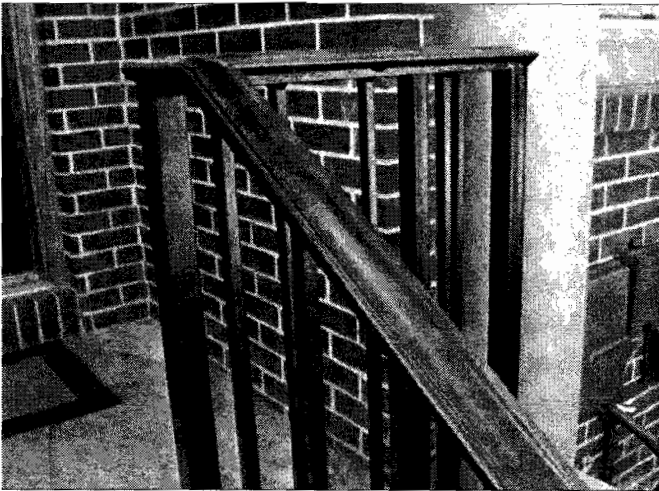
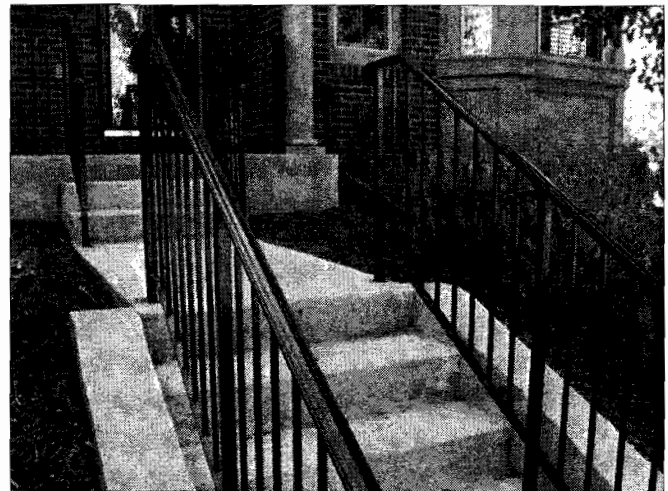
Comp #: 207 Iron Fencing - Repaint

Guard/Hand rails are in good condition and appear to have been recently painted. This type of rail should be repainted every 4 - 5 years to protect the metal from rusting and corrosion. In order to achieve a full life expectancy, proper prep work, such as scraping loose paint and removing any rust and corrosion, should be performed before each painting cycle. Remaining life is based on observed conditions.

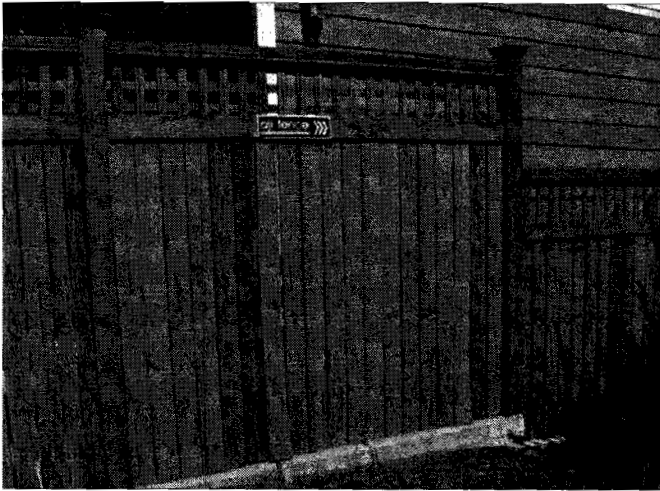
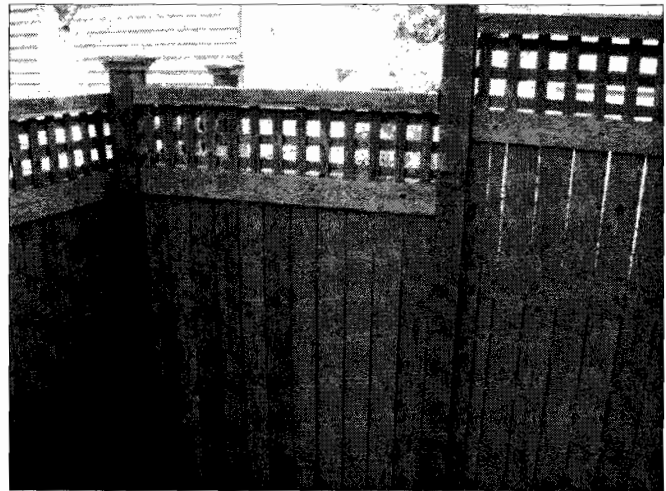
Comp #: 209 Wood Fencing - Restain

It appears the fences were recently stained and are in good condition. In this climate, we recommend staining wood fences every 2 - 4 years to protect the materials against splintering and cracking. The remaining life is based on the observed condition.

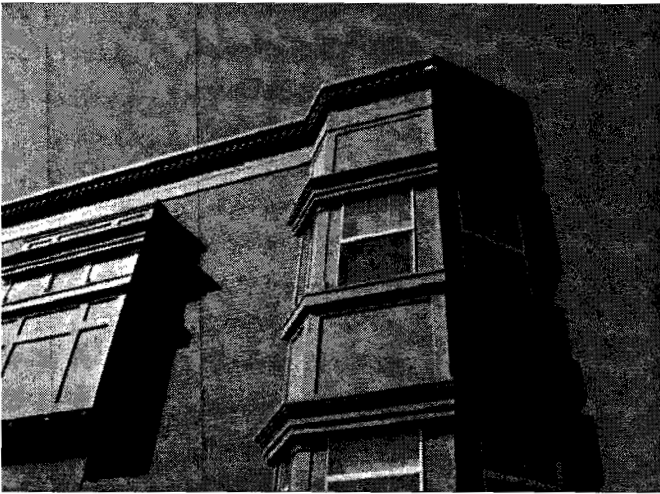
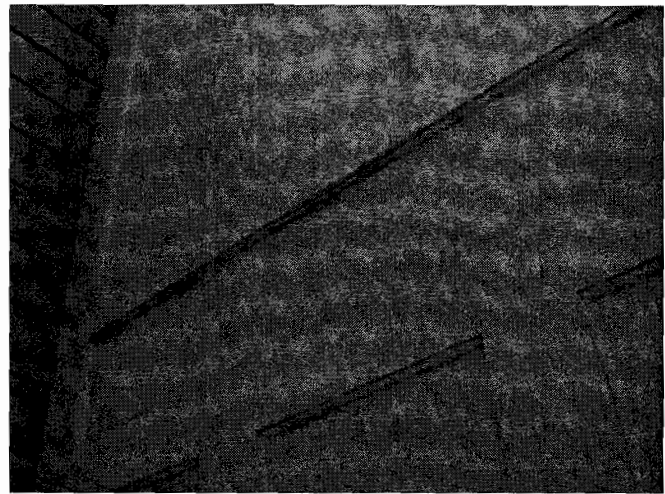
Comp #: 303 Wood Siding/Trim - Repair 3

Panel siding and decorative trim appear in overall good to fair condition. Recommended maintaining this component with painting/caulking on a regular basis and making major repairs every other painting cycle. Remaining life based on upcoming painting cycle for this phase (2012).

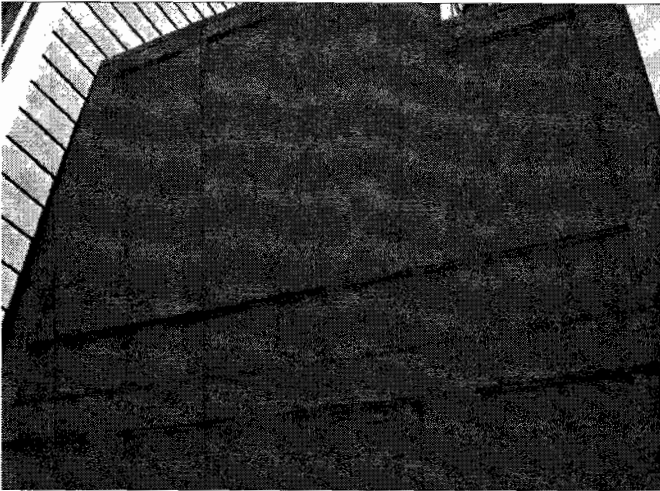
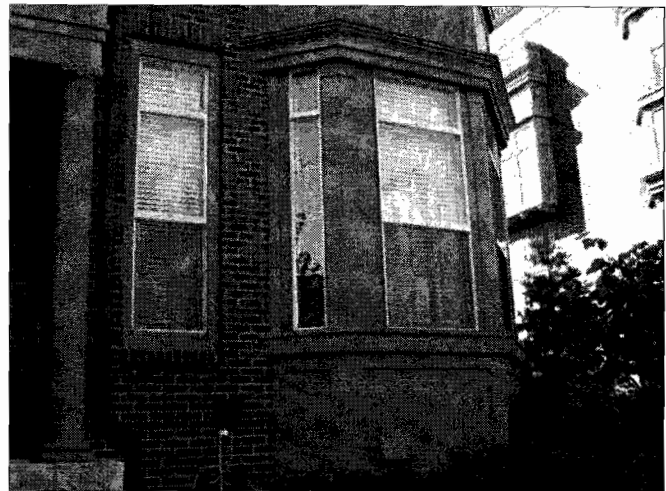
Comp #: 303 Wood Siding/Trim - Repair 1

Panel siding and decorative trim appear in overall good to fair condition. Recommended maintaining this component with painting/caulking on a regular basis and making major repairs every other painting cycle. Remaining life based on upcoming painting cycle for this phase (2011).

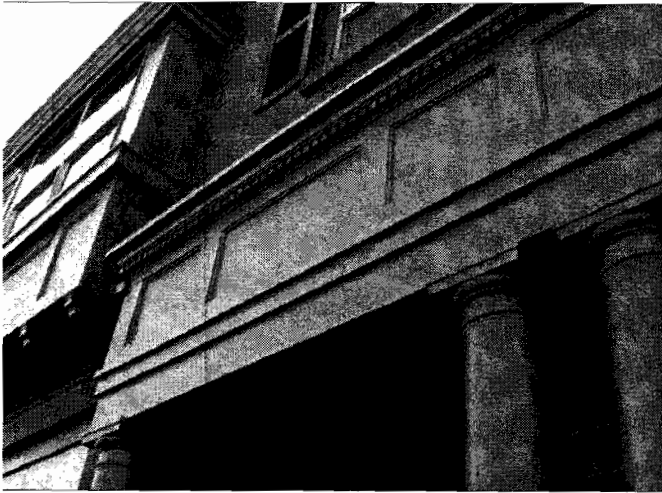
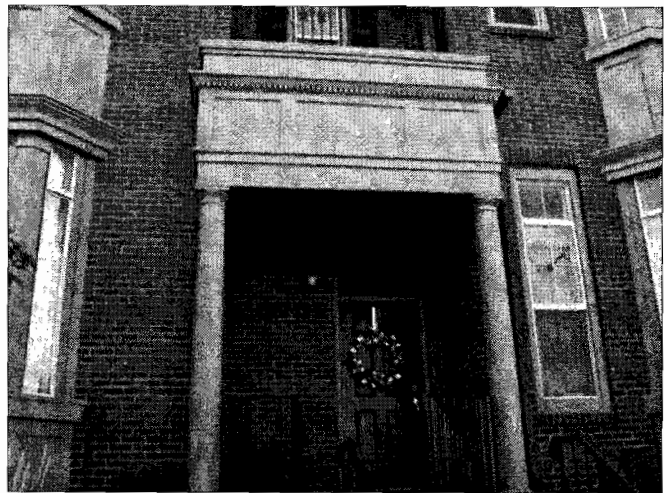
Comp #: 303 Wood Siding/Trim - Repair 2

Panel siding and decorative trim appear in overall good condition since this phase was painted in 2010. Recommended maintaining this component with painting/caulking on a regular basis and making major repairs every other painting cycle.

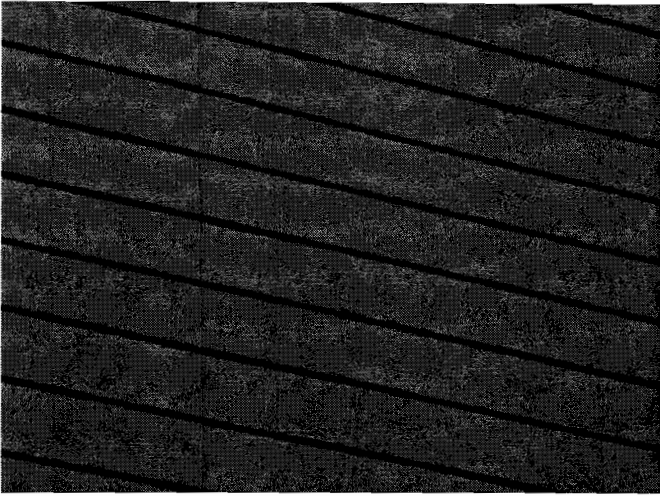
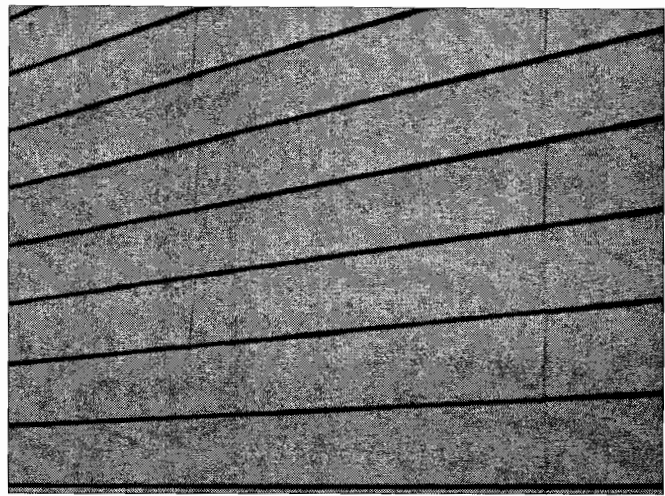
Comp #: 304 Fiber Cement Siding - Replace

There were no major problems noted. Any minor repairs can be performed as a maintenance issue as part of prep work before painting. According to the manufacturer of this product, this material has a 50+ year warranty against defects that will require replacement. Therefore, at this time, we do not suggest Reserving for replacement of siding or trim materials. If deterioration is observed in future years, there is plenty of time available to add to Reserves without substantially affecting the contribution rate. If replacement was needed, expect to spend approximately \$12.00/GSF or approximately \$1,891,000 at today's dollars (2011).

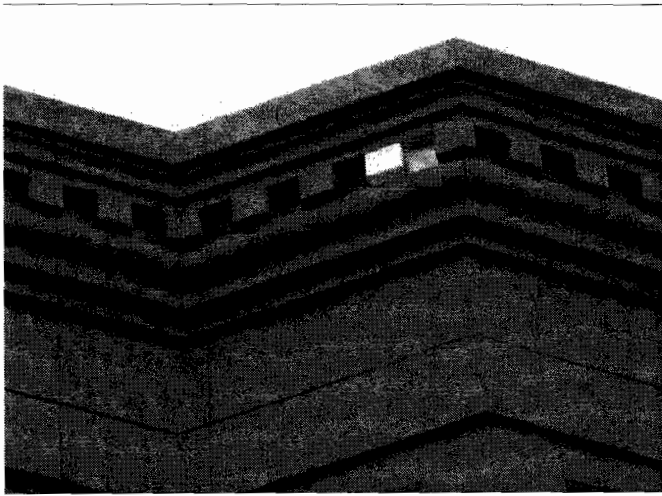
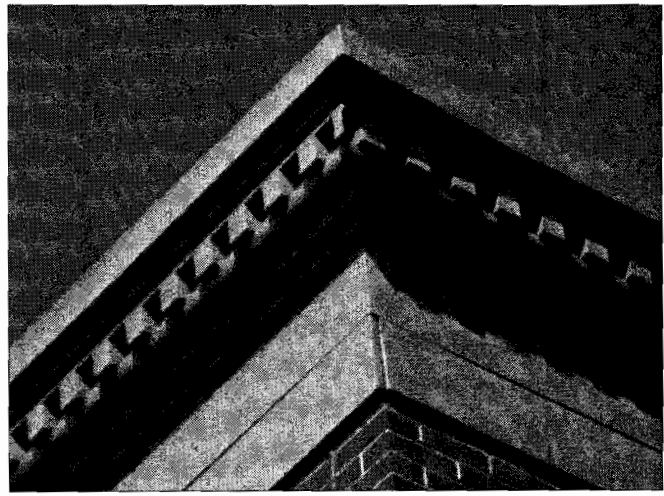
Comp #: 305 Wood Cornice - Replace - 25%

Decorative cornice details appear to be in good to fair condition with only minor signs of damage that has been repaired. It was reported that . However, signs of cracked and/or no caulking are a concern because of moisture penetration. Coordinate repairs with the painting cycle.

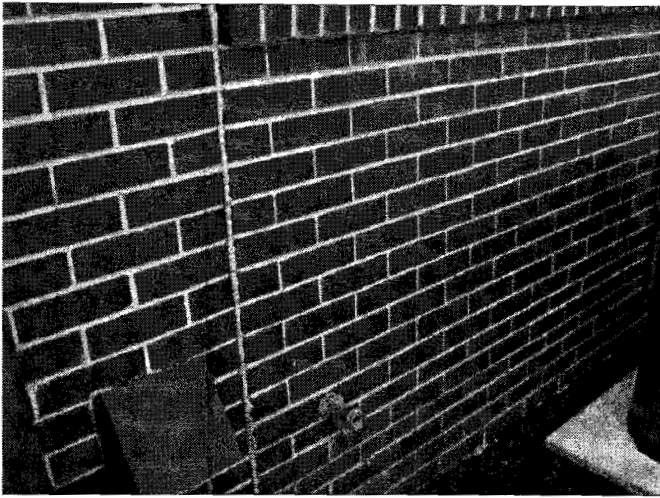
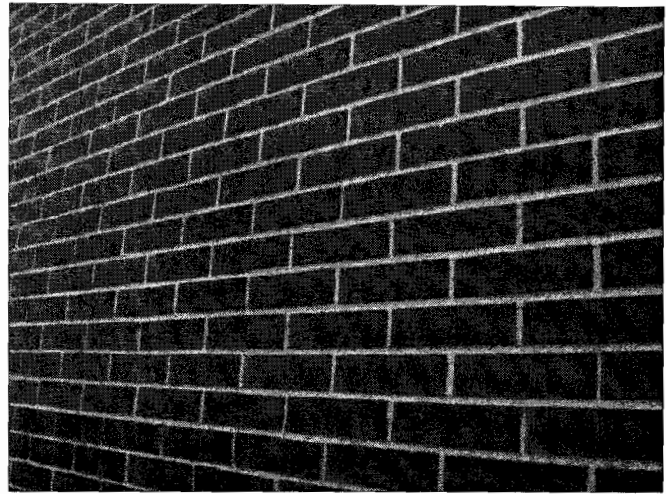
Comp #: 306 Brick Veneer - Replace

Brick veneer appears in overall good condition with no significant signs of damage or problems. An isolated area appears to have been repaired because of cracking and separation. Allowance to repair brick as needed, no anticipation for complete replacement. Recommended yearly inspection to maintain grout which will help mitigate any subsurface moisture. Remaining life based on observed conditions.

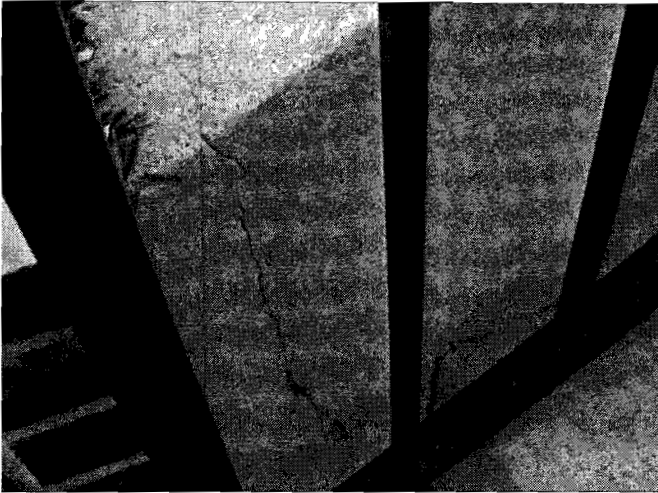
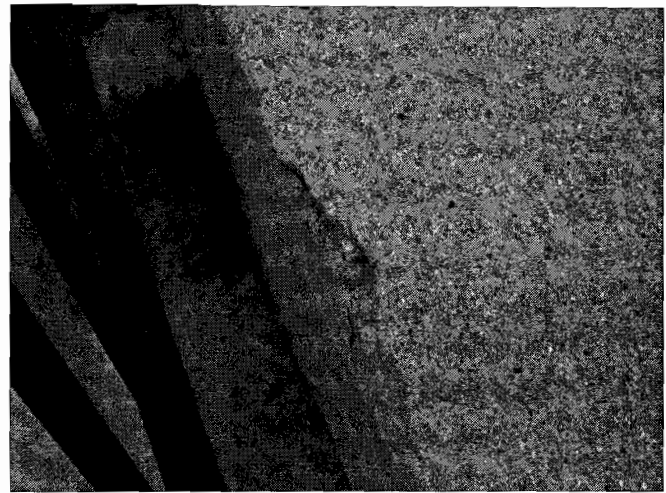
Comp #: 307 Cementious Coating - Repair

Cementious coat over concrete walls is in good to fair condition with some areas of missing or loose material. Adhesion between 2 similar products (cementious or Portland cement products) without lathe or adhesive can cause ongoing issues as previously observed. Recommend continued repairs to coordinate with the painting cycle every 5 years to maintain appearance and further investigation to explore other options which may include removing coating and applying an electrometric paint. Funding is to repair only.

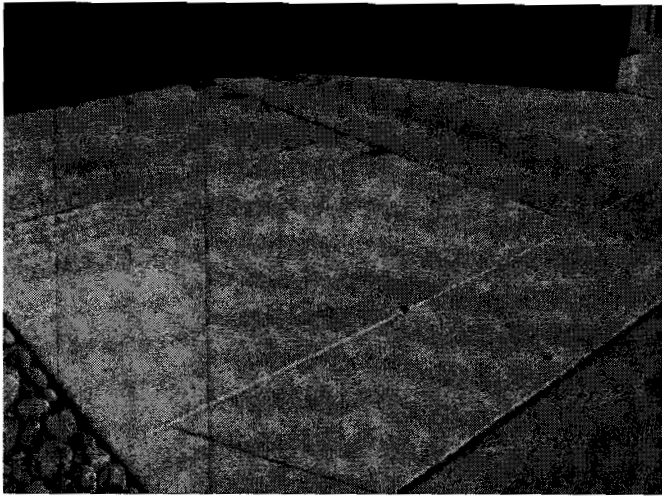
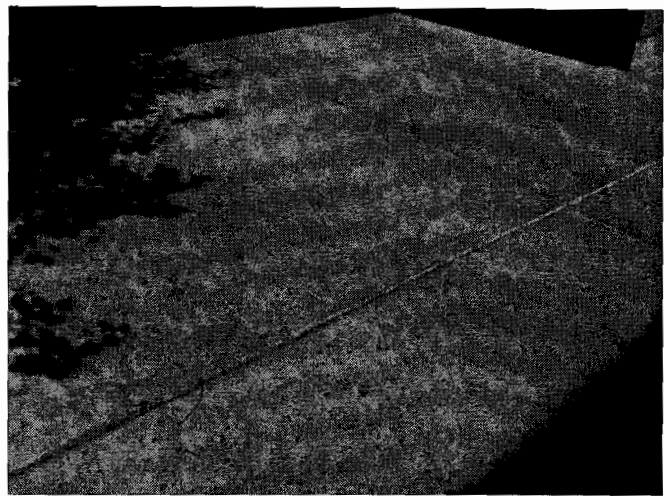
Comp #: 403 Concrete Drives - Repair/Replace

The concrete drives vary in condition throughout the community with some being in good to fair condition and others with areas of cracked and deteriorating concrete. Recommended replacing concrete that presents a trip/fall hazard and ones that have sever spalling and/or cracking. It was reported that there was some concrete driveway sections replaced in 2010. Maintain concrete by sealing cracks to mitigate subsurface moisture which may accelerate useful life. Substrate moisture can cause settling or lifting of concrete. Remaining life based on time since last replacements.

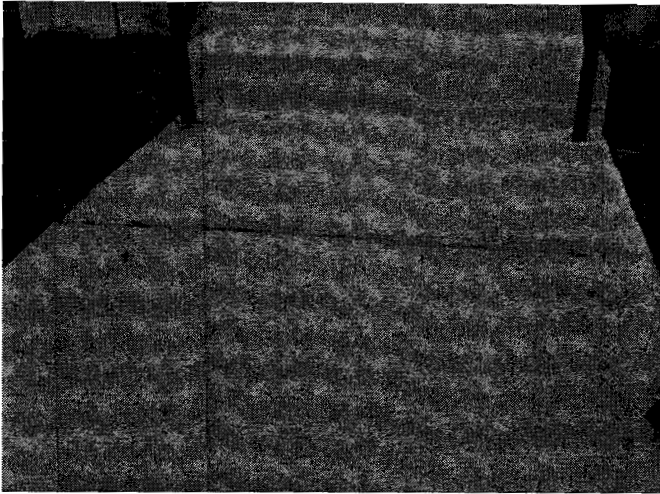
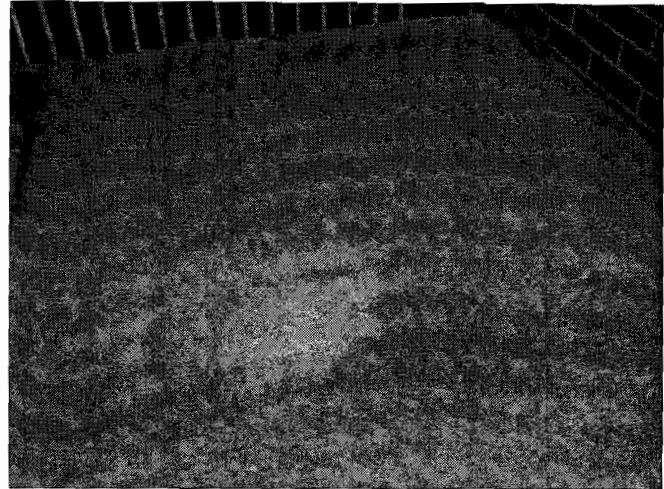
Comp #: 601 Concrete Sidewalks/Decks - Repair

Concrete steps and landings are in good to fair condition minor signs of cracking and spalling. It was reported that there was some replacement done in 2010 at 7752 and 7830 E. 29th. The rest of the buildings are in relatively good condition. Maintain concrete by sealing/caulking cracks to mitigate subsurface moisture which may accelerate useful life. While it is unlikely that all concrete surfaces will fail and need to be replaced at the same time, frequent repairs and replacement to a percentage of the area should be anticipated every 4 years.

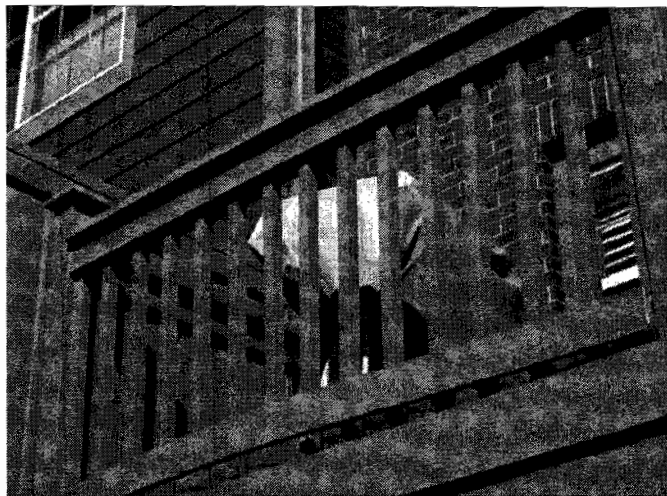
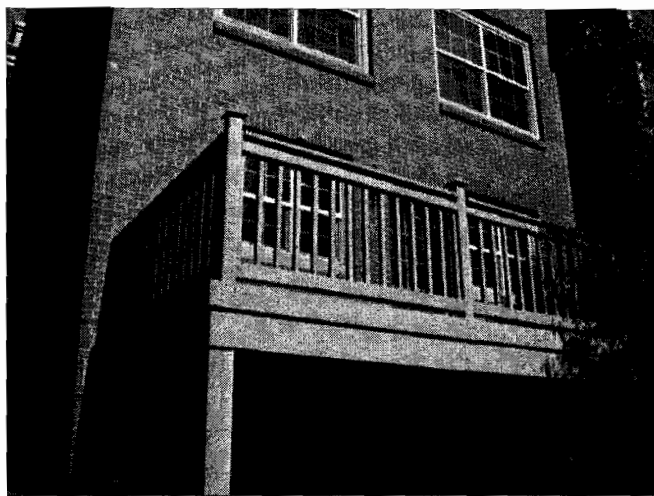
Comp #: 605 Wood Guardrail - Replace

The wood guardrails are made of 2x2 pickets, 1x4 rails, 1x6 caps and 4x4 posts. The rails are in fair to poor condition with signs of cracked, splitting and bowed wood. It was reported that the individual homeowners are responsible for maintenance and replacement of the railings and decks. It was also reported that the Association will replace any rotten wood or make minor repairs just before the painting cycle, but this is handled as an operating expense. Therefore, Reserve funding is not required for this component.

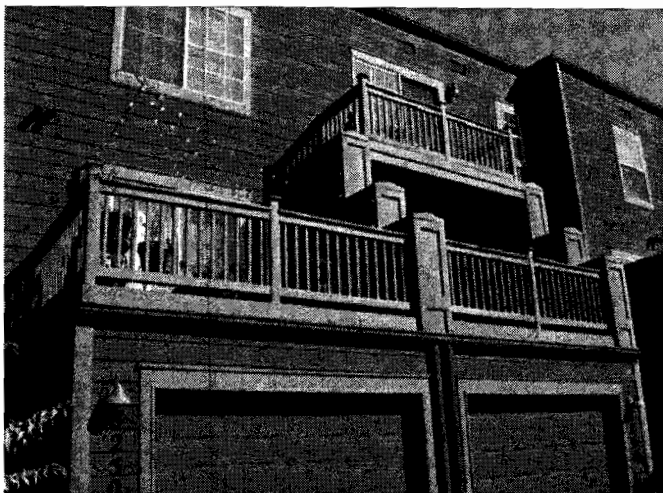
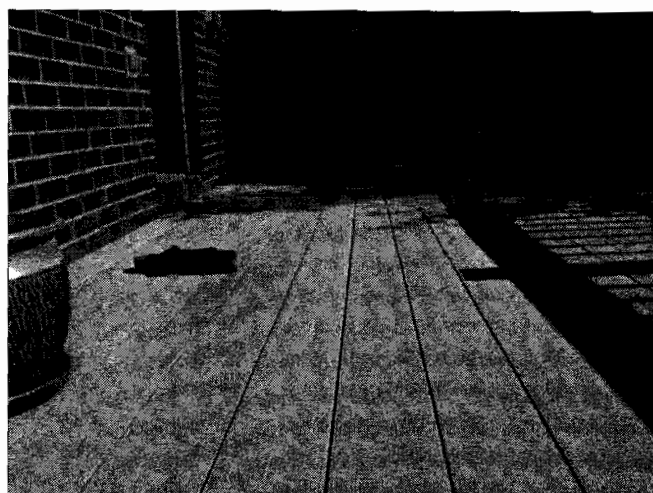
Comp #: 609 Composite Deck - Replace

Composite decking appears in overall good condition with no significant signs of damage. It was reported that the individual homeowners are responsible for maintenance and replacement of the decking material. Therefore, Reserve funding is not required for this component.

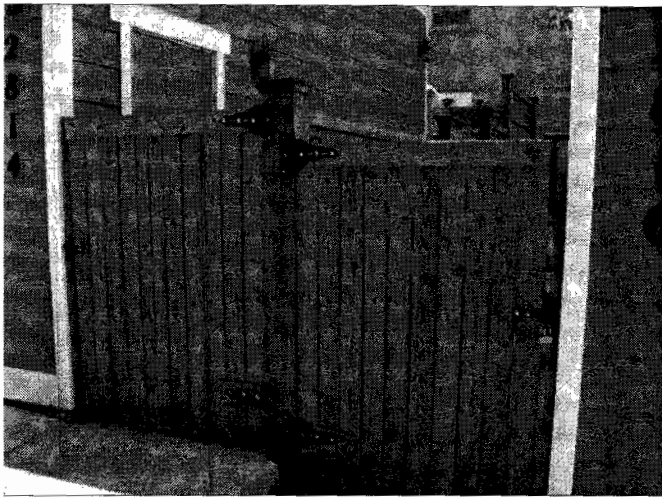
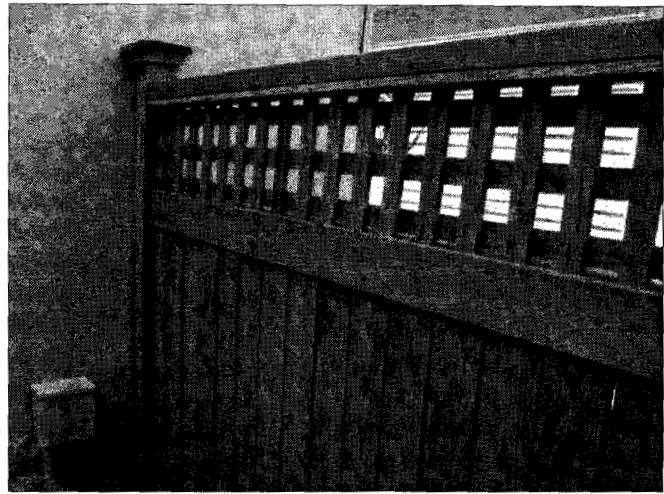
Comp #: 1001 Wood Fencing - Replace

This fence is in good condition and appears to have been recently stained. The replacement cycle is based on the observed quality of fence installed and the current condition. As long as proper weatherproofing is performed, the overall life of the fence should range between 15 - 20 years. Without maintenance, expect to replace every 10 - 12 years. The remaining life is based on age and observed condition of fence.

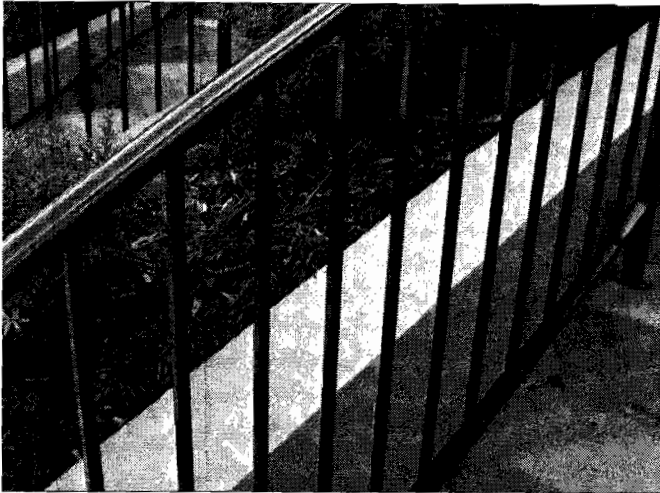
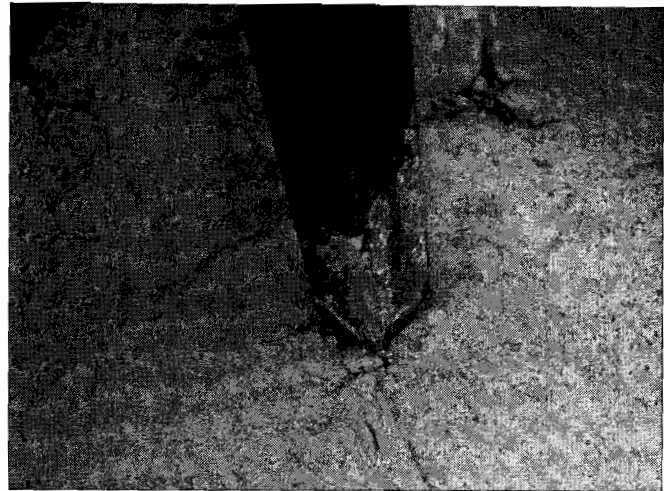
Comp #: 1002 Ironwork Fencing - Replace - 10%

Guard/hand rail is in good to fair condition with some signs of rust at the base of the posts. No anticipation for complete replacement at this time, funding is to replace 50% every 25 years. Remaining life based on age of the community.

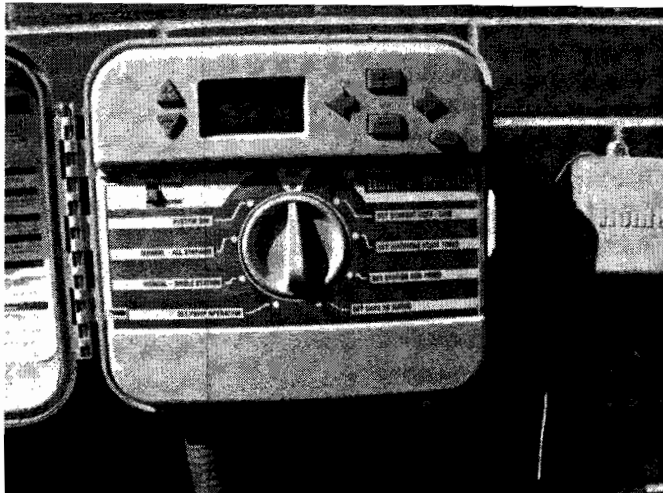
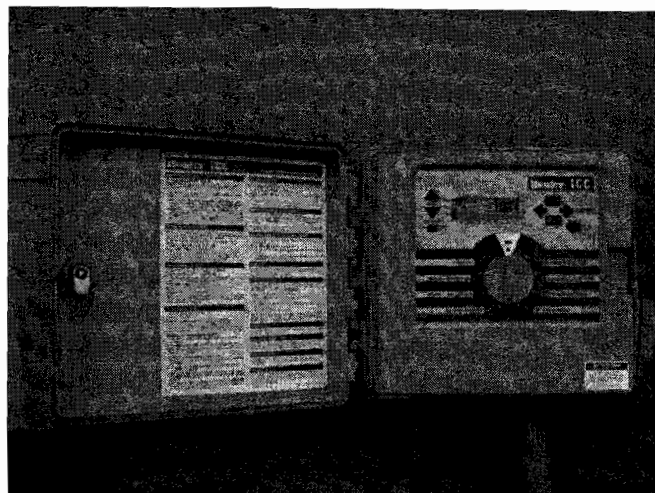
Comp #: 1703 Irrigation Time clocks - Replace

All appear to be operational and in good condition. Under normal conditions (not including Acts of God, vandalism, etc.) these clocks should last 10 - 12 years with proper maintenance. The remaining life is based on the age of the clocks.

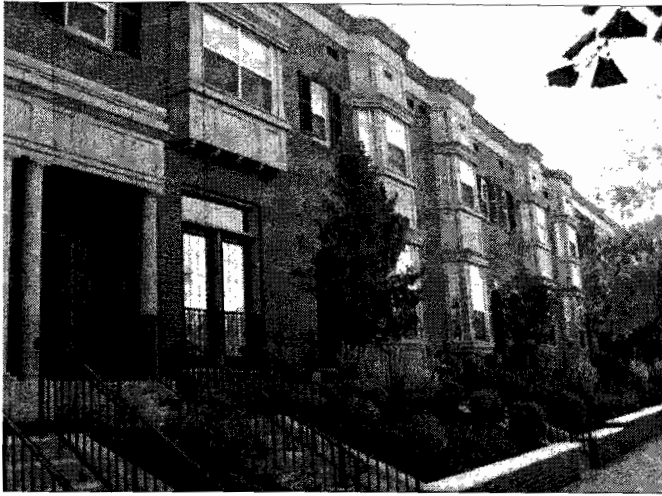
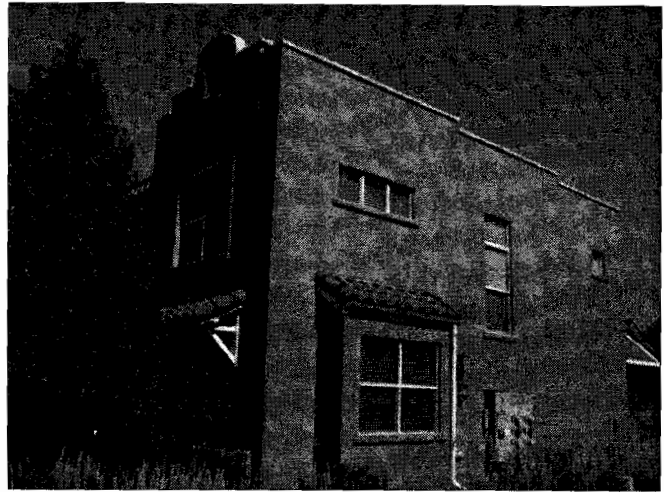
Comp #: 1804 Tree - Replacement (Partial)

Trees appeared to be healthy and in good condition at time of inspection. It is very difficult to predict a replacement cycle for trees as there are several factors that will contribute to a tree dying. Factors such as disease, infestation of insects, heavy snow storms, etc. can all attribute to eventual tree replacement. Since it is difficult to predict when the replacement will be necessary, Reserve funding is typically not a factor. However, per the request of the Association, we have included an allowance for partial replacement, or major maintenance (trimming, etc.) every 3 years.
