**Tamarac Hills HOA**  
**7500 – 7900 E. Dartmouth Ave.**  
**Denver, CO 80231**

**Level 1 Reserve Analysis**

**Report Period – 03/01/03 – 02/29/04**

| <b>Date of Property Inspection –</b> | <b>November 26, 2002</b> |

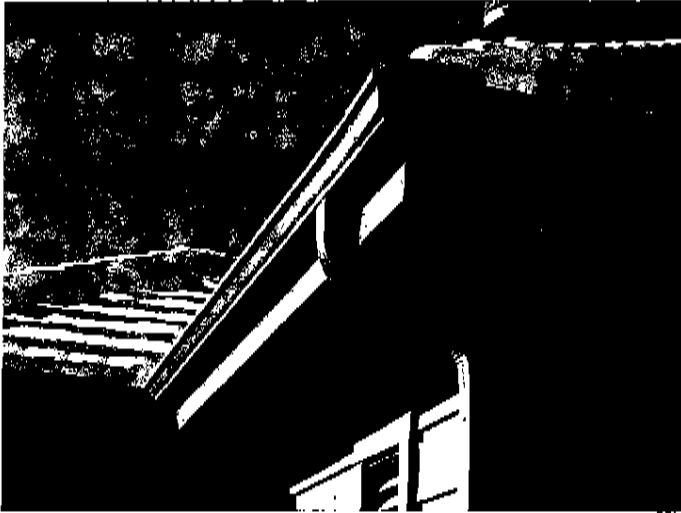
**Component Inventory for Tamarac Hills HOA****Client Reference # 2088****Comp #: 120 Raingutters/Downspouts - Replace**

No apparent problems with gutters or downspouts at time of inspection. Typically, raingutters need to be replaced when roofs are replaced to accommodate the runoff of rain from the new roof material. Reserve to replace at same time as roofs every 22 years.

\$4.00/LF; Estimate to replace

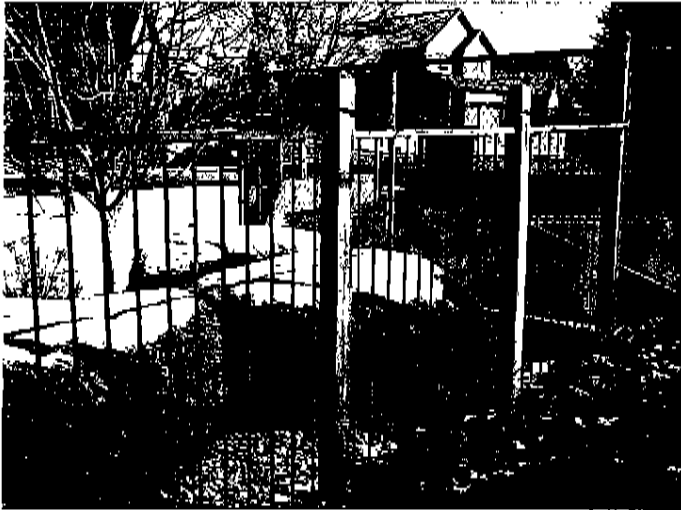
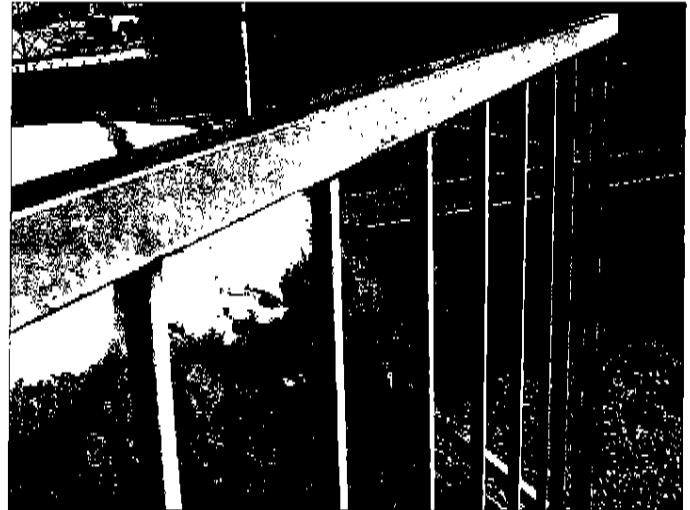
**Component Inventory for Tamarac Hills HOA****Client Reference # 2088****Comp #: 207 Iron Fencing - Repaint**

Painted surfaces are faded and dull in appearance and some metal materials are exposed to elements. These surfaces need to be painted as soon as possible to inhibit further rusting and deterioration of rail. Area is too small and cost (less than \$500) would not be enough to warrant Reserve funding. Repaint these surfaces as a general operating expense.

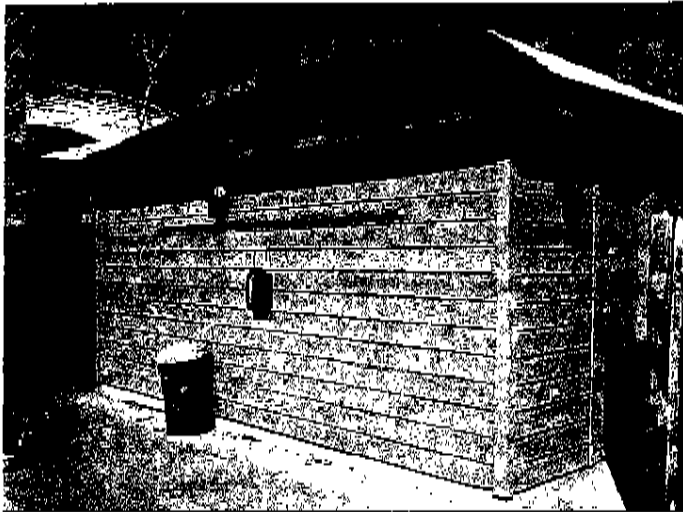
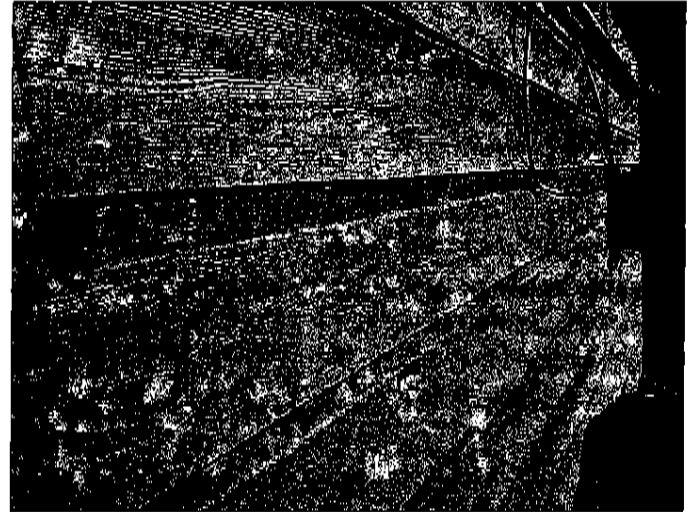
**Component Inventory for Tamarac Hills HOA****Client Reference # 2088****Comp #: 301 Wood Siding - Replace**

No major problems with warping or splitting of siding materials. With proper maintenance (frequent painting) the materials should have a life expectancy of 25 - 30 years. To ensure maximum life expectancy, properly caulk all seams before painting.

\$4.50/GSF; Estimate to replace siding

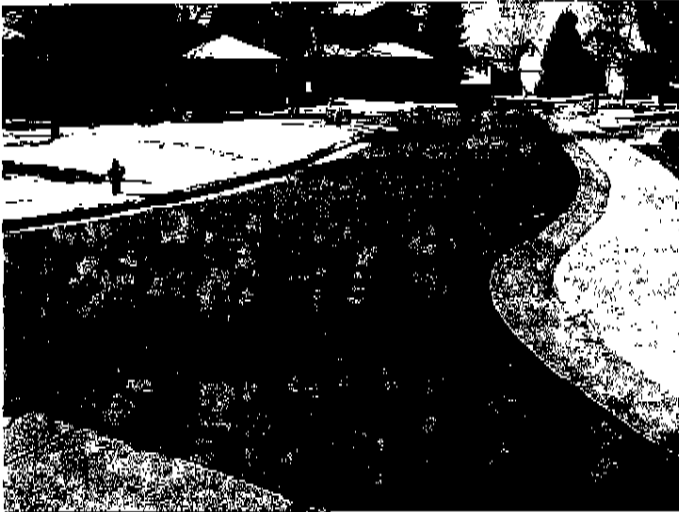
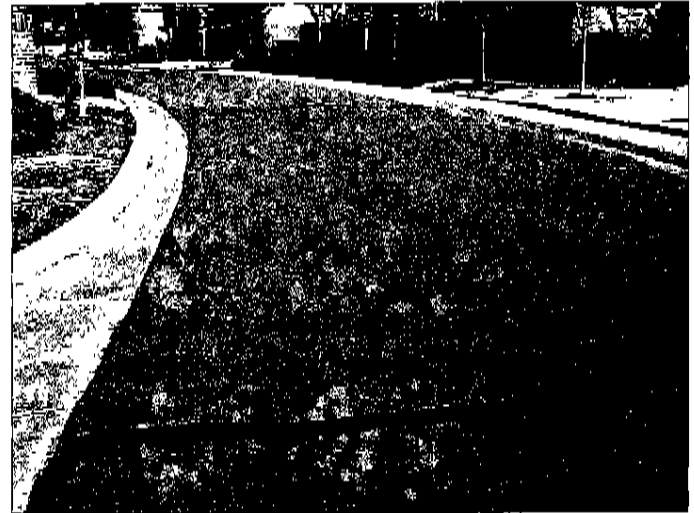
**Component Inventory for Tamarac Hills HOA****Client Reference # 2088****Comp #: 401 Asphalt - Overlay (new)**

This area was rotomilled and had a petromat underlayment applied prior to a new 2" overlay about 2 - 3 years ago (half in 2000 and the other half in 2001). Surfaces have not been seal coated as recommended by industry professionals. Areas are repaired annually with infrared patching and crack fill where needed. In our experience, with periodic seal coating (every 2 - 3 years), the average life expectancy of asphalt resurfacing has been extended by at least 5 years. An approximate cost to seal all streets would be \$6,500. Other benefits of seal coating is that it maintains the appearance of the property. Since streets are not sealed, then do not Reserve for sealing at this time. Resurface cycle is based on assumption that streets will not be seal coated.

\$.85/GSF; Higher estimate for local repairs

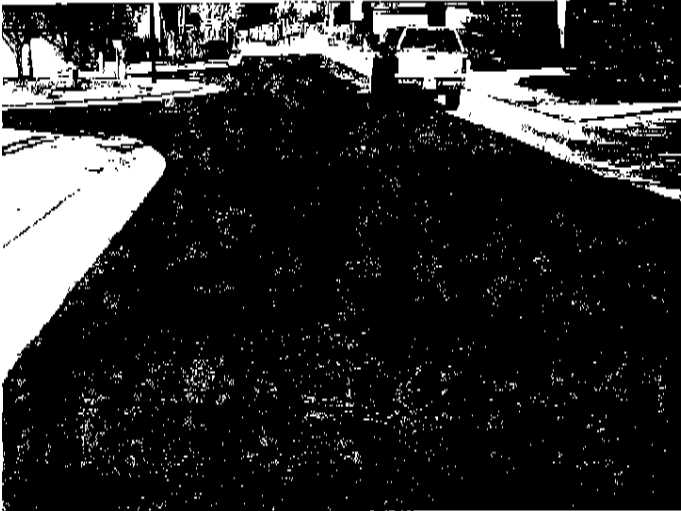
**Component Inventory for Tamarac Hills HOA****Client Reference # 2088****Comp #: 401 Asphalt - Overlay (old)**

These sections have not been resurfaced. Current conditions exhibit some cracking, alligator cracking, and minor potholes. The majority of the remaining surfaces need to be repaired in the near future. Suggest performing the same process as the "new" area (rotomill and petromat material). Association may decide to split up the remaining areas into separate phases as needed. At this time, the remaining asphalt is all in similar condition. If the association decides to resurface in separate sections, costs may be increased slightly.

\$ .85/GSF; Higher estimate for local repairs

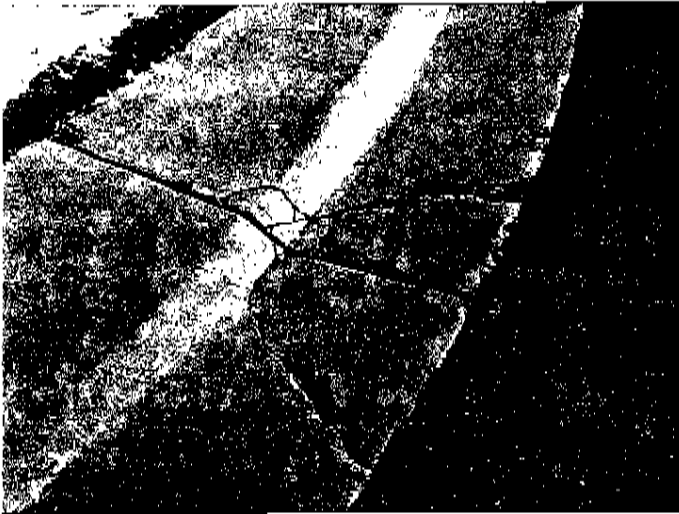
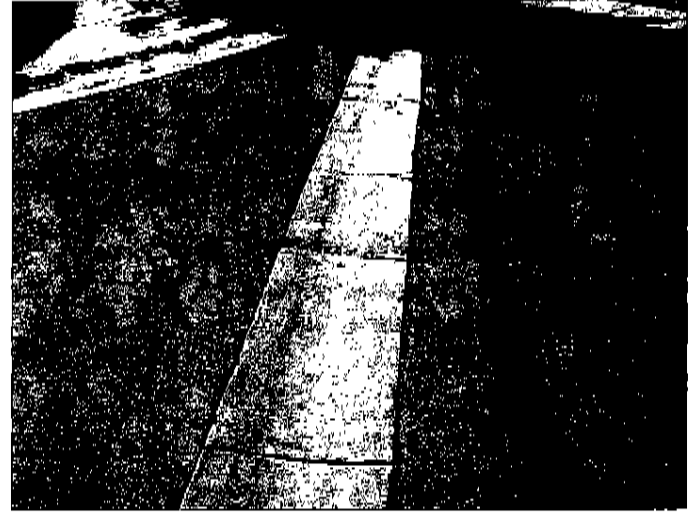
**Component Inventory for Tamarac Hills HOA****Client Reference # 2088****Comp #: 407 Concrete Surfaces - Repair**

Several sections are cracked and in need of repair. There is no well defined life expectancy for concrete materials. Provide an allowance for periodic repairs and replacements. Concrete drive materials have a shorter life expectancy than pool decks or sidewalks due to heavy vehicle traffic on a daily basis.

Estimate to repair 10% of area at this cycle

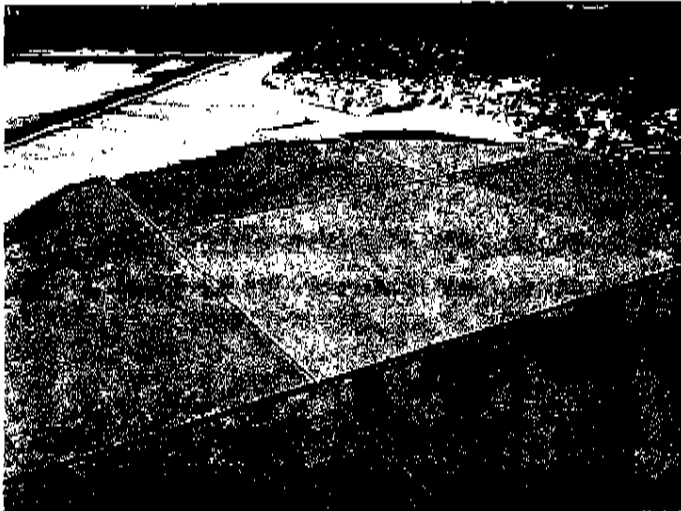
Comp #: 608 Pool Deck - Repair

Some areas of pool deck have settled which has created some tripping hazards and potential injury causing areas. These areas should be repaired immediately before a liability concern arises. Since it is difficult to predict when repairs will be needed, provide an allowance for periodic repairs every 6 years. Coordinate repairs with other concrete work for best cost estimate.

**Estimate to replace 25% of area at this cycle**

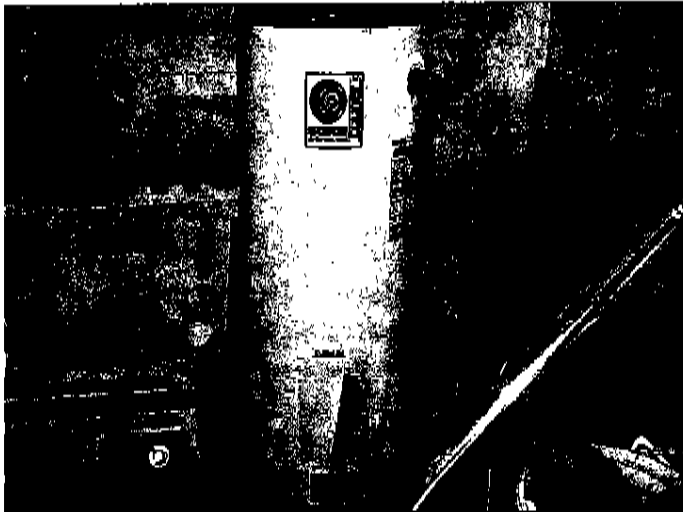
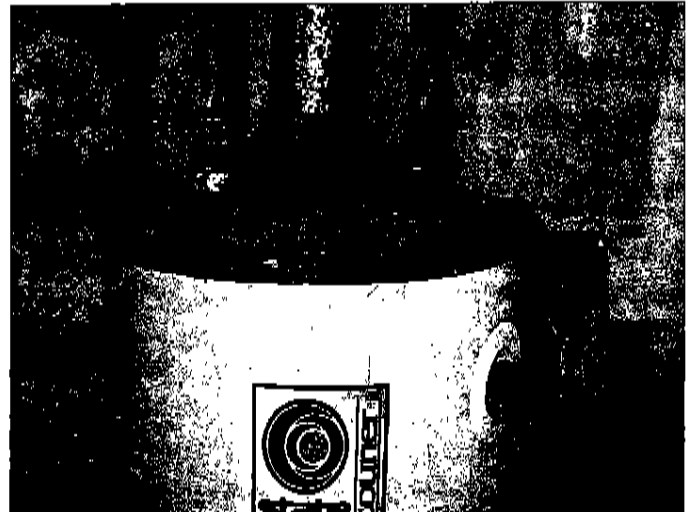
**Component Inventory for Tamarac Hills HOA****Client Reference # 2088****Comp #: 703 Hot Water Heater Tank - Replace**

This heater is original (almost 20 years old) and is in fair to poor condition. System was winterized, so unable to test heater. Due to appearance of tank, expect to replace within the next couple years.

Estimate to replace and install

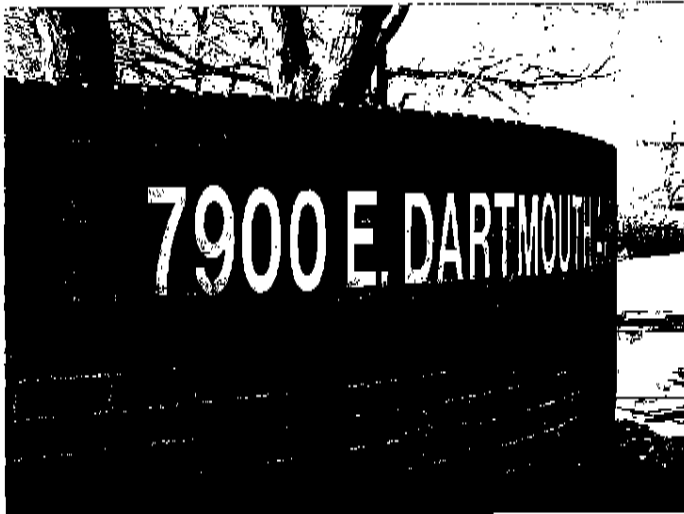
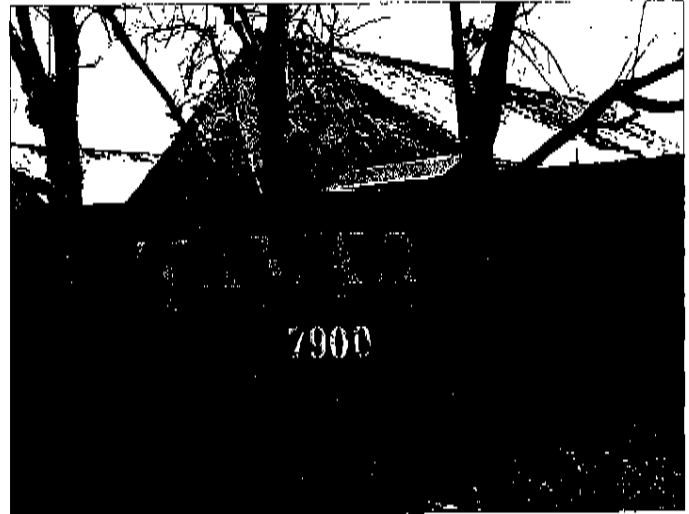
**Component Inventory for Tamarac Hills HOA****Client Reference # 2088****Comp #: 801 Brick Monument - Rebuild**

Monument is structurally stable and in very good condition. This type of wall has an extended life expectancy and replacement is not likely under normal wear and tear. No Reserve funding is required due to indefinite life expectancy. Replace lights and lettering on an as needed basis with general operating funds.

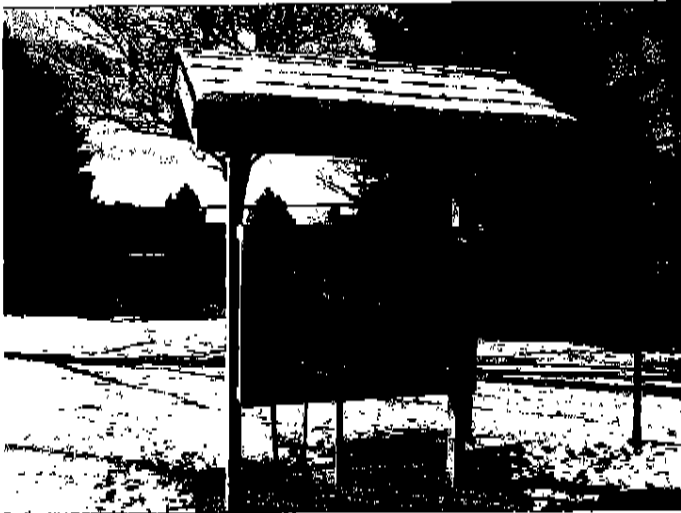
**Component Inventory for Tamarac Hills HOA****Client Reference # 2088****Comp #: 803 Mailboxes - Replace**

Boxes are in good condition with minimal signs of wear or deterioration. Typical life expectancy for this type of box ranges from 15 - 20 years. These are semi-protected by a small overhang and kiosk. Since the overhang is so small, do not assume it will extend the replacement cycle.

\$35/box; Estimate to replace and install boxes

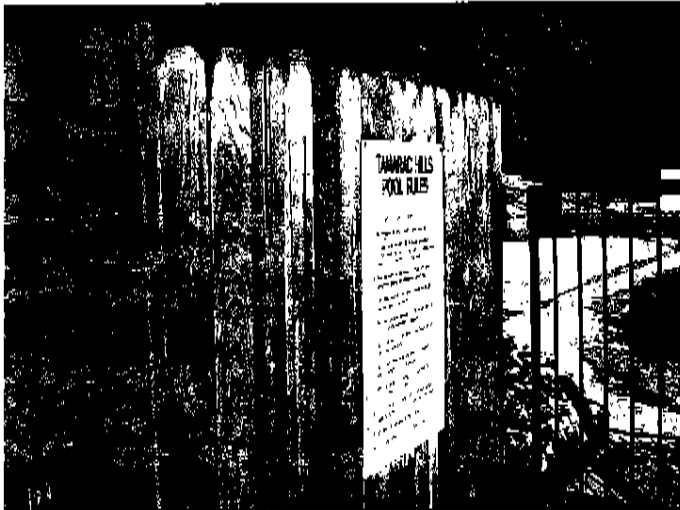
**Component Inventory for Tamarac Hills HOA****Client Reference # 2088****Comp #: 1001 Wood Fencing - Replace**

Fence was recently replaced. Fence was not stained to protect wood materials from deterioration. In our experience, we find fences that have been stained have a longer life expectancy of 5 - 8 years. However, the cost of staining over a period of time was not found to be financially beneficial in all cases. Staining will preserve the material and maintain the appearance of the fence. Since fence has not been stained and there are no plans to stain the fence, then assume a useful life for a fence without preventative maintenance. Fence was installed with metal posts that will not require replacement in the future, thus decreasing the replacement cost from the original cost.

\$20/LF; Estimate to replace

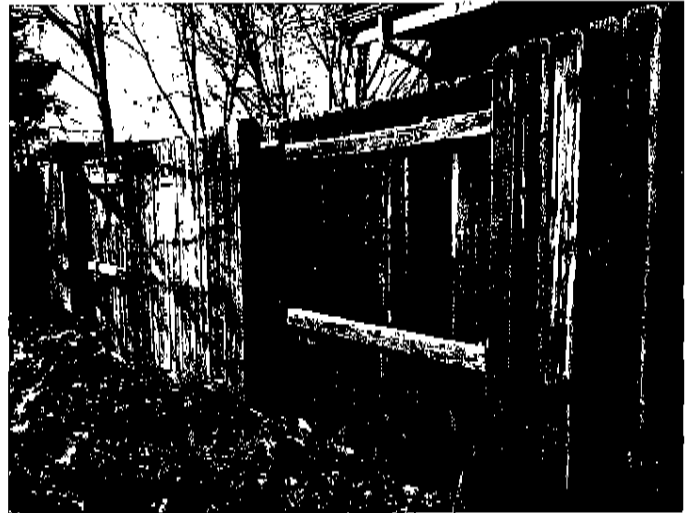
**Component Inventory for Tamarac Hills HOA****Client Reference # 2088****Comp #: 1001 Pool wood fence - Replace**

This fence is older and nearing the end of its useful life. The fence was intact, but a little unstable in sections tested. At this time, it was determined by the Board of Directors that the expense would be shared between the current homeowner and the association when replacement is required.

\$19/LF; Estimate to replace (50% HOA responsible)

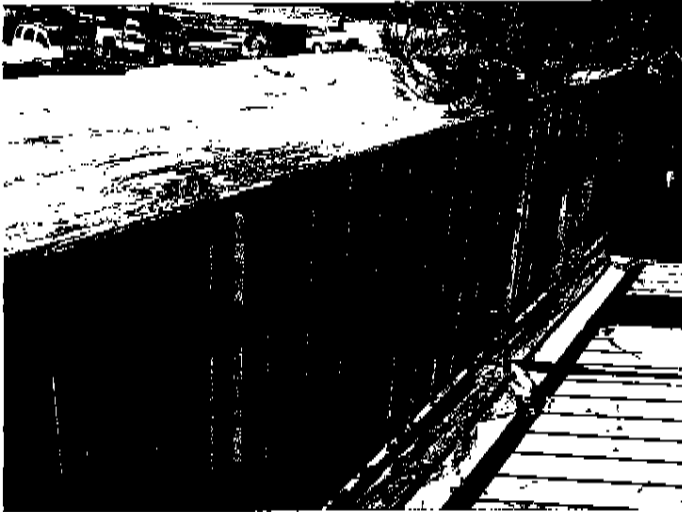
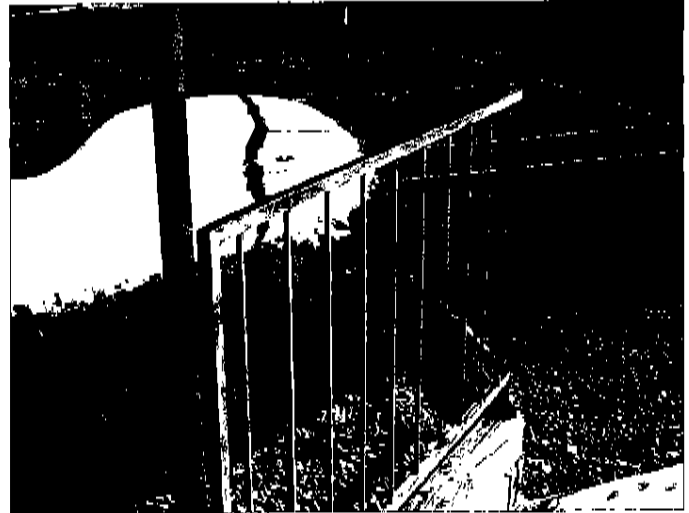
**Component Inventory for Tamarac Hills HOA****Client Reference # 2088****Comp #: 1002 Ironwork Fencing - Replace**

Fencing and handrails have not been painted recently and exposed metal is evident throughout. Continued exposure to elements will deteriorate the fence/rail and replacement will be needed in the near future. With proper prep work and maintenance of painting, the replacement cycle may be extended.

**Location:** Pool area**Quantity:** Approx. 91 LF**Life Expectancy:** 27 **Remaining Life:** 8**Best Cost:** \$1,800  
\$20/LF; Estimate to replace**Worst Cost:** \$2,275  
\$25/LF; Higher estimate**Source of Information:** Cost database**General Notes:**

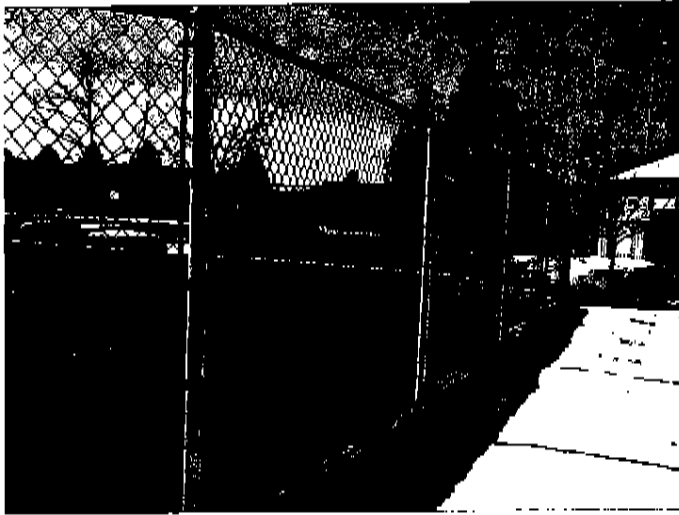
**Component Inventory for Tamarac Hills HOA****Client Reference # 2088****Comp #: 1003 Chain Link Fencing - Replace**

There is some curling beginning to develop along the base of fence. This could be a result of children trying to pry up the fence so they could access the court. With the majority of the fence being installed on top of a 3' high concrete wall, there is minimal exposure to damage to fence from players. Typical life expectancy for chain link fence ranges from 25 - 30 years.

**Location:** Tennis court perimeter**Quantity:** Approx. 360 LF**Life Expectancy:** 28 **Remaining Life:** 9**Best Cost:** \$9,000  
\$25/LF; Estimate to replace**Worst Cost:** \$10,800  
\$30/LF; Higher estimate**Source of Information:** Cost database**General Notes:****Height breakdown:**  
90 LF of 10' high fence  
270 LF of 7' high fence

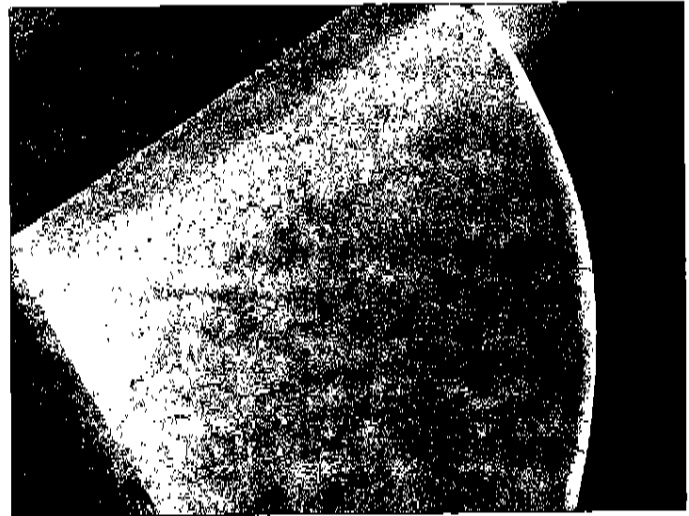
**Component Inventory for Tamarac Hills HOA****Client Reference # 2088****Comp #: 1101 Pool - Resurface**

Surface appears to be approximately 4 - 5 years old with some general roughness and minor cracking developing on the stairs. Average life expectancy for pool surfaces ranges from 8 - 10 years, depending on quality of water and chemical levels. Reported that some concrete deck work since last plastering damaged some of the plaster. Expect to resurface within the next 3 - 4 years based on age and condition of surface.

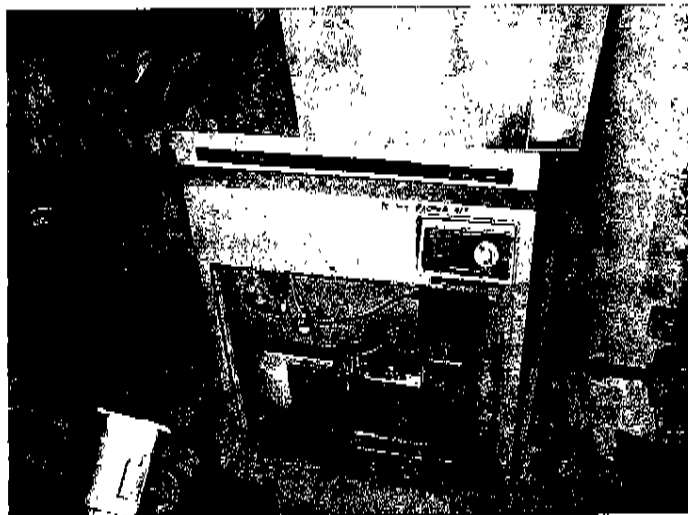
**Component Inventory for Tamarac Hills HOA****Client Reference # 2088****Comp #: 1104 Pool Heater - Replace**

Pool heater is older but still operational according to service contractor. Heater was shut down at time of inspection due to pool being winterized. There were some signs of rust and scaling around base plate beneath heat exchanger. Typical life expectancy for pool heaters ranges from 15 - 20 years under normal conditions. Overall life depends on quality of water and level of maintenance. Estimate is to replace with a new high efficient model.

Estimate to replace and install

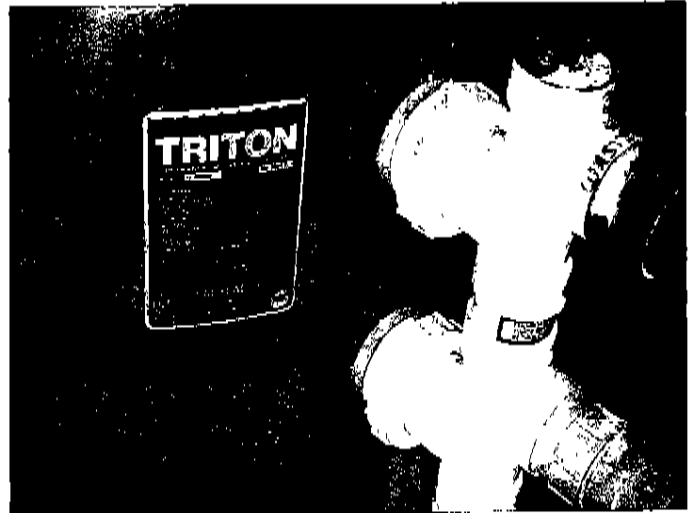
**Component Inventory for Tamarac Hills HOA****Client Reference # 2088****Comp #: 1107 Pool Filter - Replace**

No problems reported with filter system. According to service contractor, these filters have a very long life expectancy. However, periodic replacement of sand will be needed every 8 - 10 years. Cost for sand material will be approximately \$150 and this expense should be treated as an operating expense. Reserve to replace tank every 25 years based on current age of filter and conditions.

**Location:** Pool equipment room**Quantity:** (1) Triton sand filter**Life Expectancy:** 25 **Remaining Life:** 4**Best Cost:** \$1,800**Estimate to replace****Worst Cost:** \$2,200**Higher estimate****Source of Information:** Research w/ Alligator Pool & Spa**General Notes:****Model #TR-100****Serial #TR-40757**

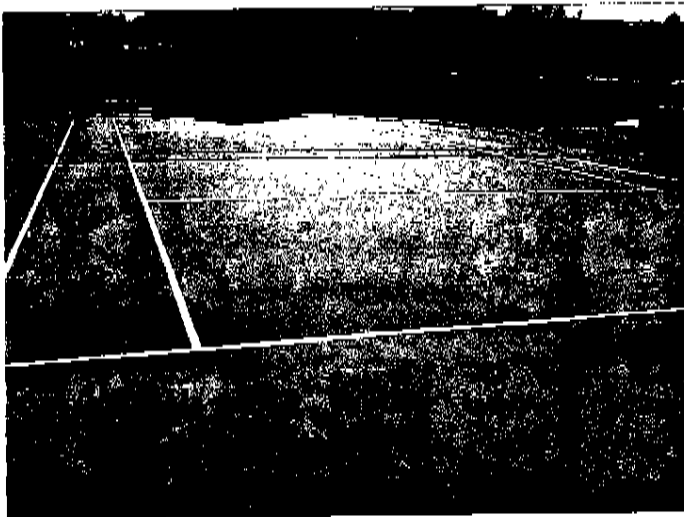
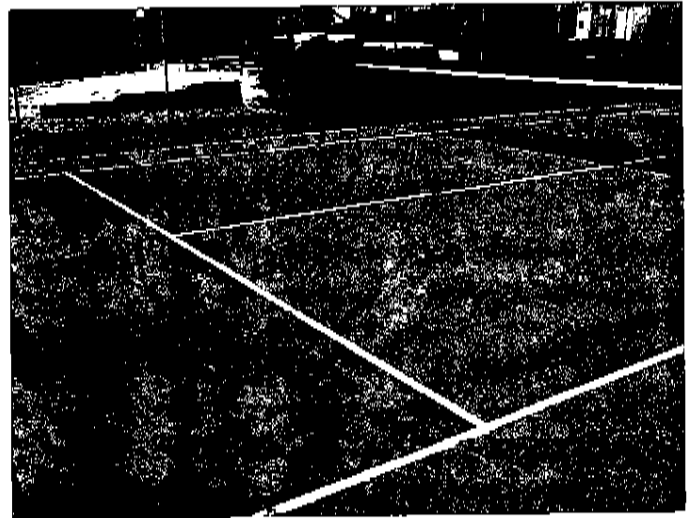
Comp #: 1203 Tennis Court - Recoat

Costing is in good condition with no fading of lines or playing surface. The main problem with the surface is the cracks forming in the asphalt. Based on the amount and location of cracks, expect to resurface with new asphalt within the next couple years.

**Estimate to crack fill and recoat**

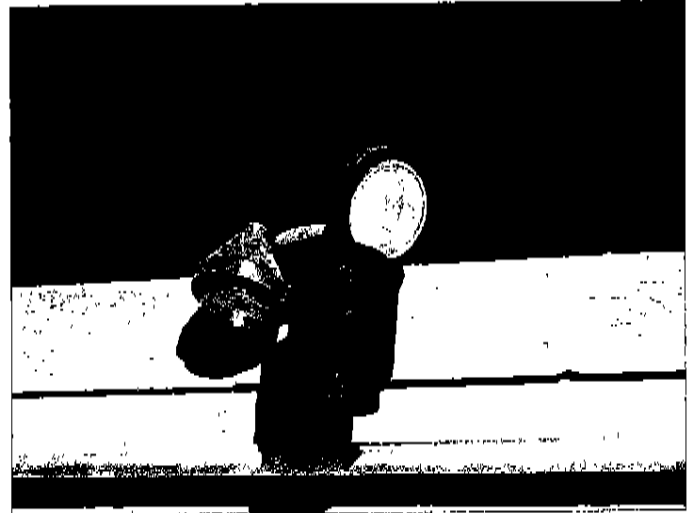
**Component Inventory for Tamarac Hills HOA****Client Reference # 2088****Comp #: 1602 Exterior Wall mount - Replace**

Fixtures were not tested during inspection since it took place during daylight. Fixtures were attached securely to buildings and assumed to be working fine. Individual replacement cost is too small to warrant Reserve funding. Replace on an individual basis using general operating funds.

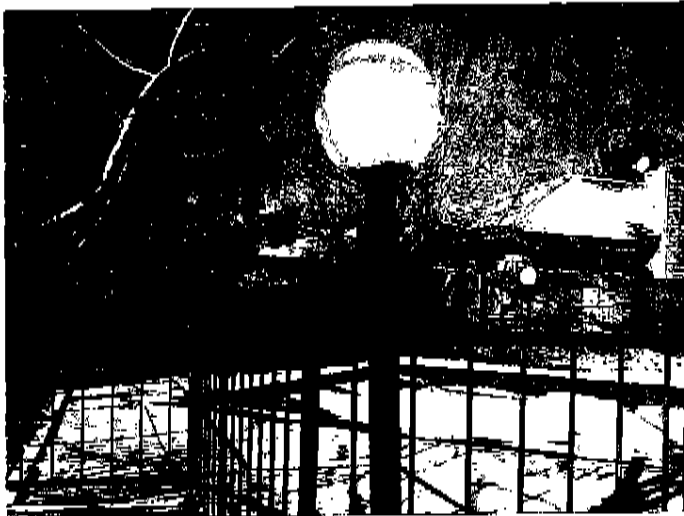
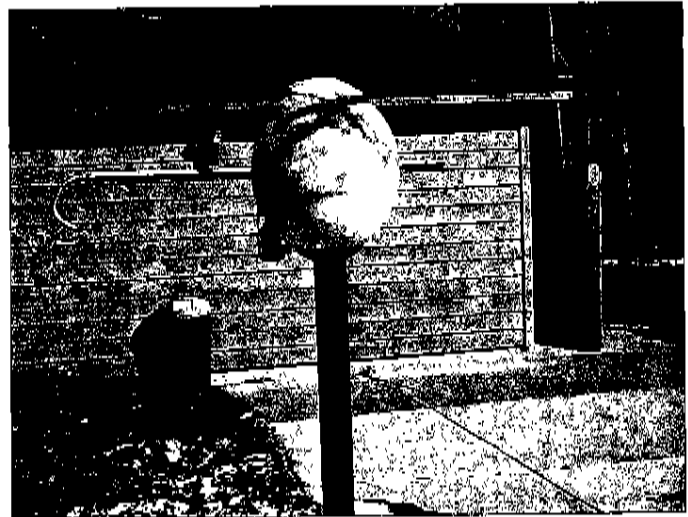
**Component Inventory for Tamarac Hills HOA****Client Reference # 2088****Comp #: 1604 Pole Lights - Replace**

Poles are stable and intact with minor signs of rust and corrosion. These poles should be painted frequently to inhibit rusting and premature deterioration. In this environment, expect to replace every 15 - 20 years under normal wear and tear.

\$250/pole; Estimate to replace and install

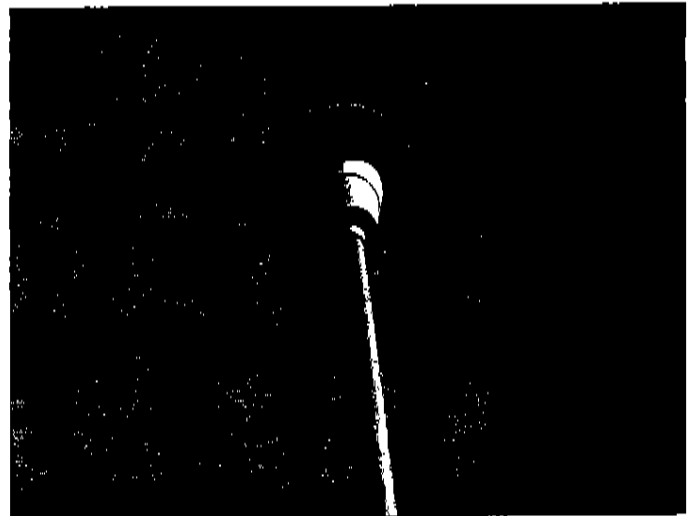
**Component Inventory for Tamarac Hills HOA****Client Reference # 2088****Comp #: 1609 Street Lights - Replace**

According to Xcel energy, these are most likely the responsibility of the energy company, not association. Typically in properties that are not privately gated, the street light are not HOA responsibility. In any case, the poles are made from fiberglass and should have an extended life expectancy. The fixture heads also have a very long life expectancy and should not need to be replaced collectively. The bulbs are replaced as needed. At this time, no Reserve funding is required for this component.

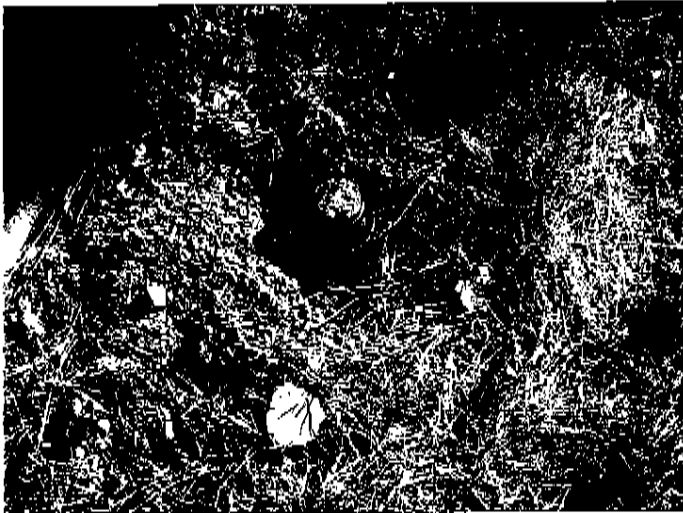
**Comp #:** 1701 Irrigation System - Rebuild (Ph 1)

System was winterized at time of inspection. According to contractor, the system is in fair condition and has 2 - 4 years left before replacement will be required. Typically, sections of irrigation systems can be repaired on an as needed basis with landscape maintenance funds. However, the association has requested for inclusion of replacement for this asset. Useful life is based on current age of system and expected remaining life. This asset has been split into 2 separate phases for easier budgeting purposes.

### Estimate to replace system

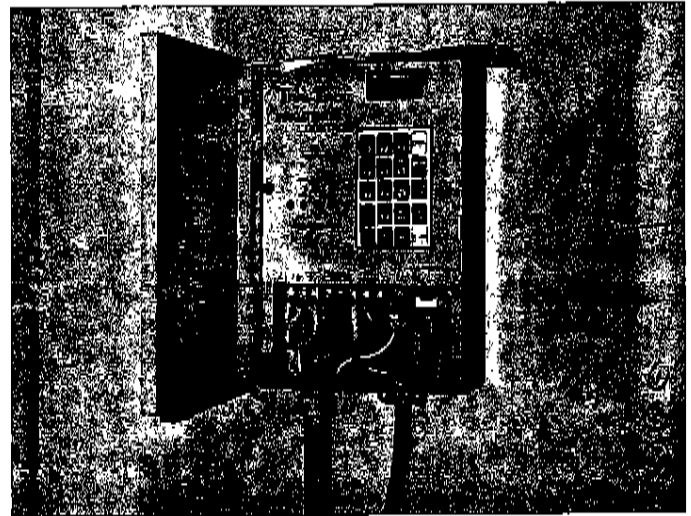
**Component Inventory for Tamarac Hills HOA****Client Reference # 2088****Comp #: 1703 Irrigation Timeclocks - Replace**

Three of the clocks are older and nearing the end of their life expectancy. Two are about 4-5 years old and about halfway through their life expectancy. The remaining 2 clocks are relatively new and in good condition. The average life expectancy for irrigation timeclocks ranges from 10 - 12 years. Due to varying conditions and ages, provide an allowance to replace 1/3rd of clocks every 3 years.

Estimate to replace 2 clocks every 3 years
