## Reserve Study

**Versailles Homeowners Association**  
789 Clarkson Street, Denver, Colorado

January 16, 2008

Re: Versailles Homeowners Association, Denver, Colorado  
Reserve Study – Project No. 07224-967

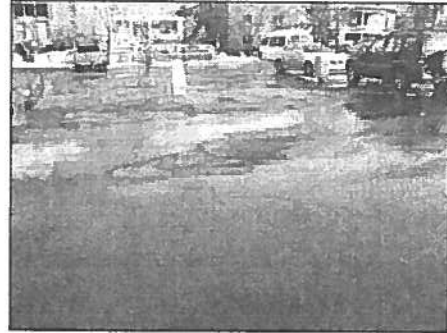
**Description:** Asphalt mat over the subsurface parking garage.

**Condition:** Fair to poor condition. We noted signs of deterioration and cracking.

In this case, it is imperative that the asphalt mat remain in a sound water tight condition with crack fill and seal coat cycles on regular intervals. If cracks are left open for extended periods, there is potential for damage to occur to the subsurface concrete parking garage ceiling and column structures.

- Cyclically crack fill and seal coat the asphalt parking deck every four years, starting in 2008.
- Mill and overlay the asphalt parking deck in 2012.

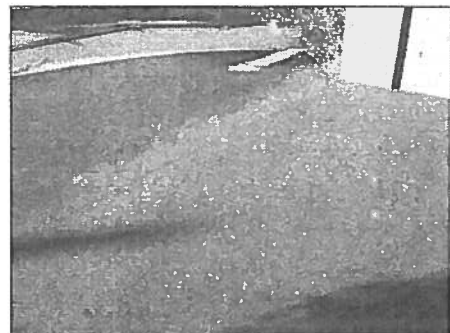
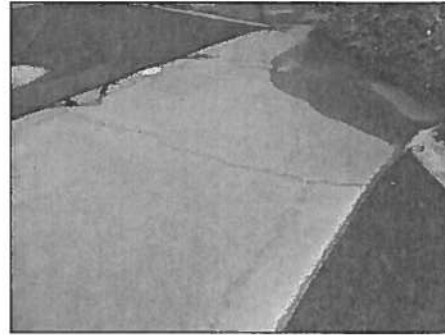
**Description:** On-grade, reinforced, concrete slabs. There is a portion, on the east end of the deck where carpet is installed.

**Condition:** Fair to poor condition, where visible.

We reviewed a bid from *WeatherSure* dated December 14, 2007 that indicates there is damage to a portion of the concrete deck, above the subsurface parking area, that is causing water intrusion into the parking garage structure.

- Make the recommended pool deck repairs, per *WeatherSure* recommendations in 2008.
- Cyclically inspect the surface; repair any cracks by routing, cleaning and epoxy injecting the cracks every three years, starting in 2008. This expense is not included in the Study because it falls below the minimum funding threshold.
- Cyclically replace damaged sections of the concrete pool deck every eight years, starting in 2008.

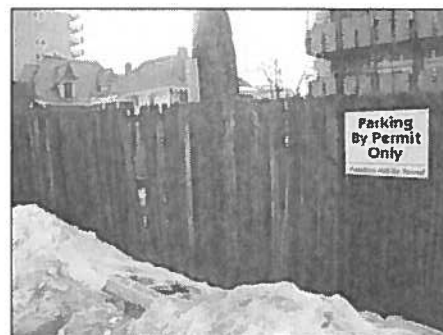
**Condition:** Fair to poor condition. We noted some areas on the west side that were damaged and leaning.

- Cyclically remove and replace the wood fencing every 14 years, starting in 2009.
- Cyclically stain or seal the wood fencing every four years, starting in 2013.

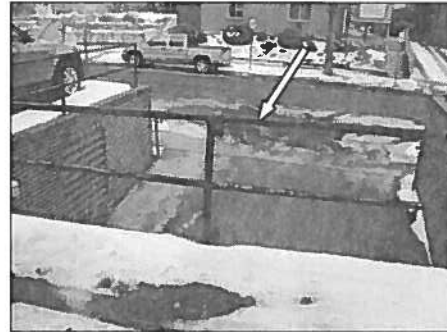
**Condition:** Fair condition with no major signs of deterioration.

- Cyclically scrape, rustproof and paint the metal fencing every five years, starting in 2010.
- Remove and replace the metal fencing in 2017.

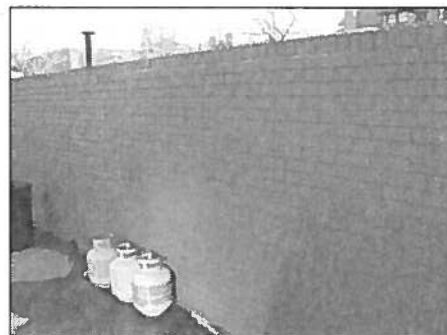
- The north and south ends of the pool have a brick free standing wall. The wall is painted; we presume it is coated with a commercial grade elastomeric paint. Typically this type of wall is reinforced per the building code.
- The west end of the pool has a freestanding concrete masonry unit (CMU) wall. The wall is painted; we presume it is coated with a commercial grade elastomeric paint.

**Condition:** All three walls were in satisfactory condition for their age. We noted some minor deterioration of the mortar joints and in the paint in various locations throughout the three walls.

- Cyclically inspect, tuck point the mortar joints and replace damaged bricks or CMU blocks every six years, starting in 2008.
- Cyclically power wash, scrape and paint the freestanding walls with a commercial grade, elastomeric paint every 10 years, starting in 2008.

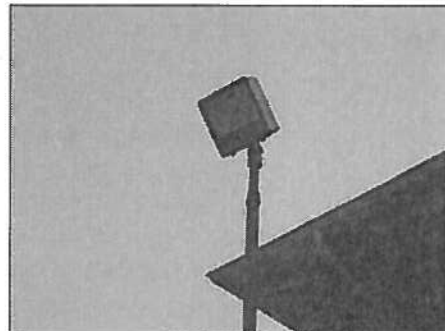
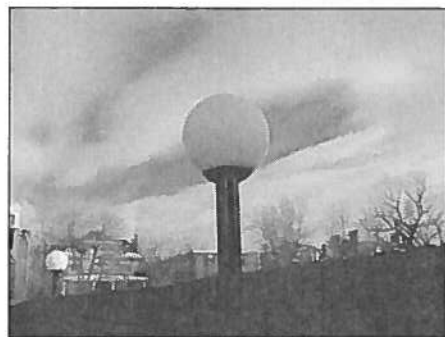
#### C4. Exterior Lighting Units

**Condition:** Good condition with no major cracking or deterioration noted.

- Replace the wall mounted lighting at the swimming pool in 2009.
- Replace the high profile parking lights in 2012.
- Replace the entry bollard lighting in 2019.

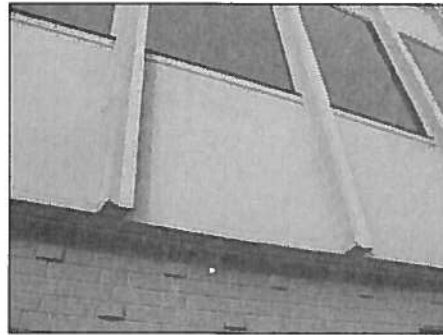
### D1. Composite Paneling

For a building of this age, it has been in our experience that these panels could potentially be made of an asbestos material. Special care and environmental testing should be taken when these panels are removed and replaced.

**Condition:** Satisfactory condition, we noted some minor signs of deterioration by weathering beneath the paint on the lower level panels. We were informed the exterior of the build was last painted in 2001.

- Cyclically power wash, scrape and paint the composite paneling at the building exterior every eight years, starting in 2010. This expense includes required scaffolding.
- Remove and replace the composite paneling at the building exterior in 2020. This expense includes required scaffolding.

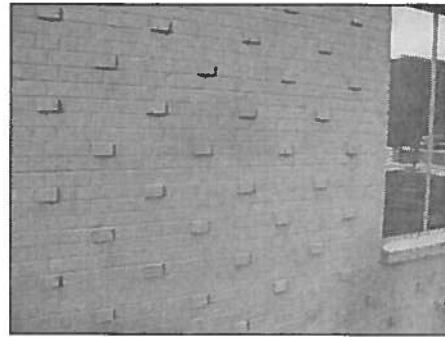
**Condition:** Satisfactory condition, the mortar joints were in fair condition with some minor deterioration in various locations. The coating on the brick was in fair condition. We were informed the brick façade was painted in 2001.

- Cyclically power wash and scrape the painted surface, repair damaged mortar joints and install a new elastomeric coating every eight years, starting in 2010.

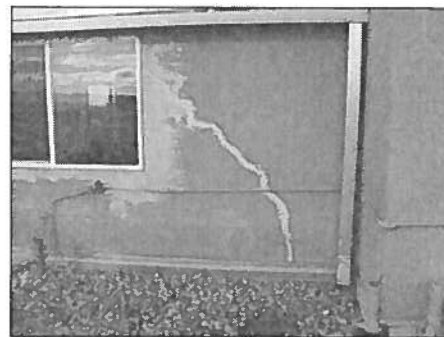
**Condition:** Poor condition with excessive cracking to the surface. Some of the cracks have repairs but new cracks have developed. There are no vertical expansion joints in the surface to allow the system to expand and contract with temperature changes. It also appears that the plaster coating was applied directly to the structure with no reinforcement behind the layer of plaster.

**Effective Useful Life:** Based on the plaster's current condition, 0 to 1 year.

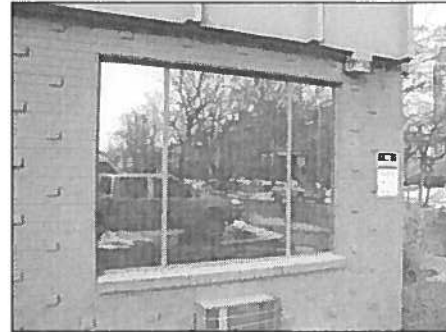
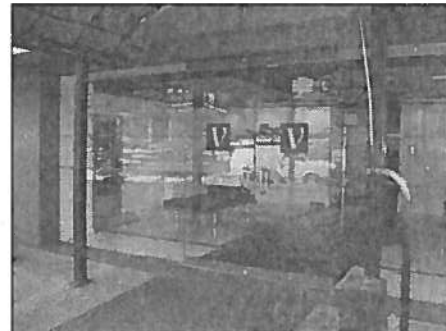
**Condition:** Good to fair condition.

- Cyclically remove and replace the sealant joints in the glass entry every three years, starting in 2009. This expense is not included in this Study because it falls below the funding threshold.
- Remove and replace the garage man door, manager's office door, restroom doors and laundry room door in 2015.
- Replace the common windows in 2015.

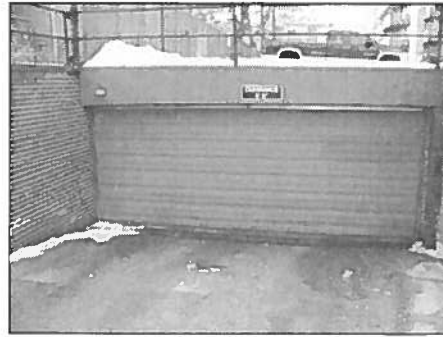
### D5. Garage Door

**Condition:** Satisfactory condition.

- Replace the garage door at the subsurface parking garage in 2015.

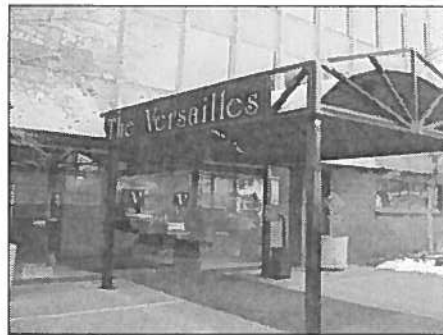
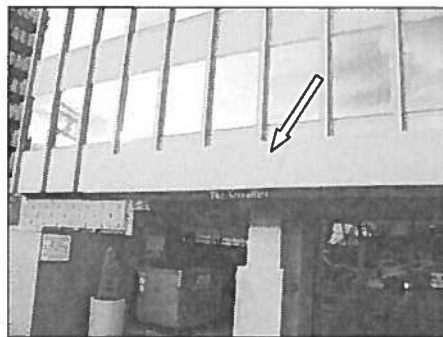
### D6. Awnings

Support structures – Good condition with minor visible signs of deterioration and corrosion.  
Canvas – Fair condition, we noted some holes in the canvas at the main entry awning.

- Cyclically replace the canvas awnings every eight years, starting in 2009.
- Cyclically scrape, rust proof and pain the awning support structures every five years, starting in 2010. This expense has not been included because it falls below the funding threshold.

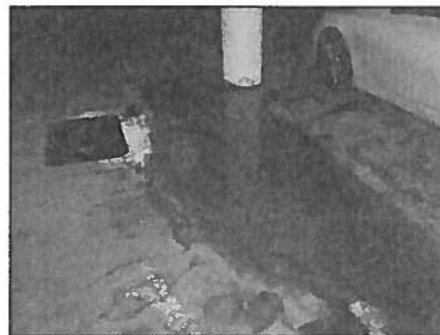
**Condition:** Fair condition with some noted cracking and minor surface deterioration.

Cracks in the horizontal concrete surface greater than 1/8" shall be routed with a V groove blade or saw cut. The crack shall be cleaned, primed and backed with closed cell backer rod or bond breaker tape. Install traffic grade sealant at the manufacturers recommended depth to width ratio.

- Cyclically inspect the surface; repair any cracks by routing, cleaning and sealing the cracks every three years, starting in 2008.
- Cyclically replace damaged sections of the concrete surface every eight years, starting in 2010.

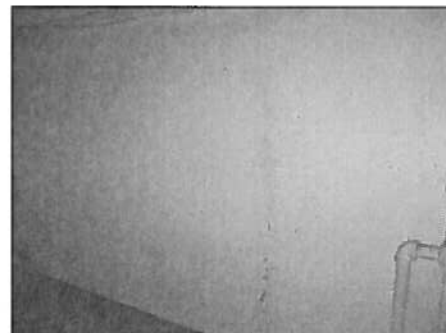
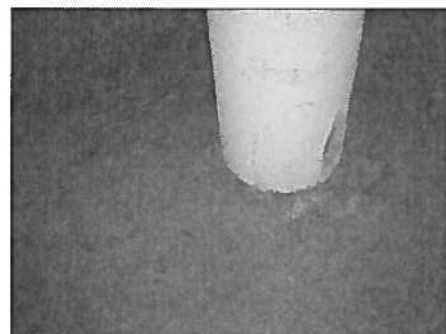
**Description:** Cast-in-place, reinforced concrete foundation walls, ceiling and concrete support columns.

**Condition:** Fair condition. We noted some minor cracking in the walls and columns that should be addressed and monitored. We also noted evidence of water intrusion above a portion of the concrete columns, based on puddling in the general vicinity, although we did not observe any leaking at the columns at the time of our observation.

Typically cracks that are 1/8" or larger should be routed and epoxy injected to prevent any further damage to the structure.

- Cyclically inspect the concrete walls and columns at the subsurface parking garage for any cracking or damage and perform any required maintenance every five years, starting in 2010.

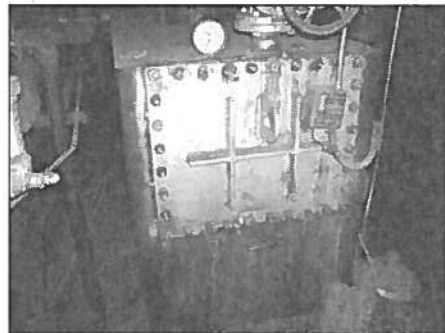
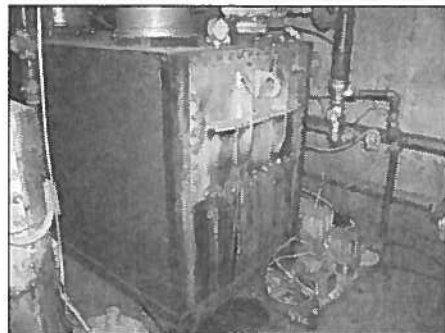
### I1. Boilers

- The smaller boiler is a Rite, 1,650,000 btu/hr, gas fired system. This boiler provides for the domestic hot water system and the heat for the swimming pool.
- The larger boiler is a Rite 3,250,000 btu/hr, gas fired system. This boiler provides space heat for the building.

**Condition:** Poor condition, we were informed that the units constantly serviced and in need of replacement. Replacement boilers are scheduled to be installed in 2008.

- Remove and replace the two existing boilers and install the four boilers in 2008.
- Bring the chimney and flue up to code by installing an interior liner in 2008.
- Retube the new boilers in 2018.

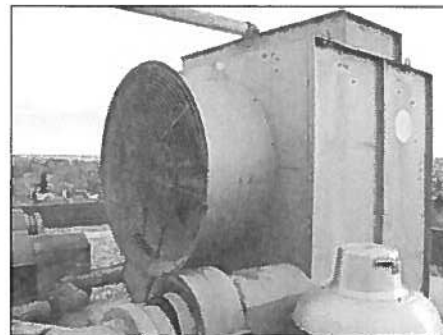
**Description:** Evapco, model FXT-60. The cooling tower cools the gas from the chiller system to be reused. The liquid gas is sprayed over a medium in the tower and cooled by blown air pulled from the outside and cooled water.

**Condition:** We were informed that the cooling tower is in satisfactory working condition. The unit was refurbished in 2003 when the chillers were installed.

**Effective Useful Life:** Under its current condition, we were informed the remaining useful life of this unit is between 5 to 7 years.

- Remove and replace the cooling tower in 2014.

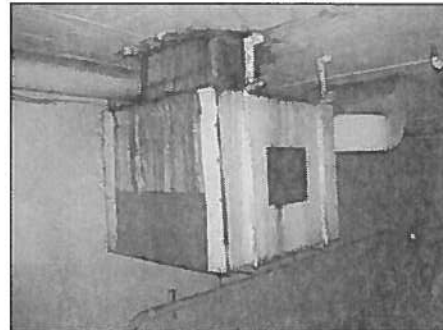
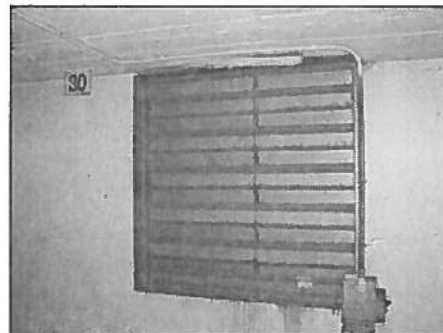
**Condition:** Appeared to be in satisfactory working condition. The return fan unit had visual signs of corrosion on the exterior casing.

- Update the CO<sub>2</sub> monitoring system every 15 years, starting in 2009.
- Replace the CO<sub>2</sub> fan in 2010.

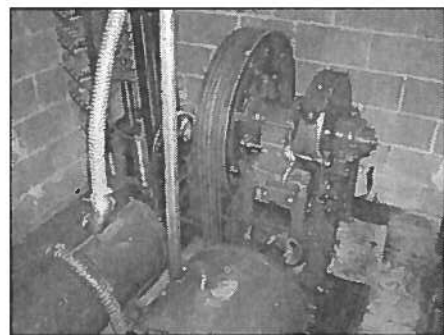
### L. Elevator

**Condition:** Poor condition, we were informed this unit requires repair on a regular basis. We were also informed this unit will be replaced in 2008.
