**Quail Ridge THCA  
11131-11167 W. 17<sup>th</sup> Ave  
Lakewood, CO 80224**

**Level 1, Limited Reserve Analysis**

**Report Period – 5/01/16-4/30/17**

**Final  
Version**

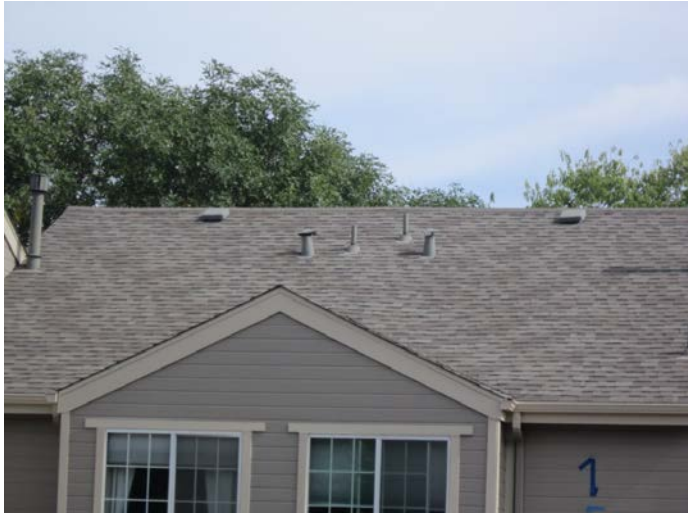
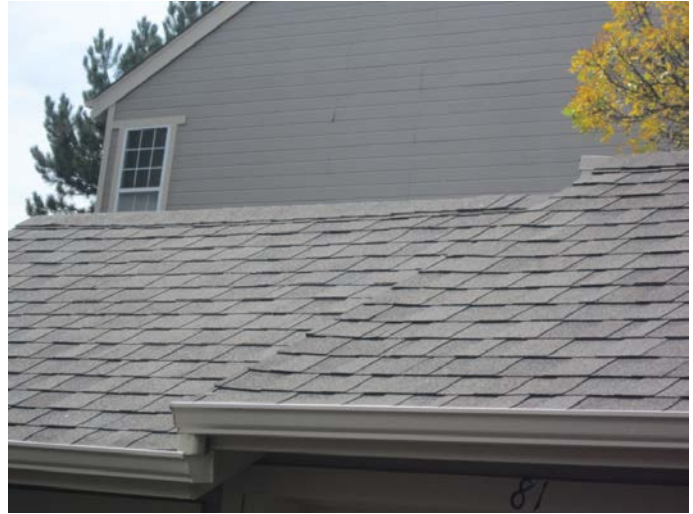
Comp #: 105    Comp Shingle Roof - Replace

*Location:*            **Throughout the Property**

\$400/square; Estimate to remove and replace

**Unit Buildings - 1,071 SQS**  
**Garage Buildings - 91 SQS**  
**Pool Building - 25 SQS**  
**Mailbox Kiosk - 4 SQS**

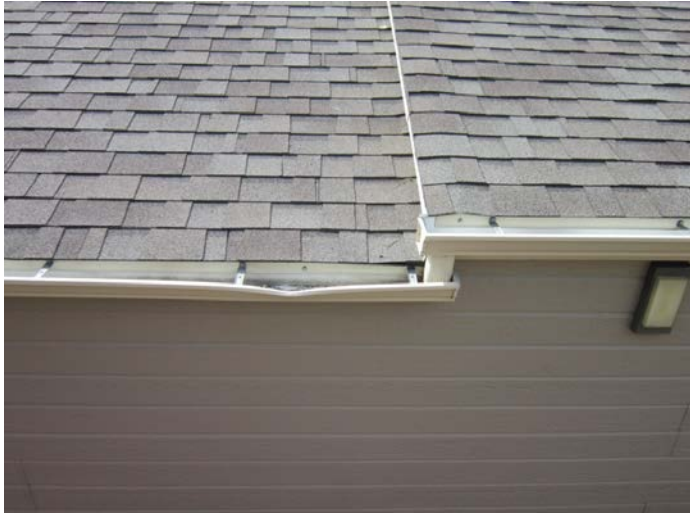
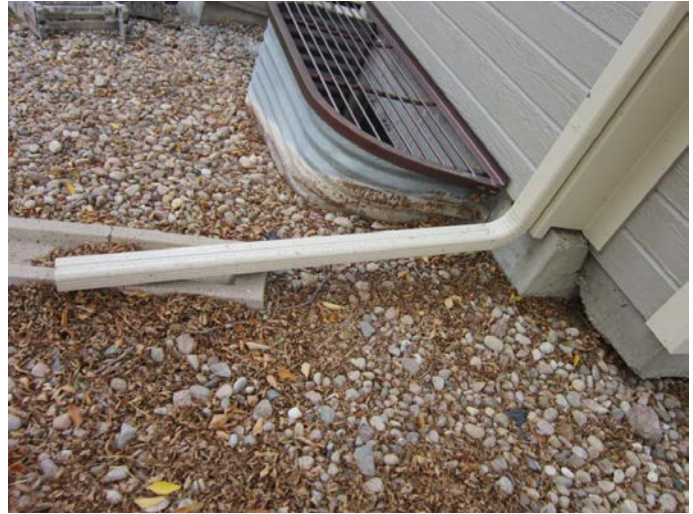
Comp #: 120 Gutters/Downspouts - Replace

Location: **Throughout the Property**

\$5.25/LF; Estimate to replace

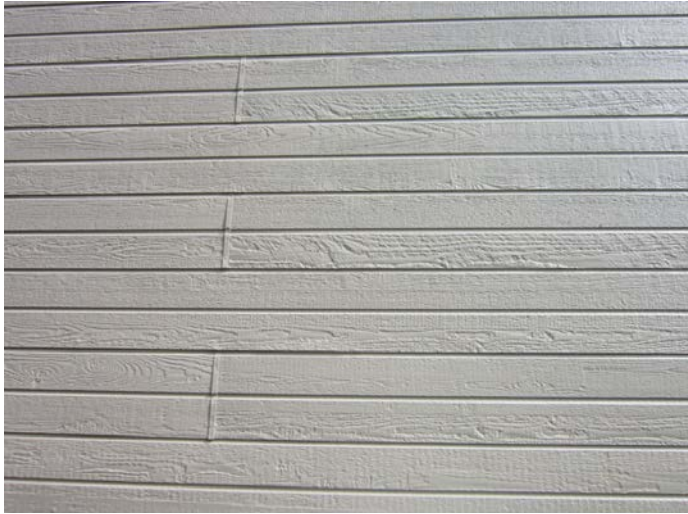
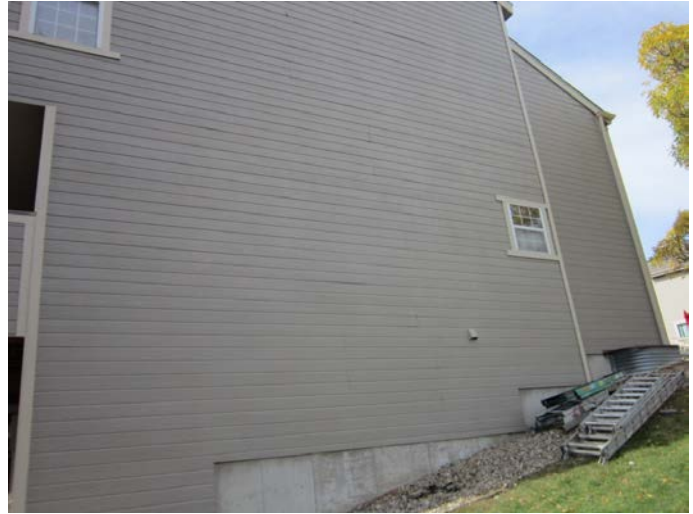
Comp #: 301 Hardboard Siding - Major Repairs

*Location:* **Throughout the Property**

\$250/unit; Estimate to repair siding

\$300/unit; Higher estimate for more repairs

**Unit Buildings - 140,550 GSF**  
**Garage Buildings - 4,560 GSF**  
**Pool Buildings - 1,530 GSF**  
**Mailbox Kiosk - 160 GSF**

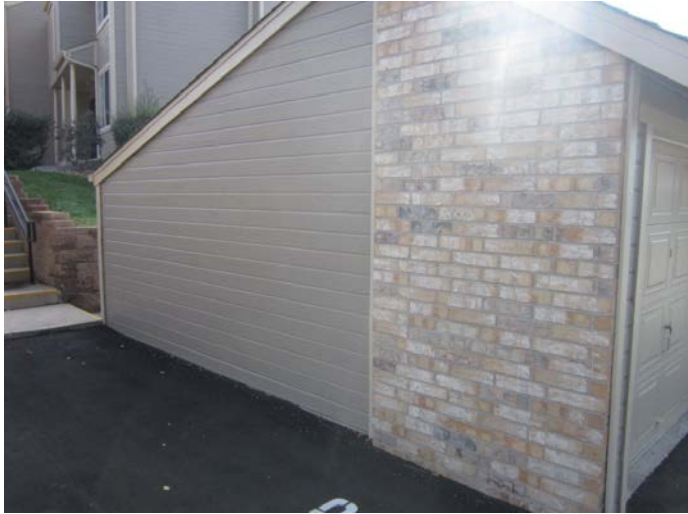
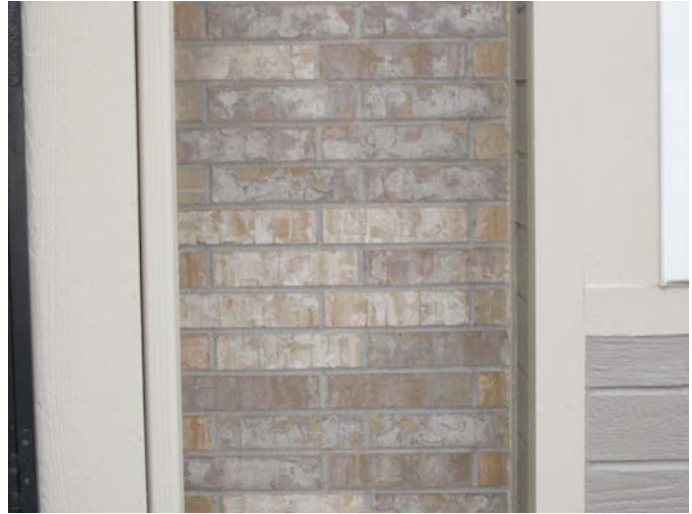
Comp #: 306 Brick - Replace

Location: **Throughout the Property**

**Typically, bricks have an extended life expectancy and complete replacement is unlikely. There are times where minor repairs may become necessary, but this is unpredictable when and how much would occur. Repairs should be handled as a maintenance issue on an as needed basis. Reserve funding is not required for this component at this time.**

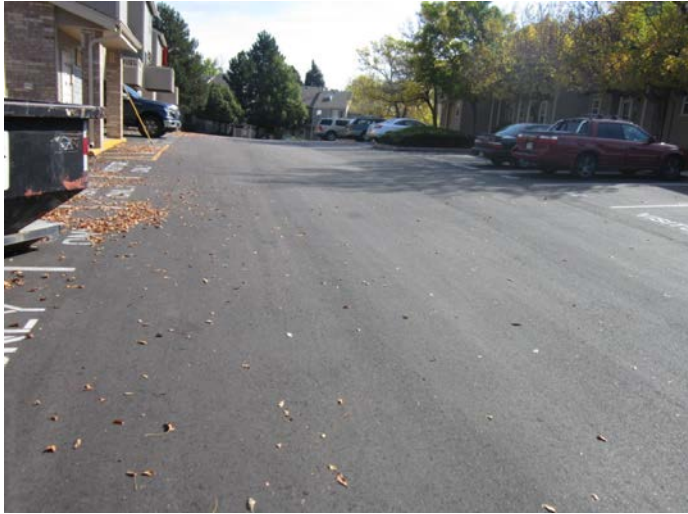
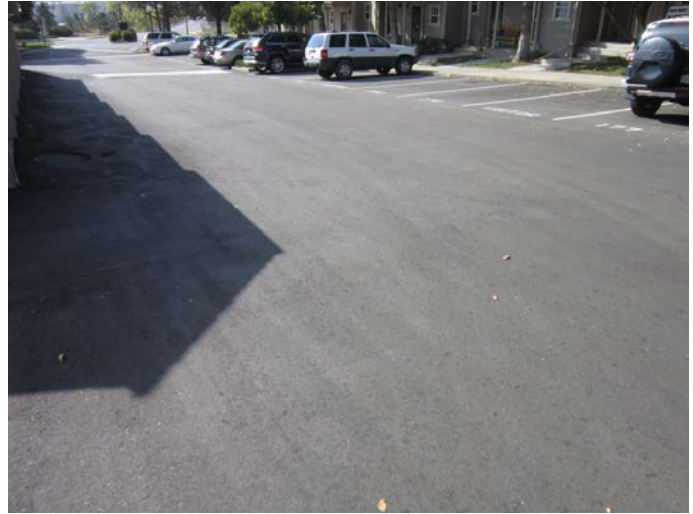
Comp #: 401 Asphalt - Major Overlay (1)

Location: **Community Streets**

\$1.05/GSF; Higher estimate for more repairs

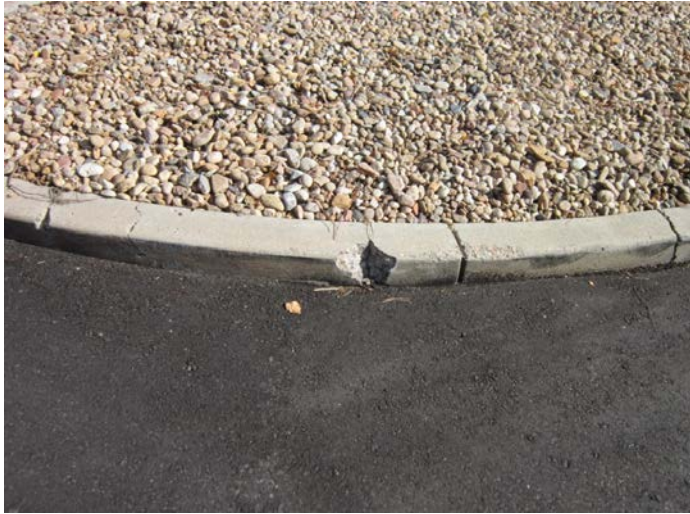
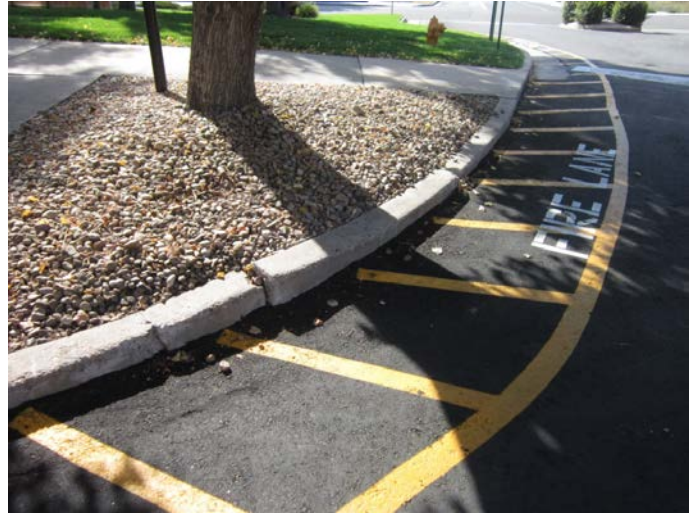
Comp #: 407 Curb and Gutters - Repair

Location: **Community Streets**

Estimate to repair 5% of area every 5 years

**Curb and Gutter - 8,960 GSF**  
**Drain Pan - 2,630 GSF**

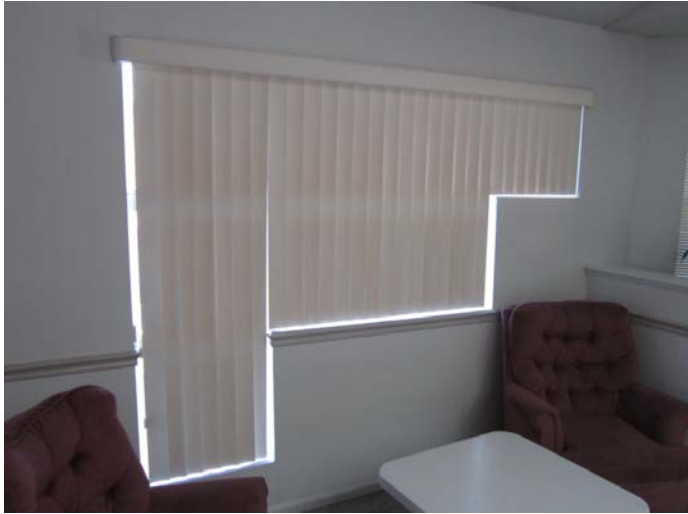
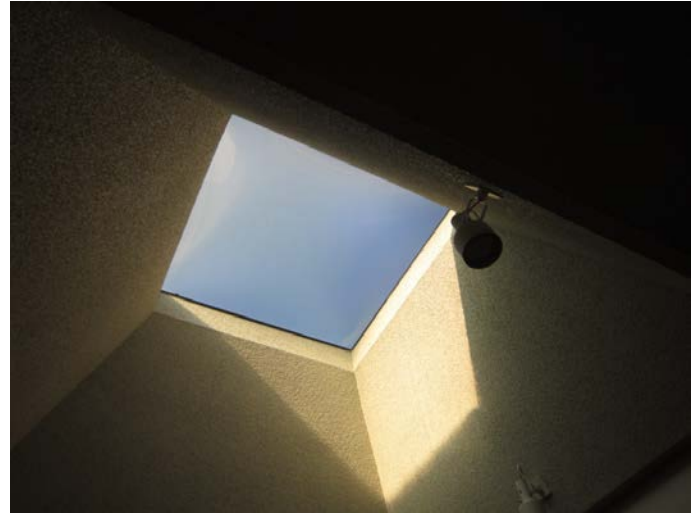
Comp #: 506 Doors/Windows - Replace

Location: **Clubhouse and Mailbox Kiosk**

\$650/opening; Average estimate to replace

**TOTAL - 30 Openings**

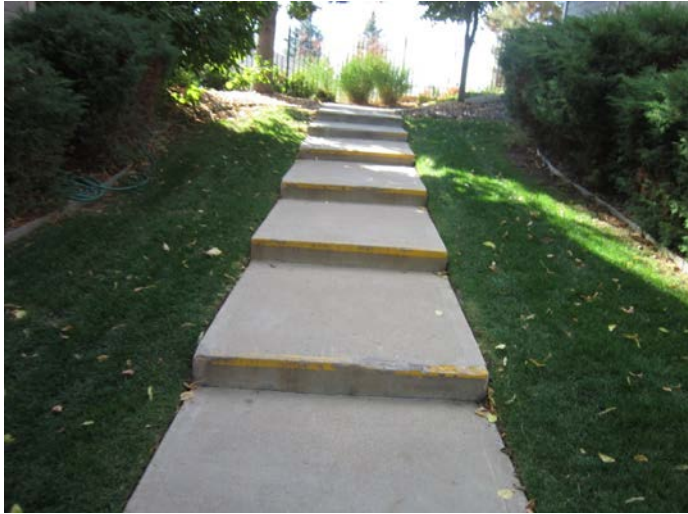
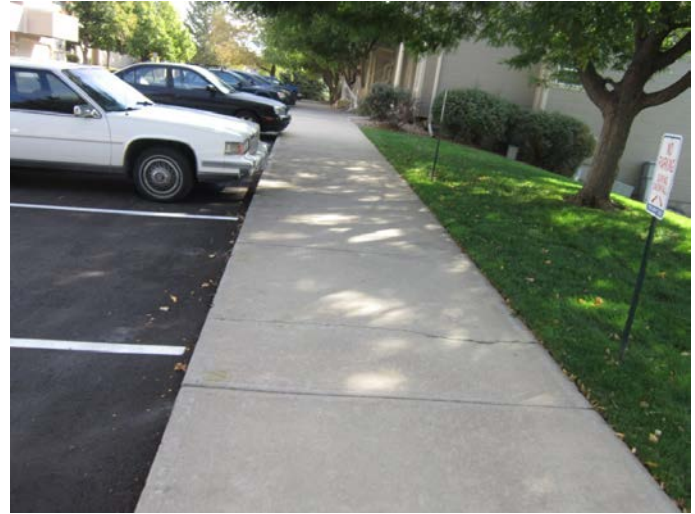
Comp #: 601 Concrete Flatwork - Partial Replace

Location: **Common Areas**

Allowance to repair 10% of area every 5 years

**Common area sidewalks - 28,570 GSF**  
**Pool Deck - 3,705 GSF**

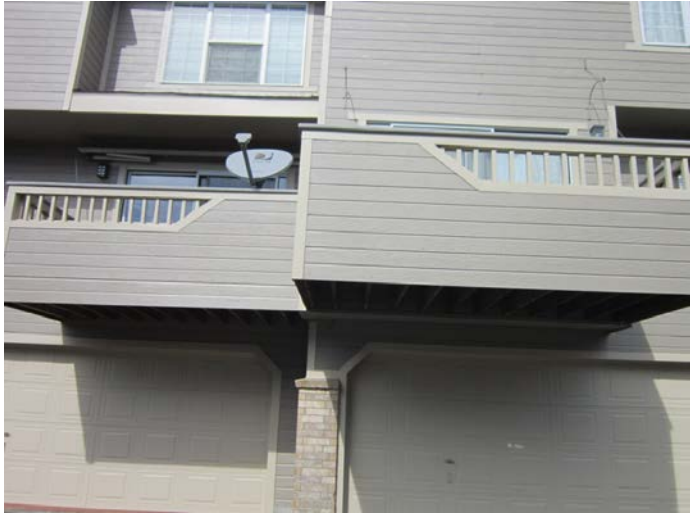
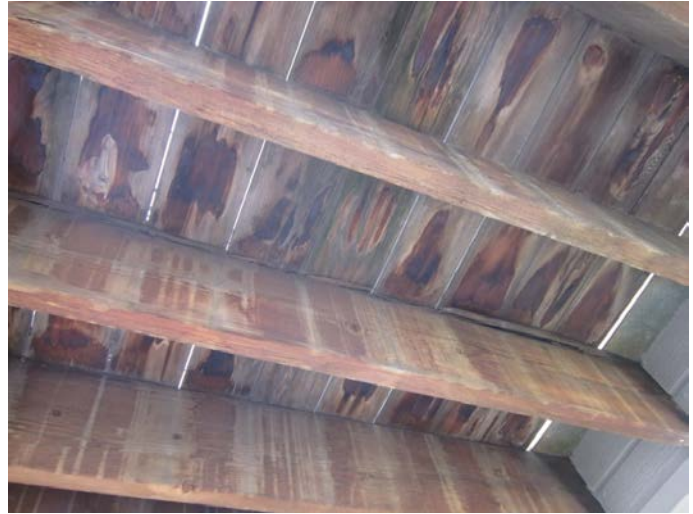
Comp #: 607 Cantilever Wood Deck - Replace 25%

Location: **Unit Buildings**

\$7,250/Deck; Estimate to replace wood decks

**This an allowance to replace (10) cantilevered decks every 4 years.**

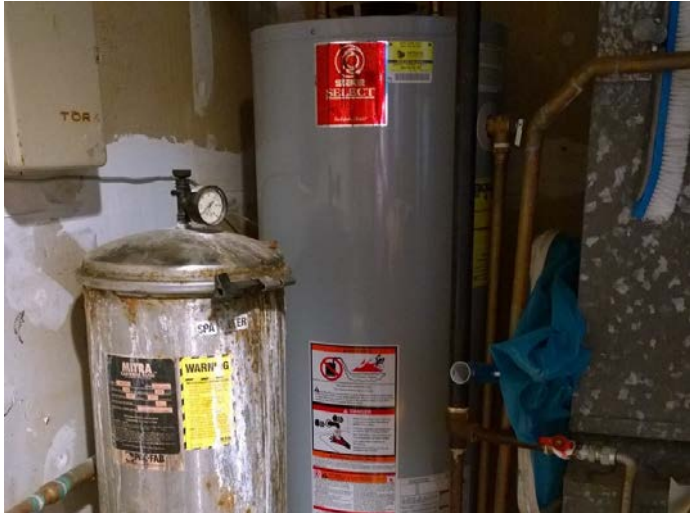
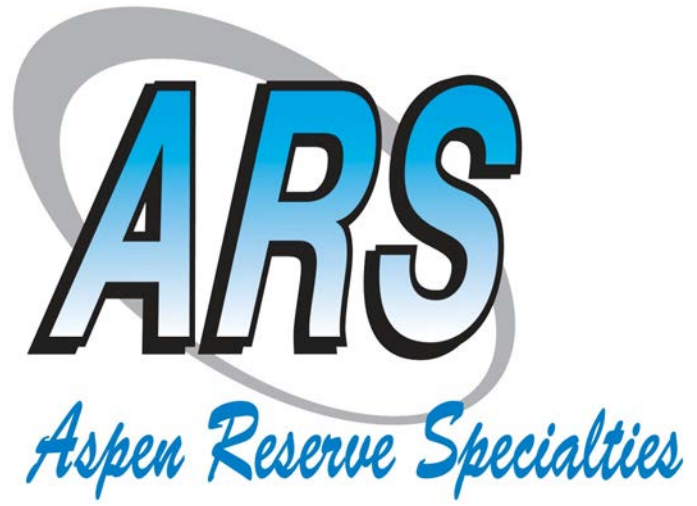
Comp #: 703 Water Heater - Replace

Location: **Mechanical Room**

\$2000/heater; Estimate to replace 50 gallon heater

**(1) - State Select**

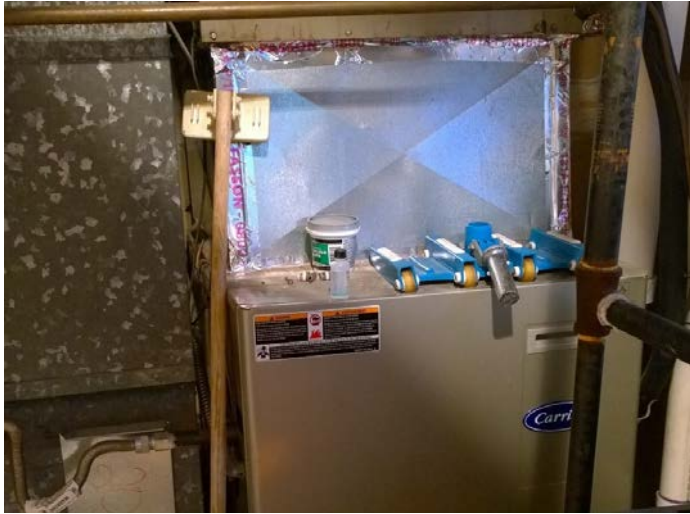
Comp #: 706 HVAC System - Replace

Location: **Mechanical Room**

\$3,250/system; Estimate to replace

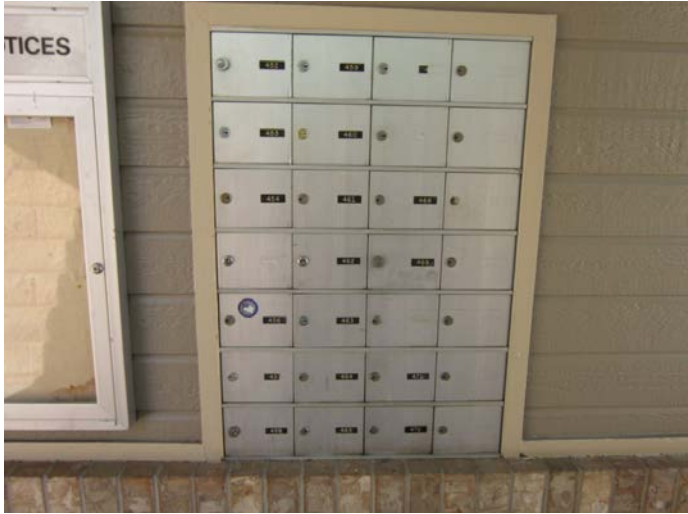
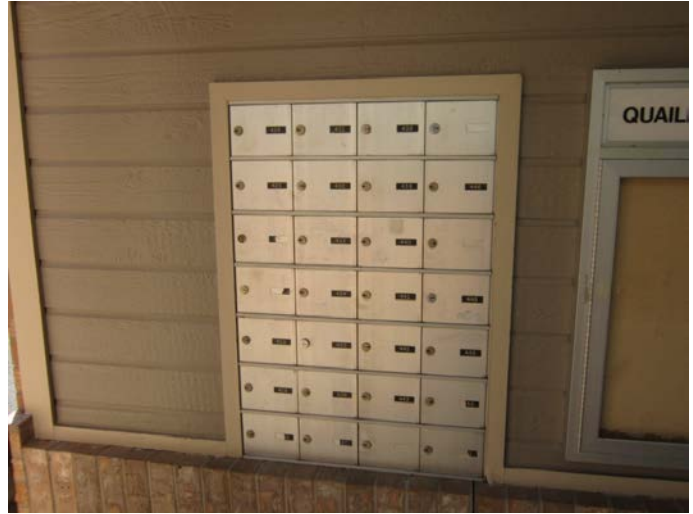
Comp #: 803 Mailboxes - Replace

Location: **Mailbox Kiosk**

Estimate to replace

(1) - 35 Box CBU - \$1650-\$1900/ea  
(3) - 28 Box CBU - \$1650-\$1900/ea  
(1) - 8 Parcel Locker - \$1500 - \$1650/ea

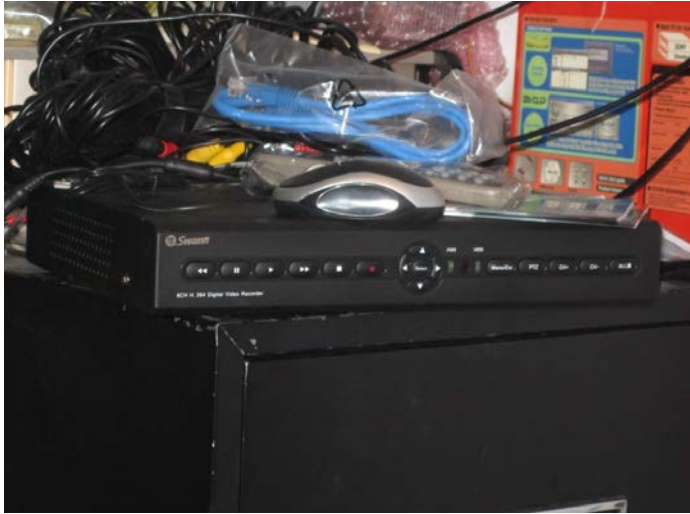
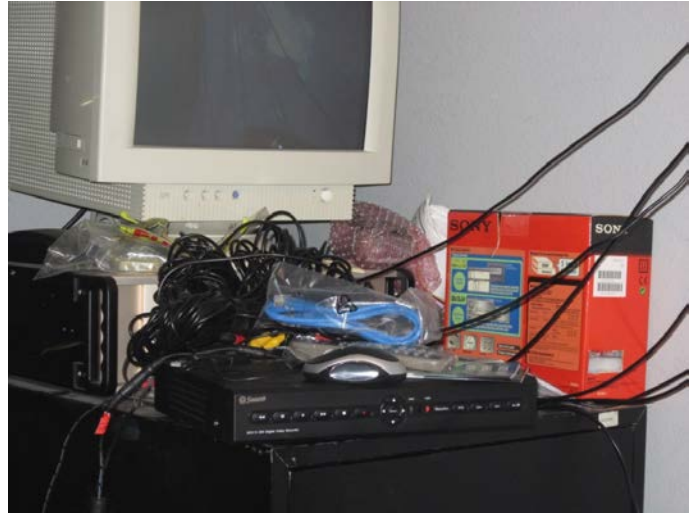
Comp #: 903 TV Security System - Replace

Location: **Clubhouse**

**(1) - Swann DVR**  
**(1) - Computer with Monitor**  
**(8) - Cameras**

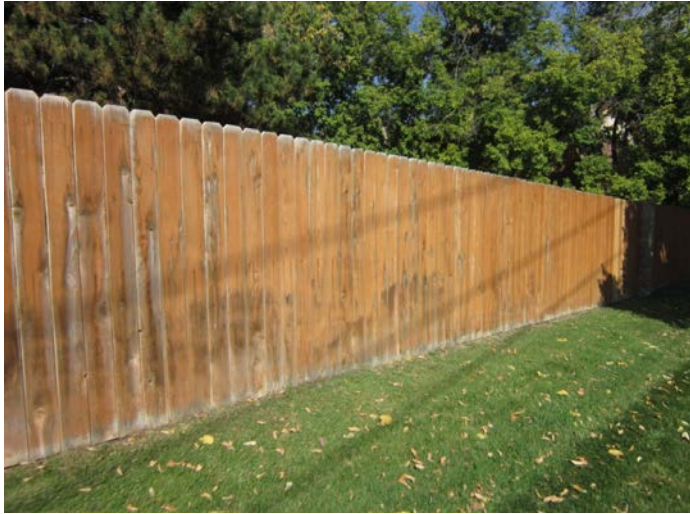
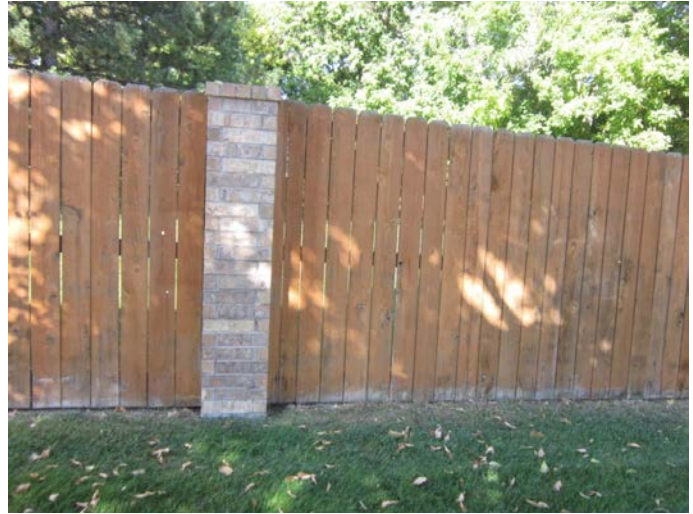
Comp #: 1001 Wood Fencing - Replace

*Location:* **Perimeter of Community**

\$33/LF; Estimate to replace

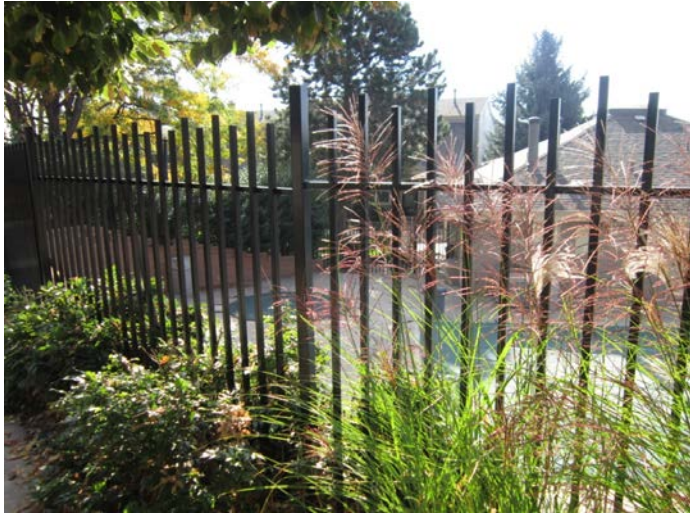
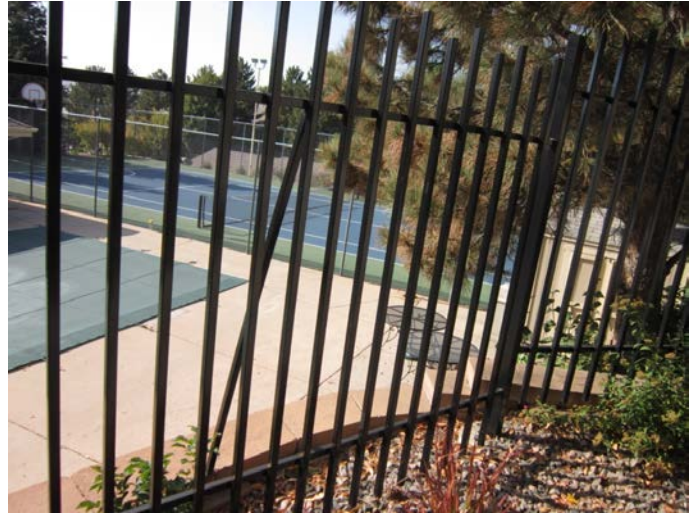
Comp #: 1002 Metal Fencing - Replace

*Location:* **Common Areas**

\$45/LF; Estimate to replace

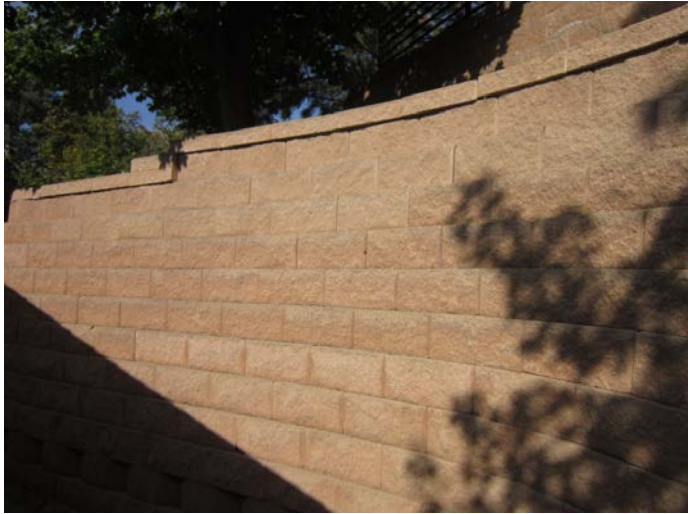
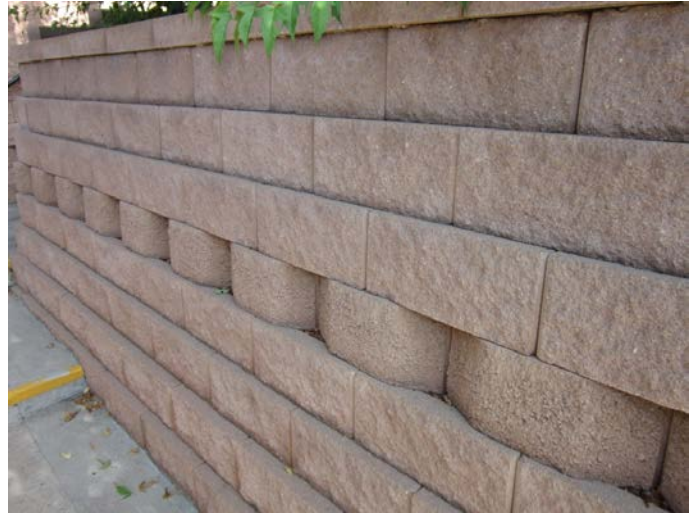
Comp #: 1005 Block Wall - Replace

Location: **Common Areas**

**As long as block wall was installed conforming to county code, this wall should have an extended useful life. Since there is no expectation to replace wall, Reserve funding is not required for this component.**

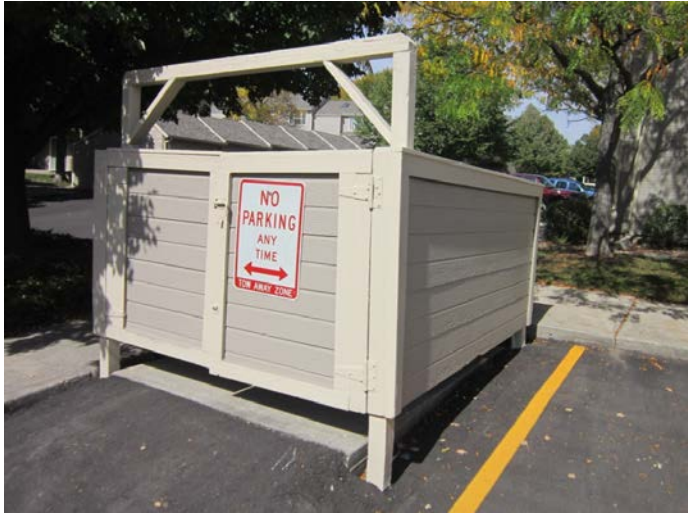
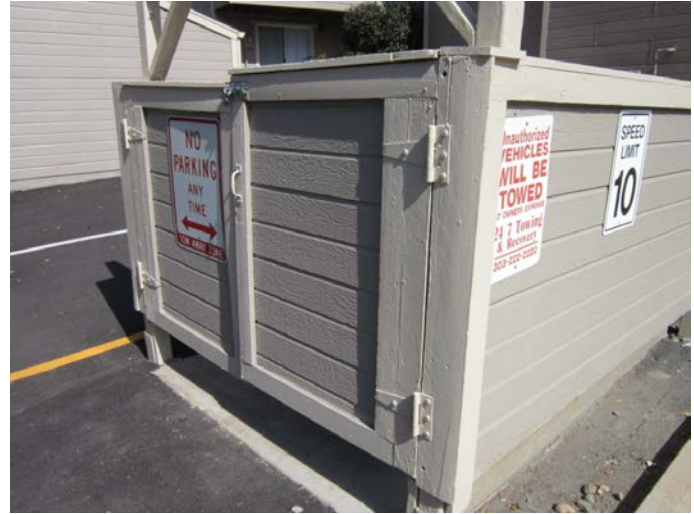
Comp #: 1010 Trash Enclosures - Major Repairs

Location: **Common Areas**

Allownace for general repairs

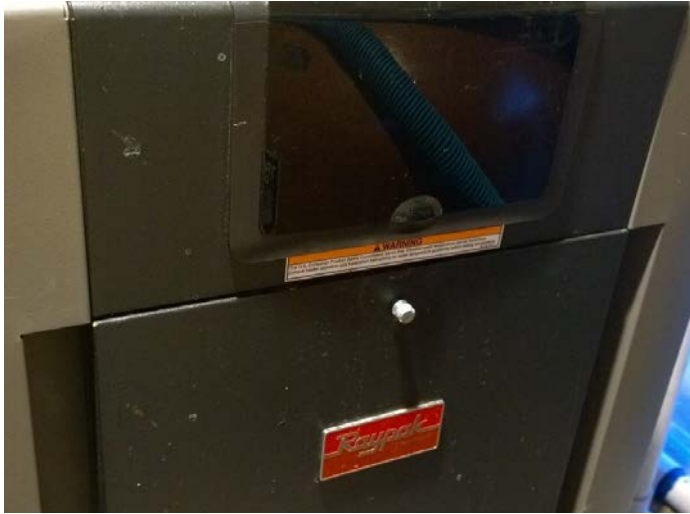
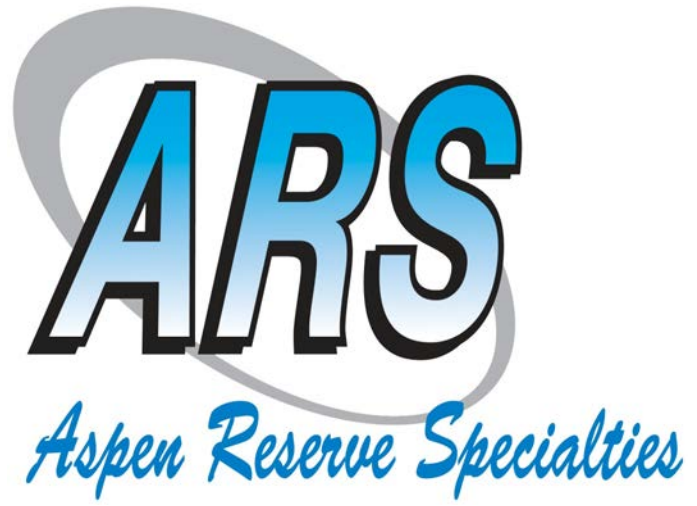
Comp #: 1105 Pool Heater - Replace

Location: **Mechanical Room**

\$5000/heater; Estimate to replace

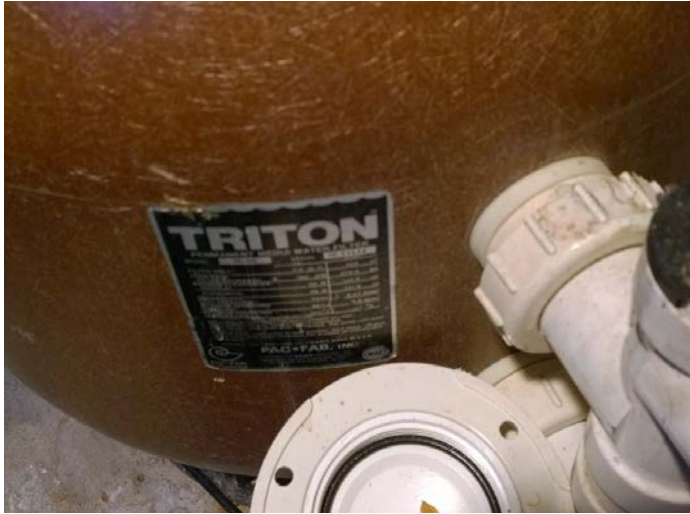
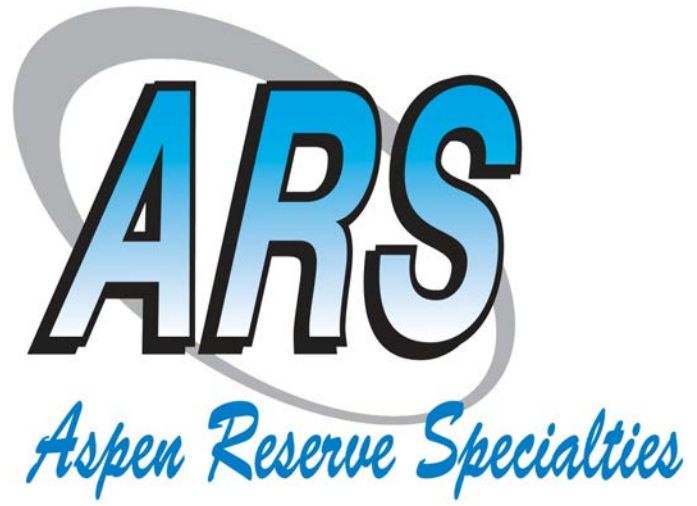
Comp #: 1108 Pool Filter - Replace

Location: **Mechanical Room**

\$1200/filter; Estimate to replace

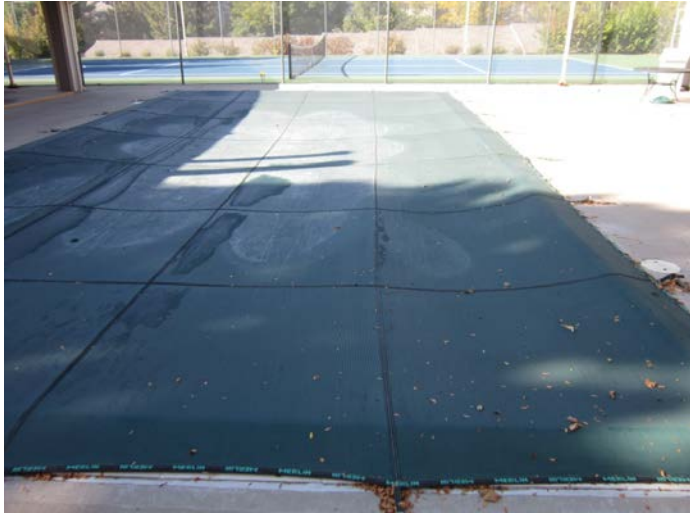
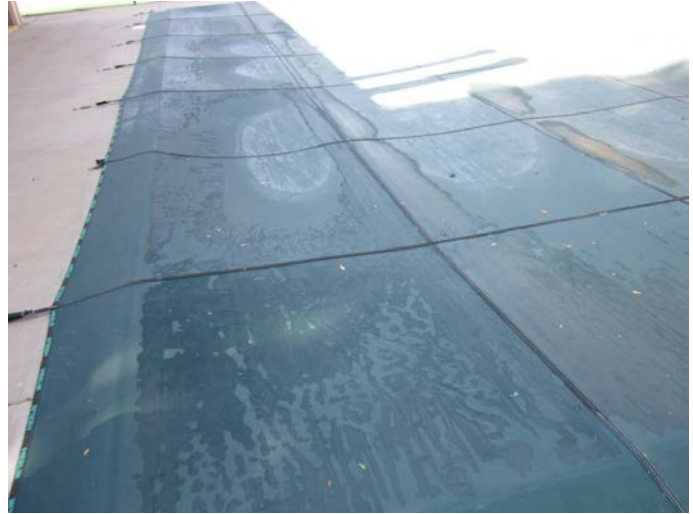
Comp #: 1113 Pool Cover - Replace

*Location:* **Pool Area**

\$3.25/GSF; Estimate to replace

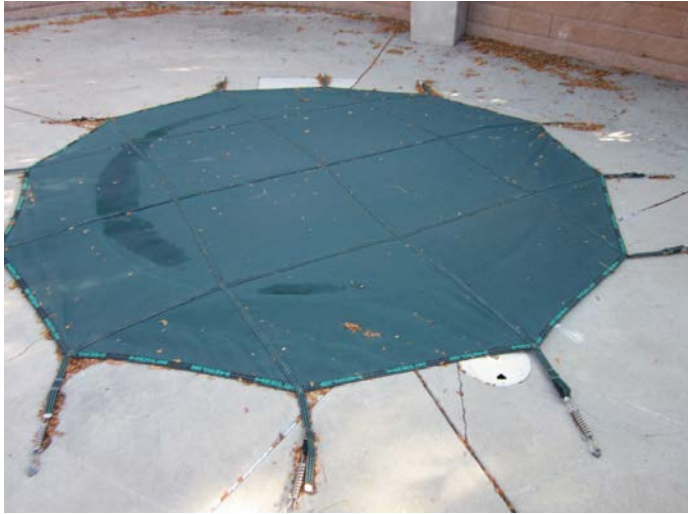
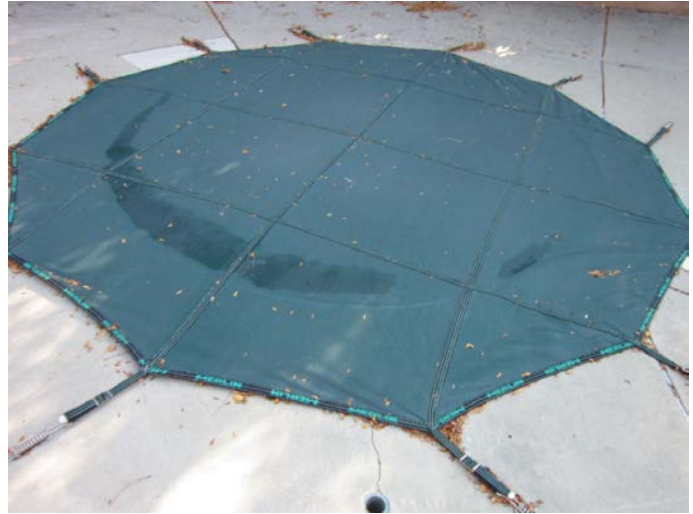
Comp #: 1114 Spa Cover - Replace

Location: **Pool Area**

**Due to the low cost of this spa cover, replace as-needed out of operating funds.**

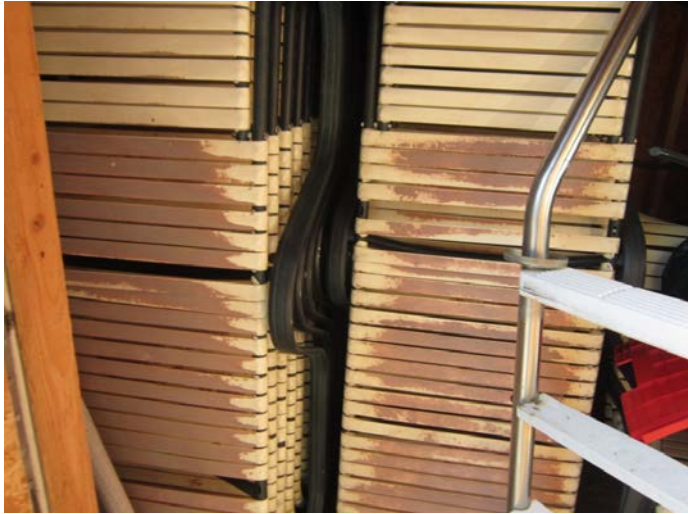
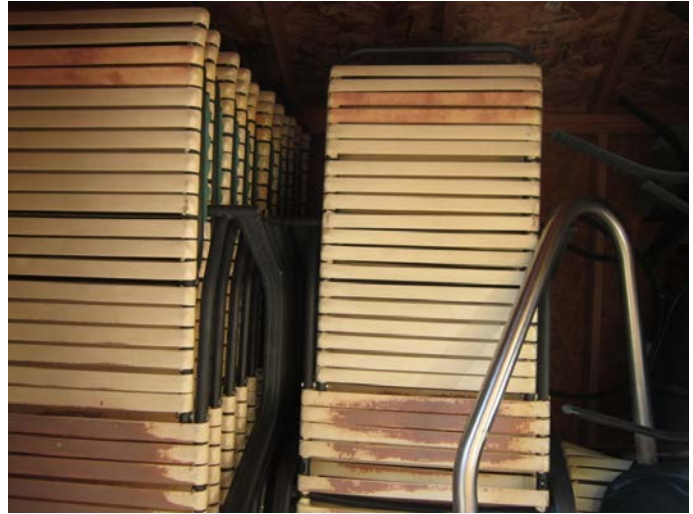
Comp #: 1121 Pool Furniture - Replace

*Location:* **Pool Area**

\$175/Piece; Estimate to replace pool furniture

**(20) - Chaise Lounge**  
**(10) - Chairs**  
**(2) - Tables**

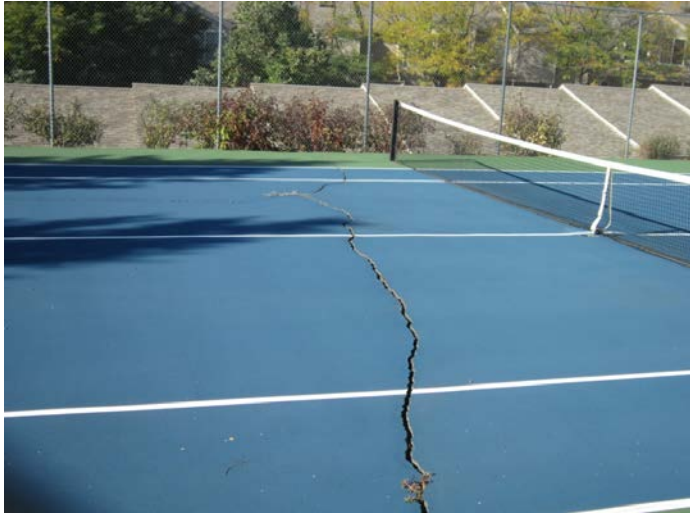
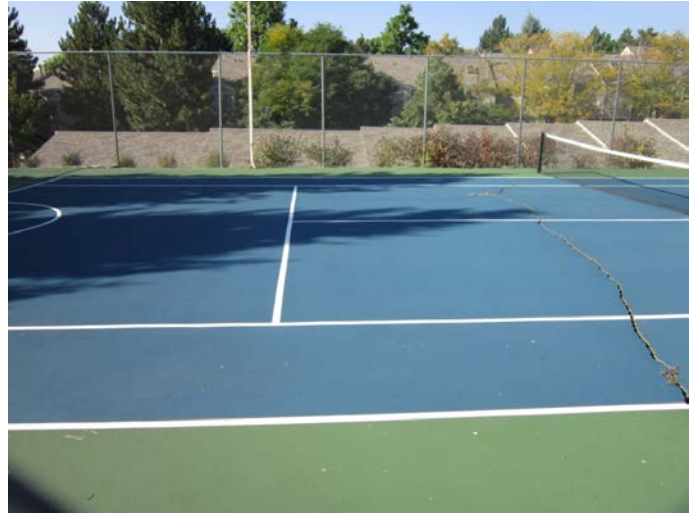
Comp #: 1201 Tennis Court - Replace

Location: **Pool Area**

**Cost estimate to replace with post tension concrete:  
\$40,000 - \$45,000**

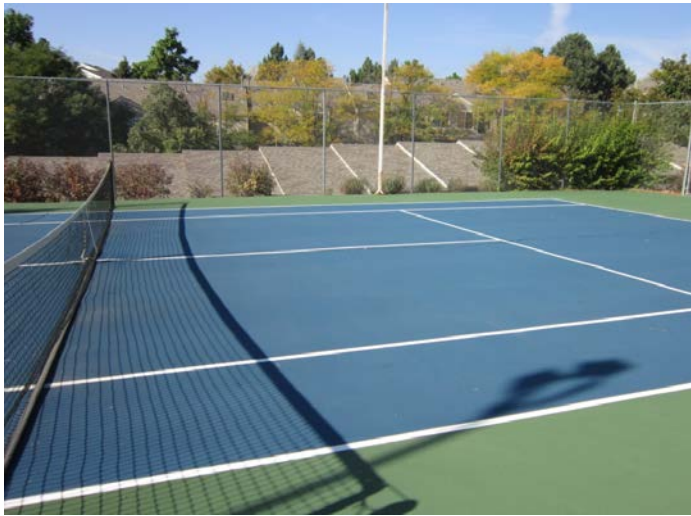
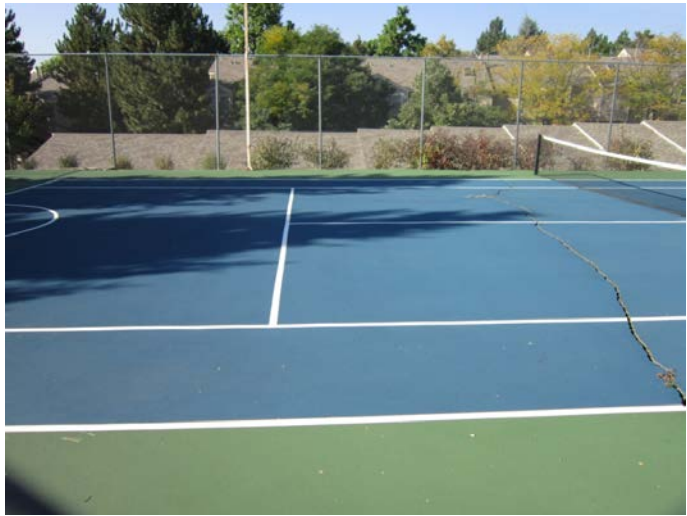
Comp #: 1202 Tennis Court - Recoat/Paint

Location: **Pool Area**  
 Quantity: **(1) Court**  
 Life Expectancy: **5** Remaining Life: **0**  
 Best Cost: **\$4,500**  
 \$4,500/court; Est. to repaint/coat  
 Worst Cost: **\$5,250**  
 \$5,250/court; Higher estimate  
 Source of Information: Cost Database

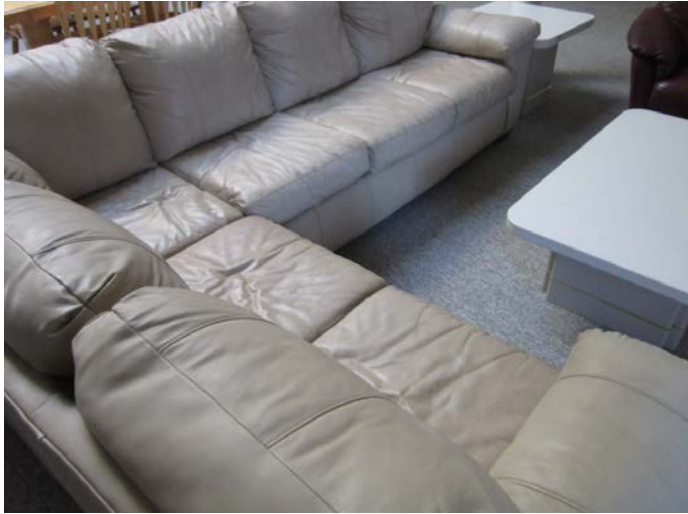
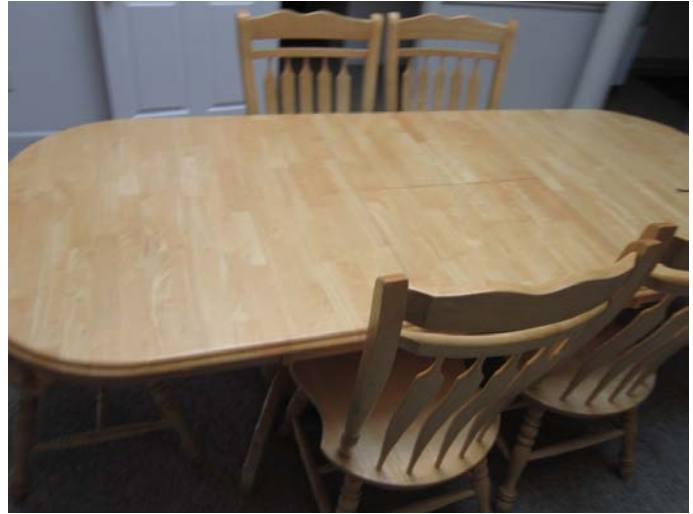
Comp #: 1405 Furnishings - Replace 25%

Location: **Clubhouse**

Estimate to replace

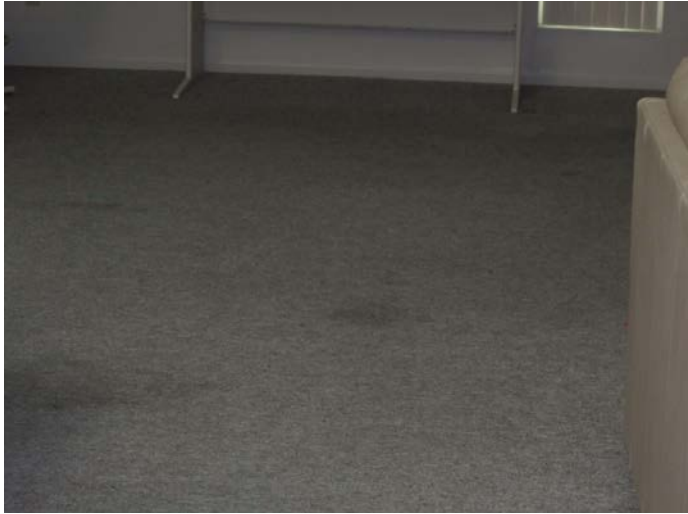
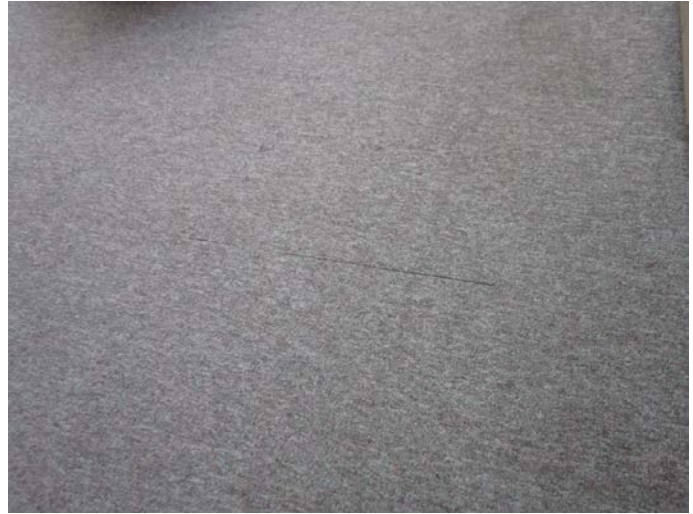
Comp #: 1501 Carpeting - Replace

*Location:* **Clubhouse**

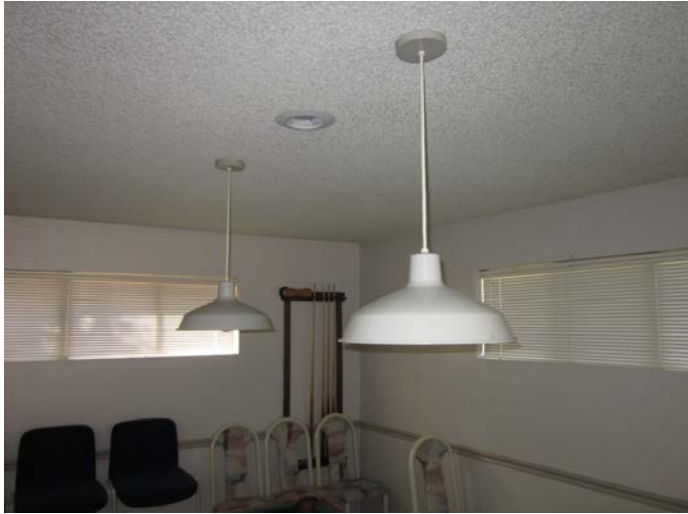
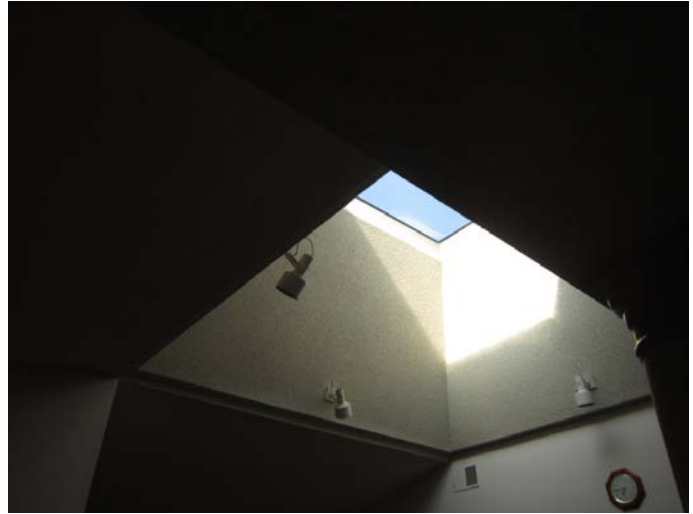
Comp #: 1601 Interior Lights - Replace

Location: **Clubhouse**

\$200; Estimate to replace and install new

**Hanging Lights over pool table - (2)**

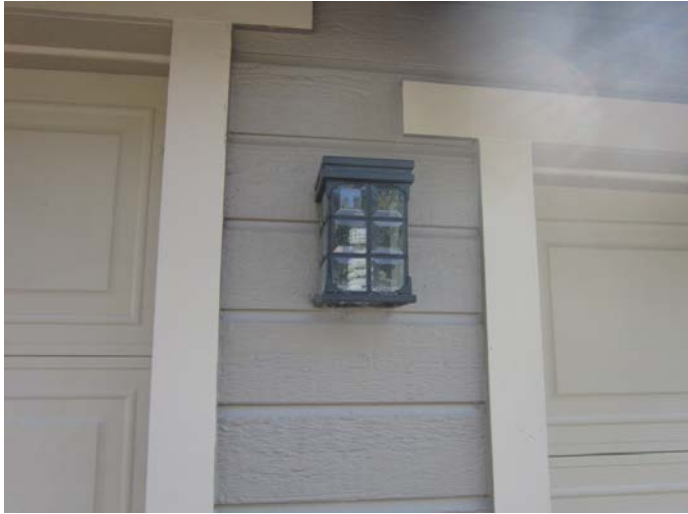
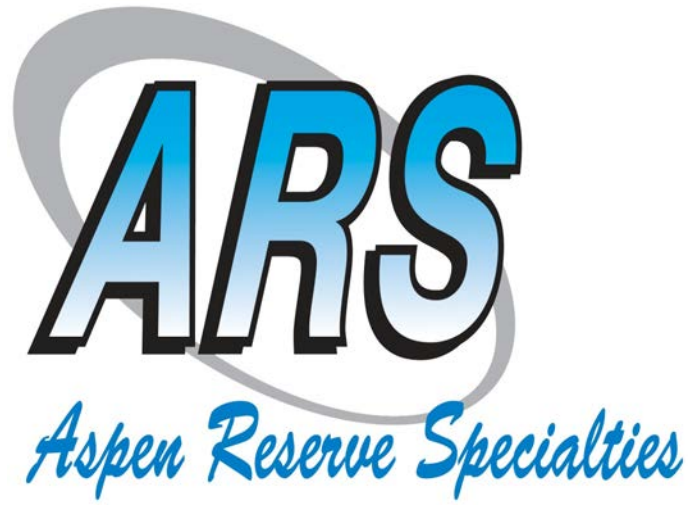
Comp #: 1602 Exterior Wall Mount - Replace 25%

Location: **See General Notes**

\$125/light; Estimate to replace

**Unit Buildings - (264)**  
**Clubhouse - (4)**

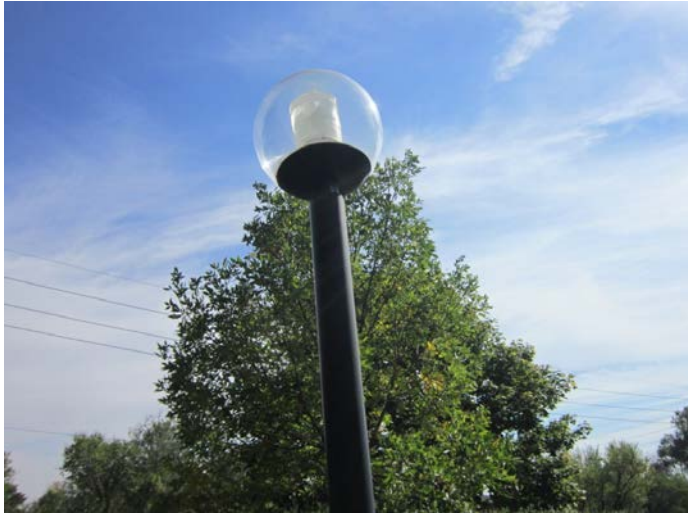
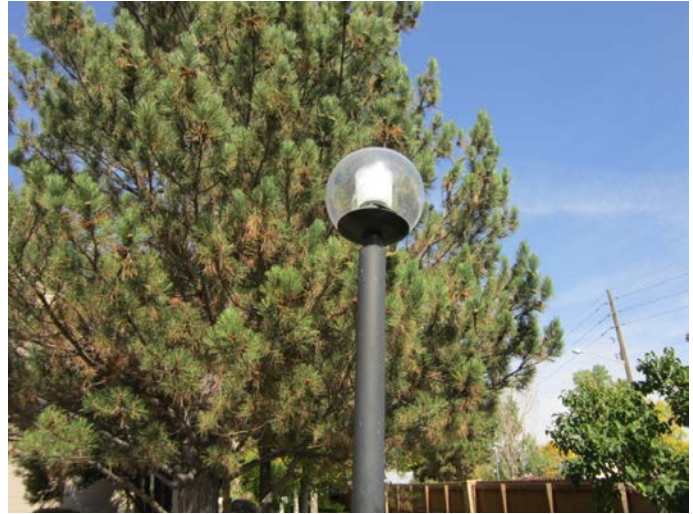
Comp #: 1604 Pole Lights - Replace

*Location:* **Common Areas**

\$250/fixture; Estimate to replace with similar

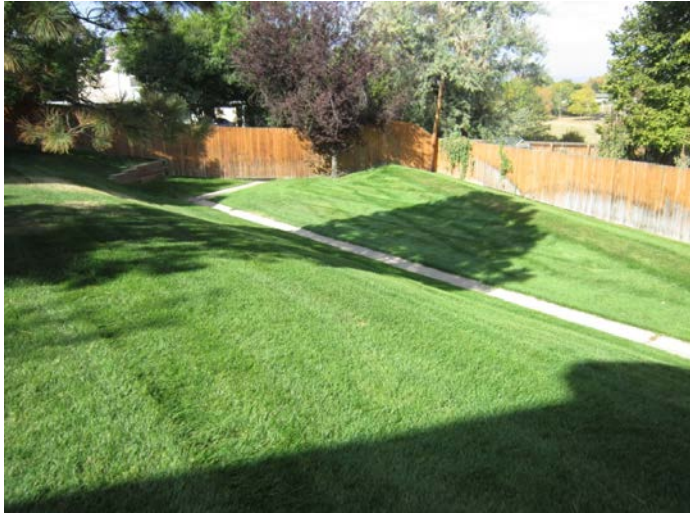
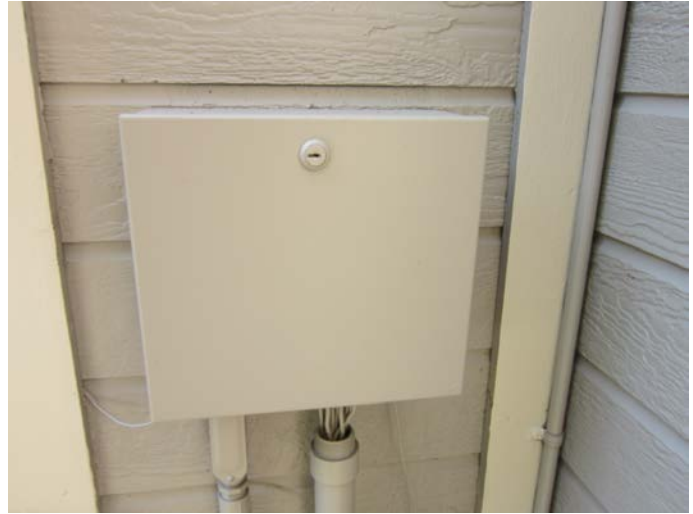
Comp #: 1701 Irrigation System - Major Repairs and Replacement

Location: **Throughout the Property**

Allowance for major repairs and renovating system

***This line item is for irrigation repairs and replacement of irrigation controllers.***

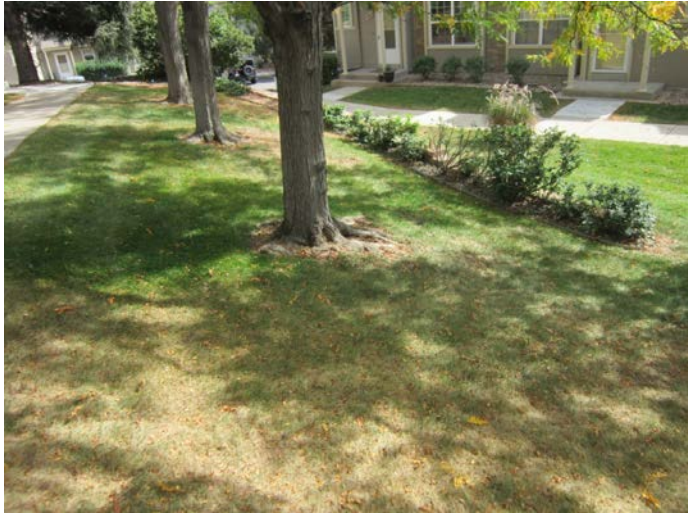
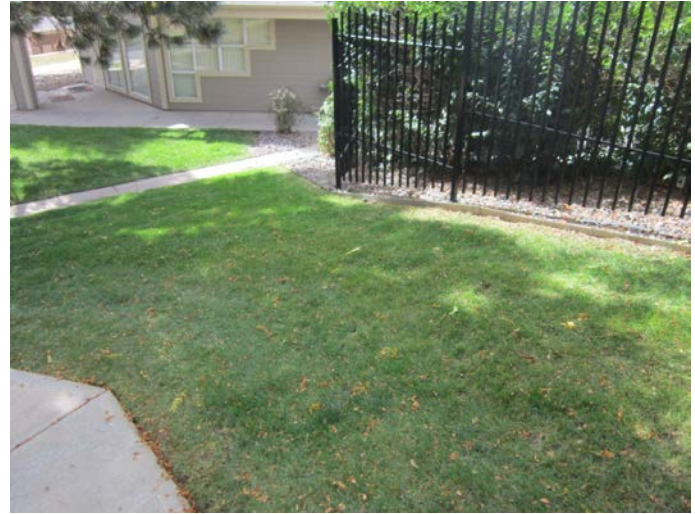
Comp #: 1801 Landscaping - Replenish

Location: **Throughout the Property**

**This line item is for improvements outside of the landscaping contract.**
