**Quail Ridge THCA  
11131-11167 W. 17<sup>th</sup> Ave  
Lakewood, CO 80224**

**Level 1, Limited Reserve Analysis**

**Report Period – 5/01/16-4/30/17**

**Final  
Version**

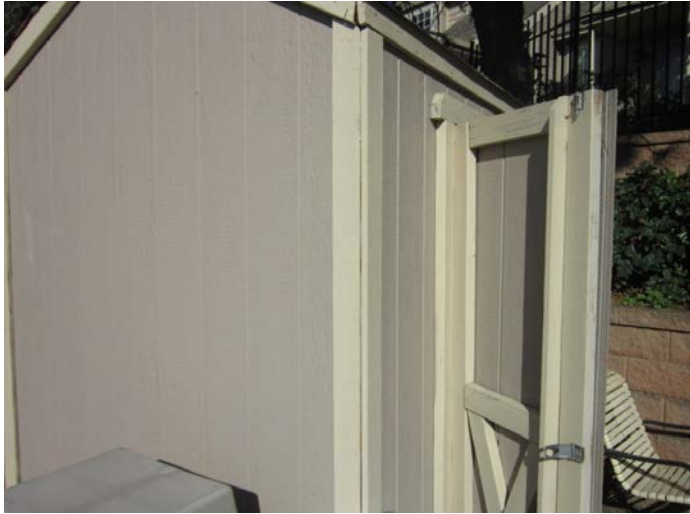
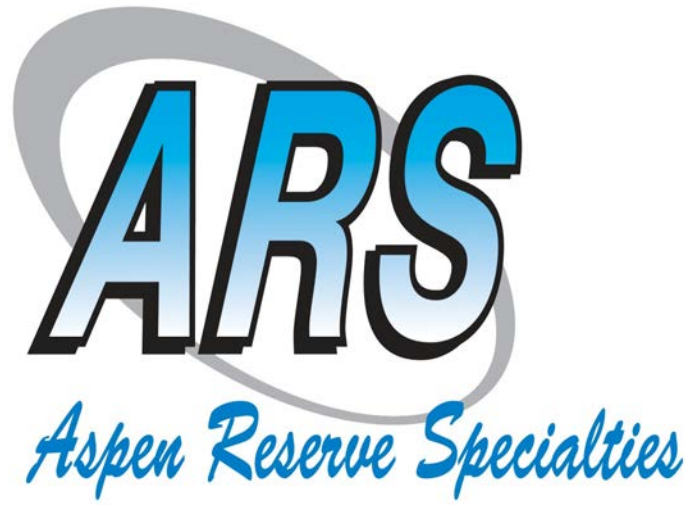
Comp #: 2005 Storage Shed - Replace

Location: **Pool Area**

Estimate to replace
