## Reserve Study

**Cheesman Tower West**  
1200 Humboldt Street  
Denver, CO 80218

July 16, 2008

Re: Cheesman Tower West Condominium Association, Denver, Colorado  
Reserve Study – Project No. 07183.1

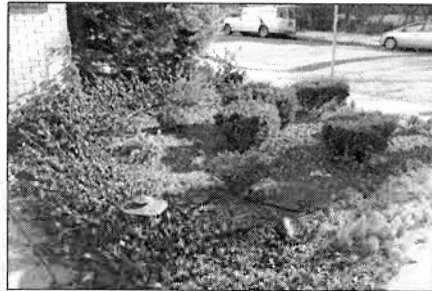
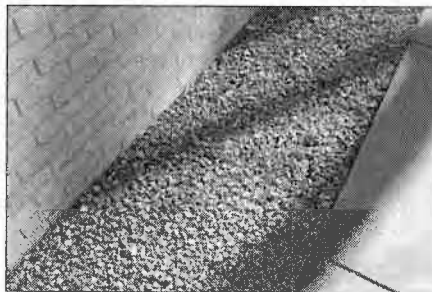
**Description:** The community utilizes zero-scape sloped grade and rock to move moisture to the collection systems. There is an irrigated lawn area on the west side of the property.

**Condition:** Satisfactory condition.

- Cyclically regrade a portion of the zero-scape sloped areas every seven years, starting in 2010.

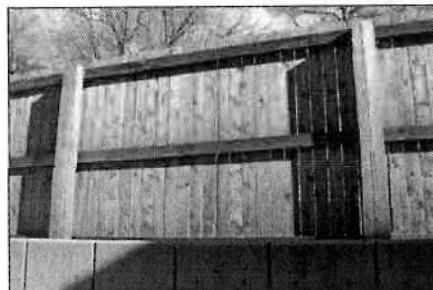
**Condition:** Good condition. We were informed that the fence was installed in 2006.

- None. We were informed that the cost for maintaining the fence is funded from the operating budget.

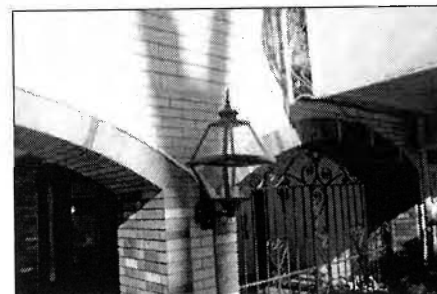
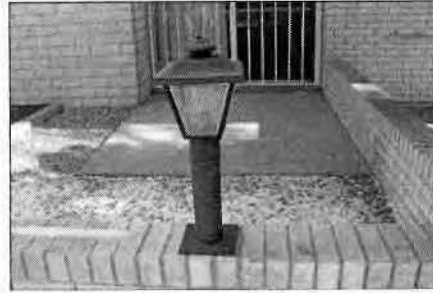
- High profile lighting – Asphalt parking deck.
- Wall mounted lighting – At the top of the freestanding wall.

- High profile lighting – Metal light pole with top mounted lighting unit.
- Wall mounted lighting – Metal pole mechanically attached to the top of the brick wall with single lighting unit mounted to the top.

**Condition:** Good condition with no major cracking or deterioration noted.

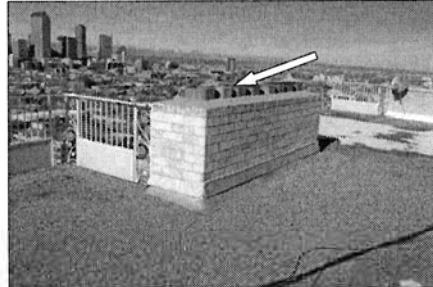
**F2. Chimney****Location:** Building exterior.**Description:** Brick chimney with clay flue.**Condition:** The brick chimney appears to be in good condition. We are unable to determine the internal condition of the chimney flue. If this chimney is active, we recommend that the Association contract with a professional engineering/contracting company to evaluate the flue and fireplace construction and operation.**Age:** 43 years.**Expected Useful Life:** Infinite with maintenance.**Effective Useful Life:** Infinite with maintenance.**Action(s):**

- Cyclically power wash and repair damaged mortar joints every ten years, starting in 2014.

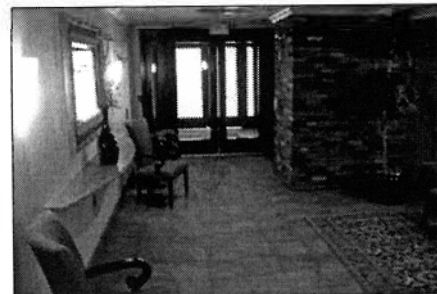
### H2. Corridor Walls and Ceilings

**Description:** Painted walls and ceilings. There is a small brick wall at the main entrance to the building.

**Condition:** Good condition.

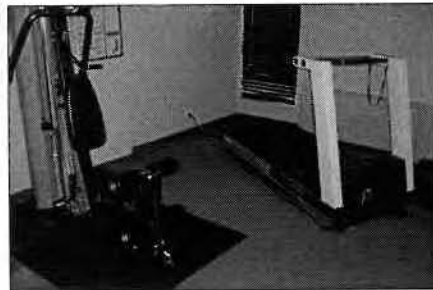
- Life Cycle cross trainer.
- Life Cycle 9500 HR stationary bike.
- PreCor C964 Treadmill.
- Hoist V4 Weight Machine.
- Various hand weights and exercise balls.
- Wall mounted JVC television with built in VCR.

**Condition:** Good condition.

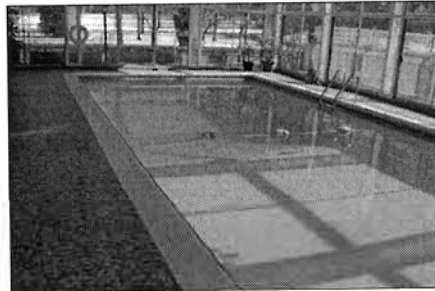
**Description:** The swimming pool is a cast-in-place concrete basin with a plaster finish.

**Condition:** The pool deck, plaster basin and pool coping is in good condition. We were informed that the pool was re-plastered in 1995 and painted in 2005. We were informed that the pool interior was painted in 2006.

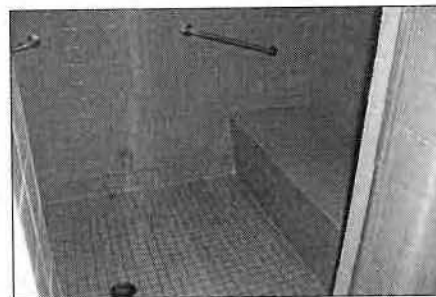
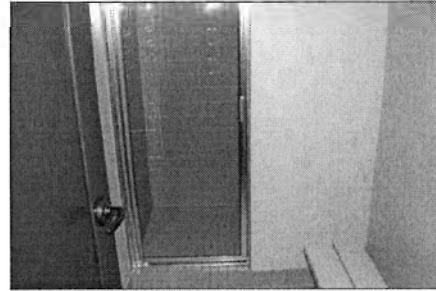
**Description:** The steam room has a tile floor, tile walls and ceilings. There are two showers located directly across from the steam room. The showers have tile floors, walls and ceilings and a glass door.

**Condition:** Good condition. The steam room was remodeled in 2002.

- Cyclically clean and re-grout the tile surfaces every 7 years starting in 2010.
- Remove and replace the steam generator in 2020.

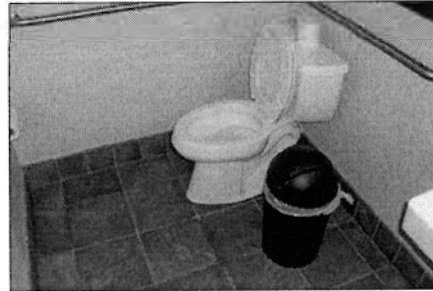
## I5. Restrooms

**Description:** Men's and women's restrooms include tile floors, painted walls and ceilings, sink and commode.

**Condition:** Good condition. The restrooms were remodeled in 2002.

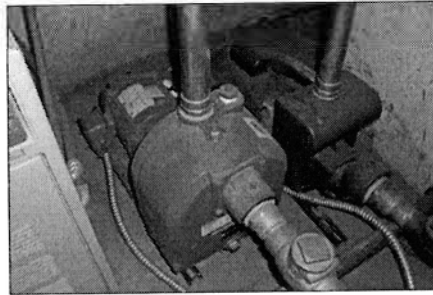
- There are two US Electric 5-hp and one US Electric 7.5-hp pumps for the domestic hot water, heat and snowmelt systems.

**Condition:** We were informed that these units are in good working condition.

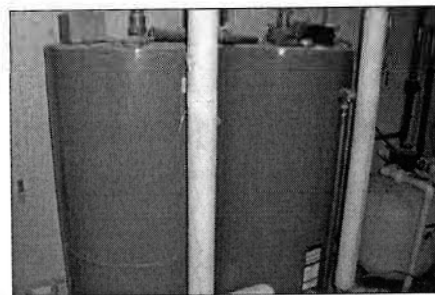
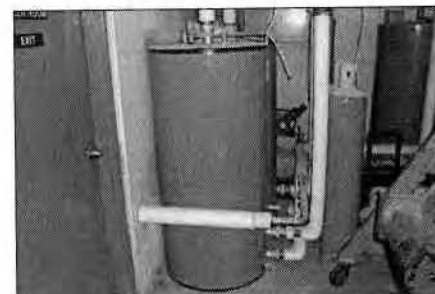
- Blue 115 gallon storage tanks – 14 years.
- Grey 115 gallon storage tanks – 1 year.

- Blue 115 gallon storage tanks – 11 to 16 years.
- Grey 115 gallon storage tanks – 24 to 29 years.

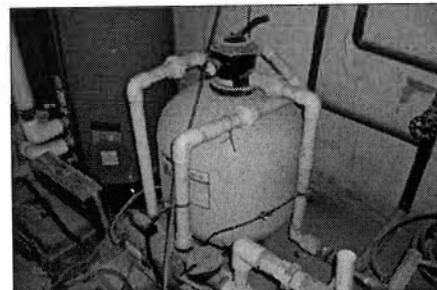
**Description:** System3 hi-rate sand filtration systems. The filter has a filter area of 450 square feet.

**Condition:** We were informed that the unit is in good operating condition.

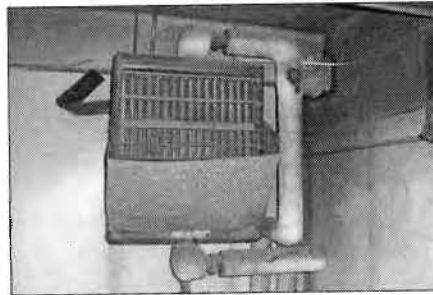
**Description:** There are four Beacon/Morris heating units. The heat is provided from the main boiler loops.

**Condition:** We were informed that these units are in satisfactory operating condition.

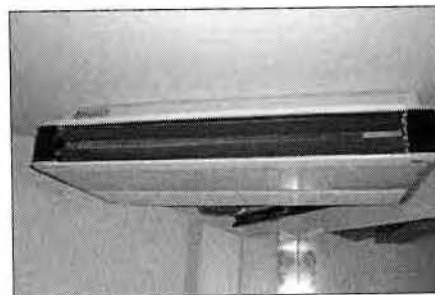
**Description:** United Technologies heating and cooling units.

**Condition:** We were informed that these units are in good operating condition. These units were installed during the remodel in 2002.

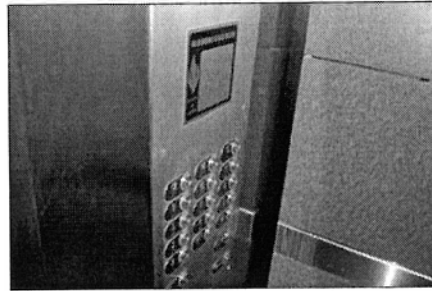
## L2. Elevator Cabs

**Description:** The passenger elevator cabs are finished with composite paneling and tile floor.

**Condition:** Good condition. We were informed that the elevator cabs were modernized in 2002 during the lobby remodel.
