**Sorrel Ranch HOA**  
**Aurora Parkway & Alexander Drive**  
**Aurora, CO 80016**

**Level 1 Reserve Analysis**

**Report Period – 01/01/09 – 12/31/09**

**Date of Property Inspection – February 12, 2009**  
**Report Prepared by – G. Michael Kelsen**  
**Property Inspected by - G. Michael Kelsen & Curtis Karkoski**  
**Main Contact Person - Mr. Scott Ryan, Community Manager**

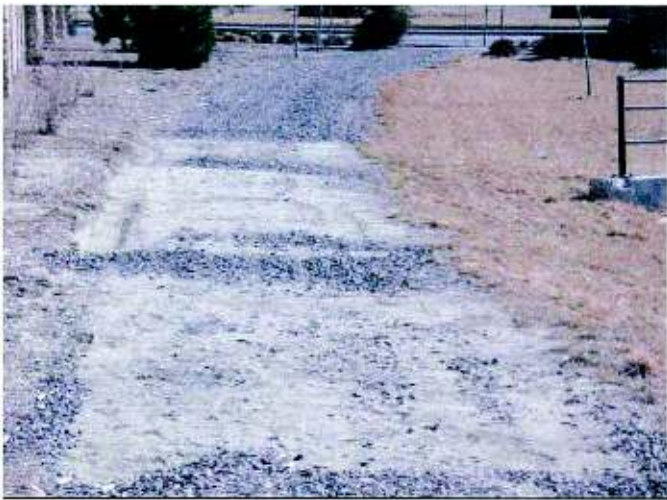
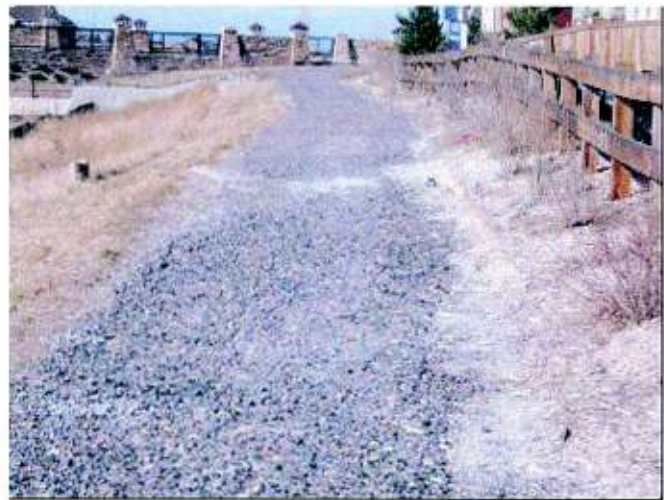
Comp #: 602 Crushed Granite Pathway - Replenish

There was extensive signs of dirt washed over the pathway, or material that has been washed away from heavy rains. Based on the age of the community and the type of materials that are used here, we suggest establishing a Reserve allowance for periodic maintenance and refurbishment every 2 - 3 years. Refurbishment includes weed abatement, trimming any grass encroachment, and replenishing the crushed granite.

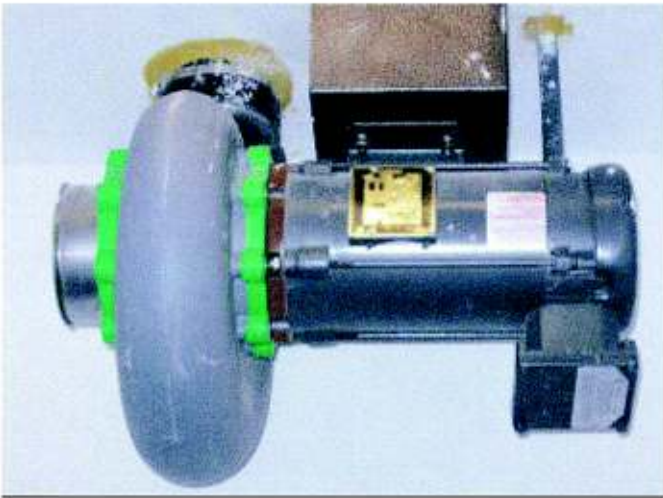
Comp #: 714 Chemical Room Exhaust Fan - Replace

Unit was in working order when inspected and appeared to be new and in good condition. Due to the low replacement cost of this unit, we suggest treating replacement on an as needed basis with general operating funds. Therefore, separate Reserve funding is not required for this component.

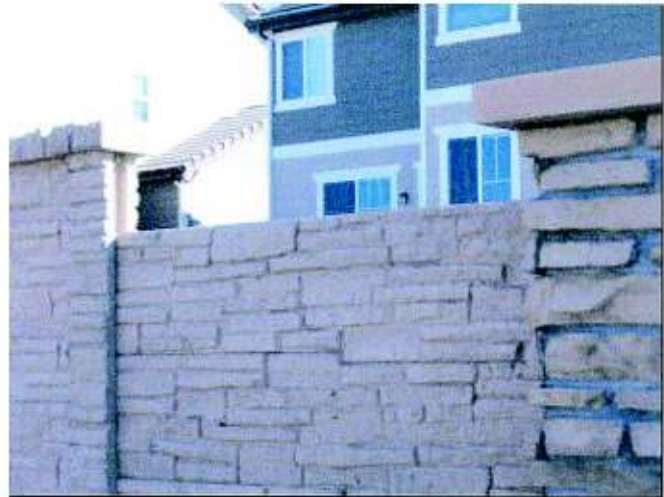
Comp #: 1003 Concrete Fence - Replace

Pre-Cast concrete perimeter wall appeared in good condition. We observed one section that was missing the top cap in filing 6 at the intersection of E Garden Dr and E Alexander Dr. Also observed another area in filing 6 along Aurora Parkway near the fire hydrant at the backyard of the 3rd house west of the intersection of Catawaba Way and Duquesne Ct that appeared more unstable than any other areas of the wall. According to the vendor, this material has a 10 year warranty against manufacturer defects. If moisture enters these cracks and with the temperature fluctuations, frequent cracking can be expected. While these panels can be replaced as needed, gradual replacement will result in a patch quilt appearance, which will lead to complete replacement.

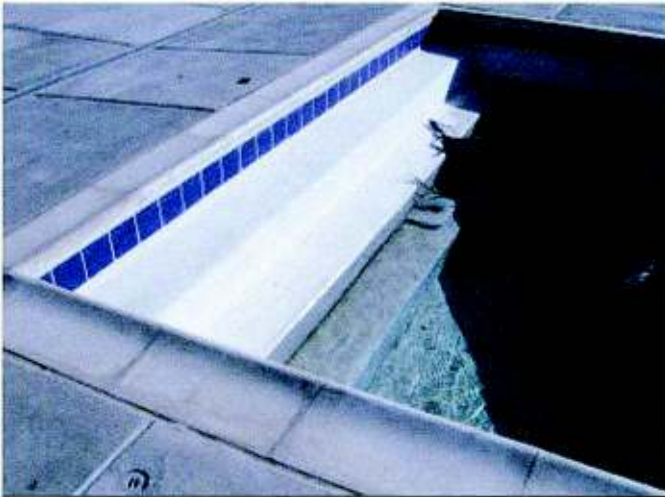
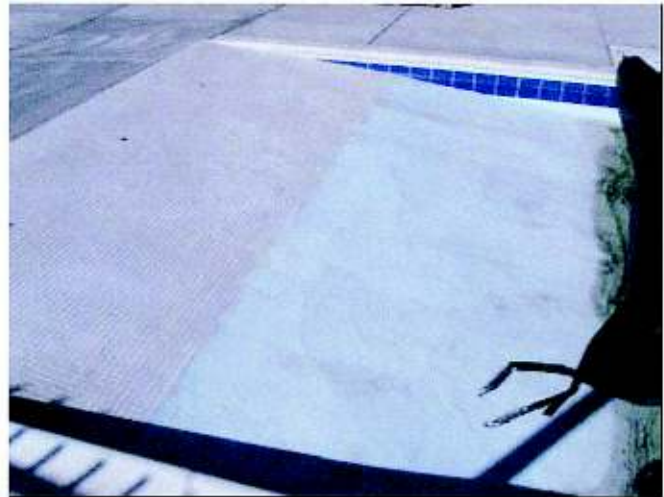
Comp #: 1104 Coping Stone/Tile - Replace

Pool was covered at time of inspection, so it was difficult to inspect the condition of all tiles and coping stones. The materials inspected were in good condition with no missing or broken tiles/coping stones noted. It is typical to replace these materials every other pool resurface cycle. Therefore, assuming all materials are all new and in good condition (like the ones inspected), we suggest replacing at the time of the following replaster job (in 18 years).

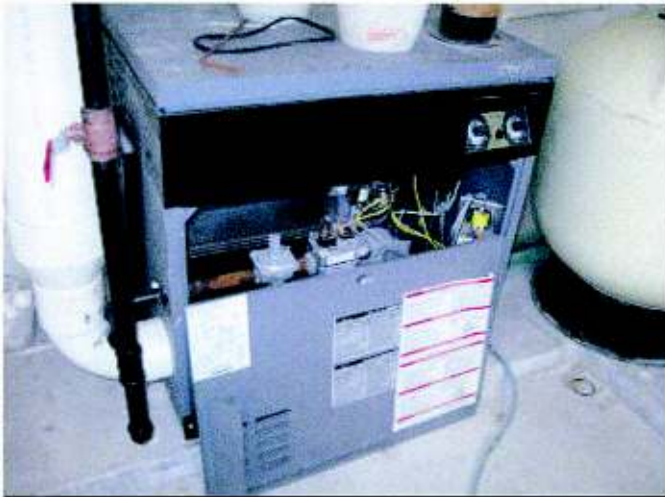
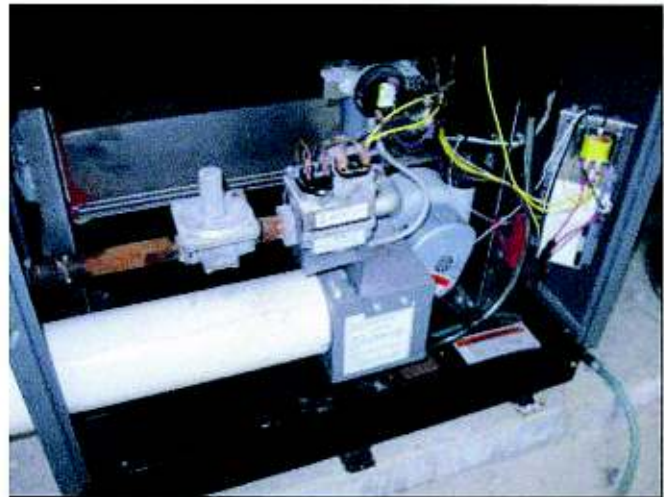
Comp #: 1105 Pool/Wader Heaters - Replace

Heaters are relatively new and in good condition with no signs of rust or corrosion. It is possible the wader heater will fail before the pool heaters due to the extra chemicals that are typically needed for wader pools. The overall replacement cycle depends on the level of maintenance and the quality of the water running through the system. For this type of heater, the average replacement cycle will range between 12 - 15 years with proper maintenance and under normal conditions. Continue to monitor and adjust the remaining life to the wader heater if necessary.

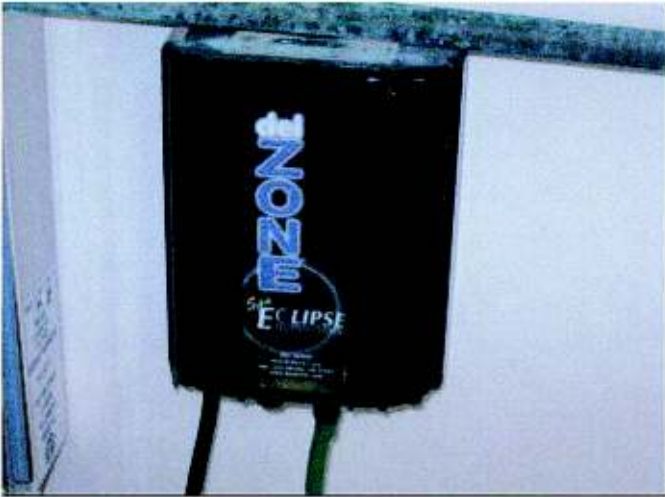
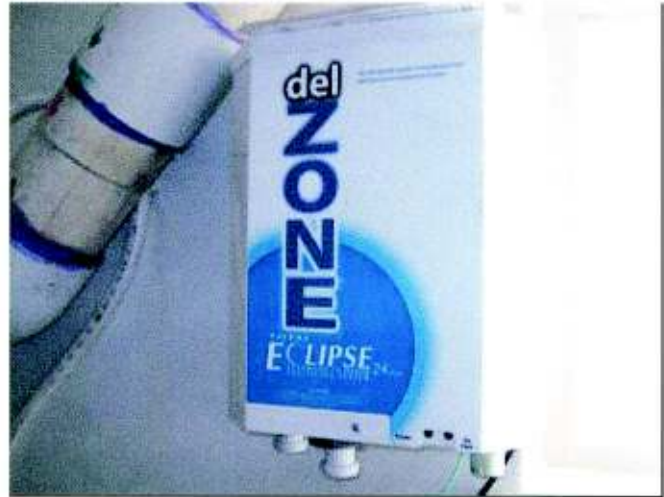
Comp #: 1112 Pool/Spa Sanitizers - Replace

Both units appeared in good condition but were not in operation due to winterization of the pools. According to the manufacturer, the average replacement cycle for this type of unit ranges between 5 - 8 years depending on level of use. For pools that are only used 3 months a year, the replacement cycle may be extended a few years. At this time, establish a replacement cycle of 7 years and adjust the useful life in future Reserve Study updates if required.

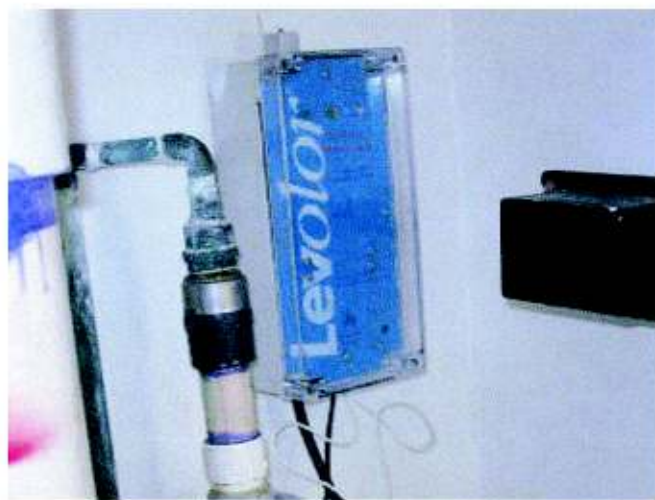
Comp #: 1112 Pool/Wader Levelers - Replace

No unusual conditions observed during inspection. Pools were winterized at time of inspection so operation could not be verified. The replacement cost of these units (less than \$400 each) is too small for separate Reserve designation. Therefore, at this time, we suggest treating replacement on an as needed basis with operating funds.

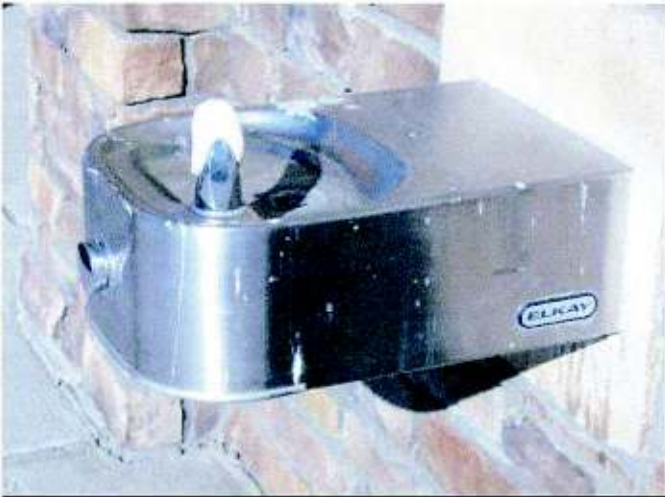
Comp #: 1304 Drinking Fountain - Replace

No problems noted with drinking fountain at the time of inspection. System was winterized. Due to the minimal replacement cost associated with this component, Reserve funding is not appropriate. Repair and replace as necessary as an operating expense.

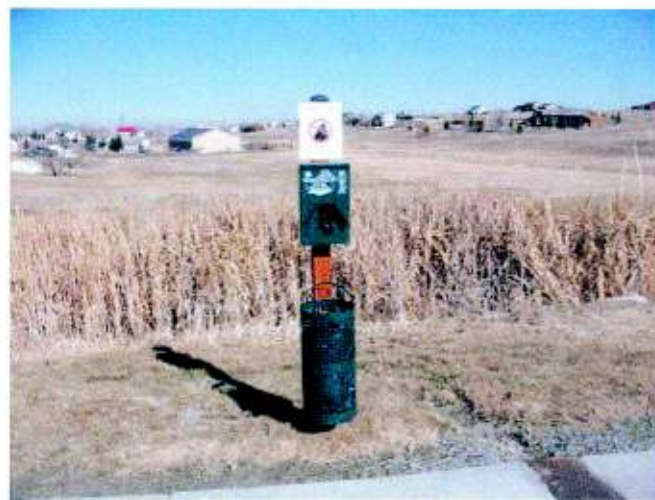
Comp #: 1311 Pet Waste Pick Up Stations - Replace

No unusual conditions observed during inspection. The individual replacement cost of these stations (less than \$400 each) is too small for Reserve consideration. Therefore, we recommend replacing these on an as needed basis with general operating funds.

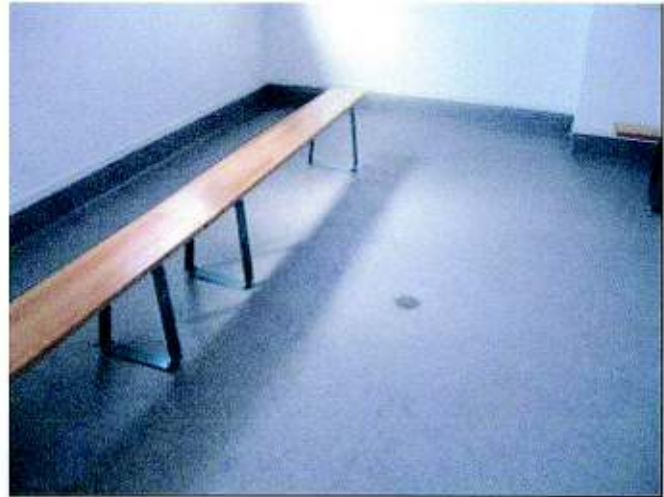
Comp #: 1405 Furnishings - Replace

No problems noted with benches at the time of inspection. Due to the minimal replacement cost and long life associated with wood benches of this type, Reserve funding is not appropriate. Make repairs or replacements as necessary as an operating expense.

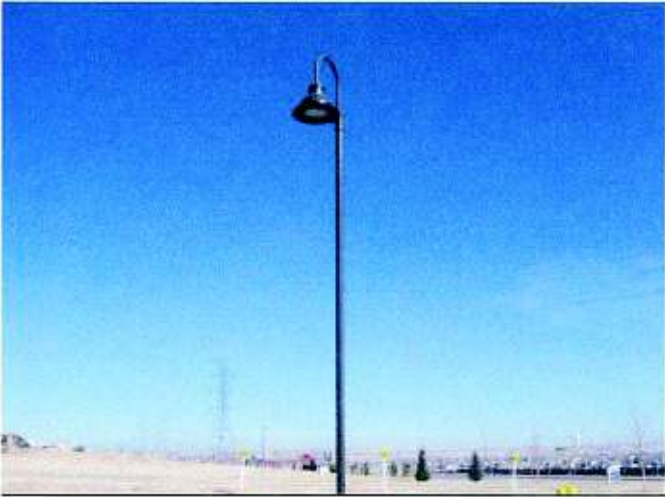
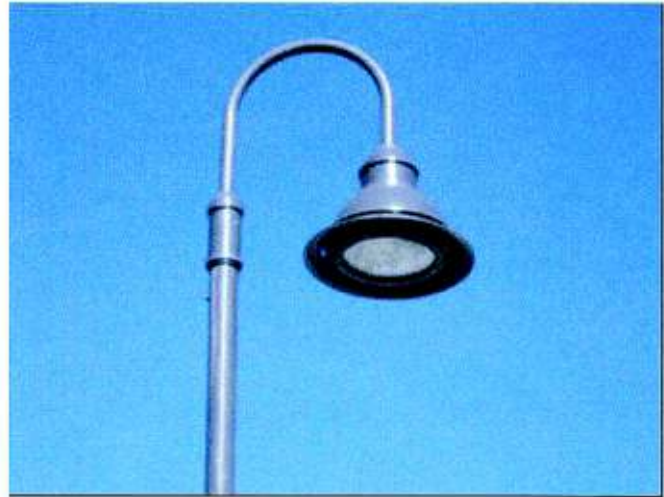
Comp #: 1604 Pole Lights - Replace

No structural problems noted with lights at the time of inspection. Paint these pole lights regularly to prevent rust damage, maintain an appropriate appearance, and to ensure a full life expectancy. Expect to replace these lights approximately every 20 - 30 years to maintain appearance and function.

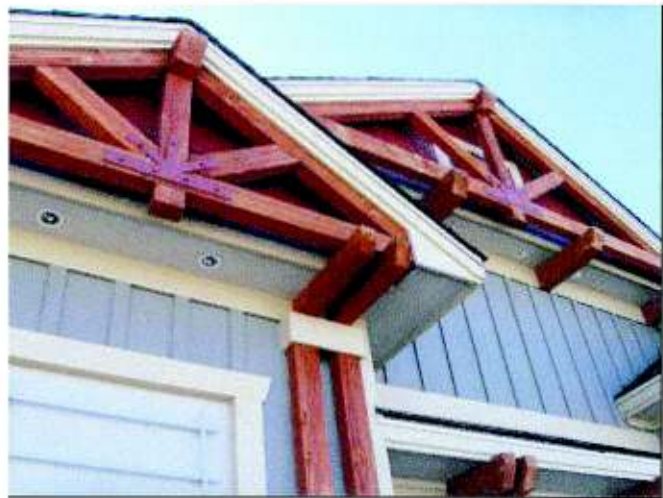
Comp #: 1608 Can Lights - Replace

No unusual conditions observed during inspection. The individual replacement cost (less than \$60 each) is too small for separate Reserve designation. Also, these are not considered to be decorative lights, so periodic replacement should not effect the consistent appearance of the clubhouse. Therefore, we suggest replacing these on an as needed basis with general operating funds.
