**Tamarac Hills HOA**  
**7500 – 7900 E. Dartmouth Ave.**  
**Denver, CO 80231**

**Level 1 Reserve Analysis**

**Report Period – 03/01/03 – 02/29/04**

| <b>Date of Property Inspection –</b> | <b>November 26, 2002</b> |

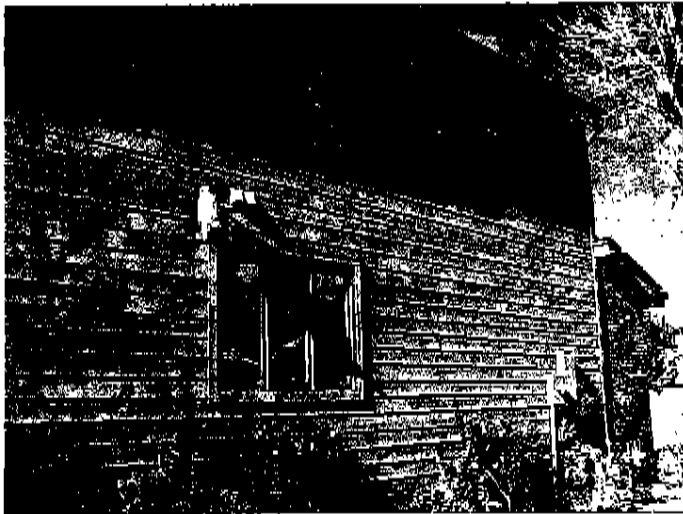
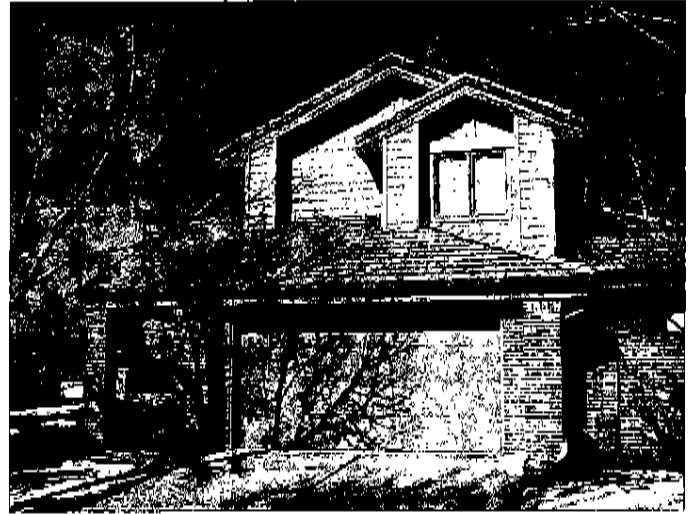
**Component Inventory for Tamarac Hills HOA****Client Reference # 2088****Comp #: 215 Pool/Mailbox Building Surfaces - Repaint**

A portion of the units are painted on an annual basis as a separate issue from Reserves. The pool buildings and mailbox kiosks are painted along with the unit buildings when deemed necessary by the Board of Directors. No separate Reserve funding is required for this asset.
