## Reserve Study

**Versailles Homeowners Association**  
789 Clarkson Street, Denver, Colorado

January 16, 2008

Re: Versailles Homeowners Association, Denver, Colorado  
Reserve Study – Project No. 07224-967

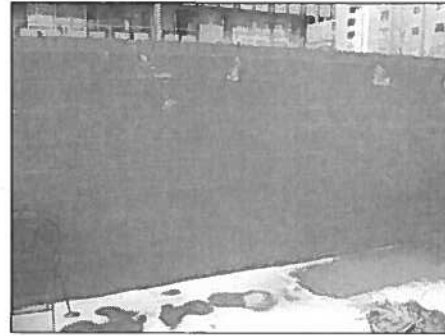
**Condition:** All three walls were in satisfactory condition for their age. We noted some minor deterioration of the mortar joints and in the paint in various locations throughout the three walls.

- Cyclically inspect, tuck point the mortar joints and replace damaged bricks or CMU blocks every six years, starting in 2008.
- Cyclically power wash, scrape and paint the freestanding walls with a commercial grade, elastomeric paint every 10 years, starting in 2008.

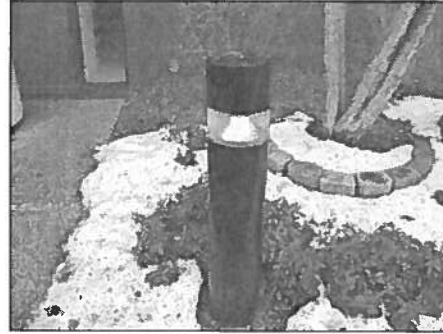
#### C4. Exterior Lighting Units

**Condition:** Good condition with no major cracking or deterioration noted.

- Replace the wall mounted lighting at the swimming pool in 2009.
- Replace the high profile parking lights in 2012.
- Replace the entry bollard lighting in 2019.

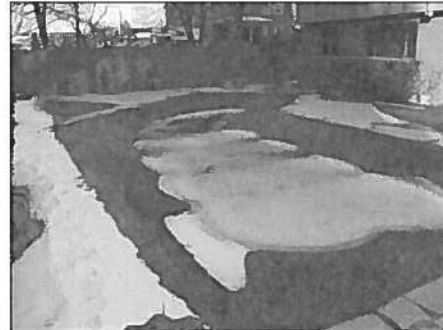
**Condition:** We were unable to observe the pool surface or coping stones due to the cover being installed for the season, we were informed that the surface is rough and is in need of plaster resurfacing and the coping stones are in fair condition.

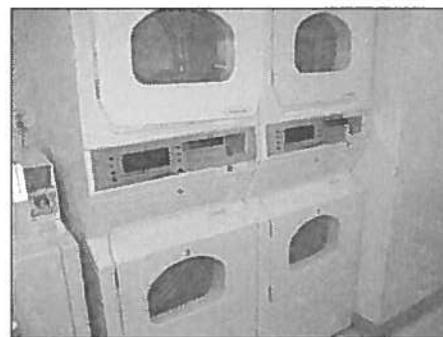
**Description:** There are five Maytag washers and five Maytag dryers. All units are commercial grade, coin-operated systems.

**Condition:** We were informed the machines are in satisfactory working condition.

- None, we were informed these units are leased and replacement costs are not the responsibility of the Association.

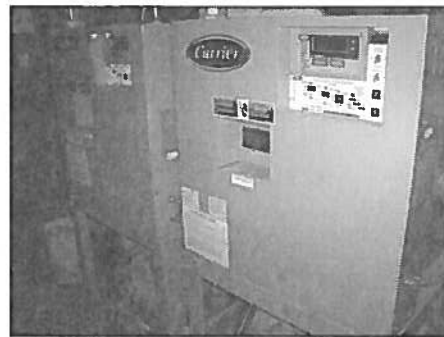
**Description:** There are two Carrier chiller units for the cooling system in the building.

**Condition:** We were informed these units are in good operating condition.

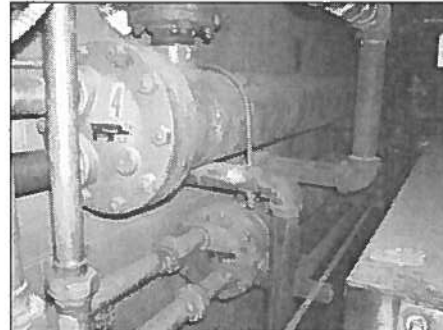
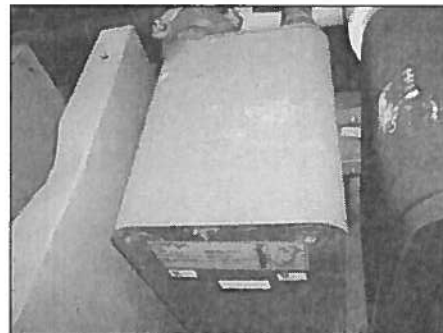
- The chiller system utilizes two SWEP, flat plate heat exchangers.
- The boiler system utilizes two tube and shell type heat exchangers.

- The chiller system heat exchangers are in good working condition.
- The boiler system heat exchangers are in satisfactory working condition. We were informed these units will be replaced with the boilers in 2008.

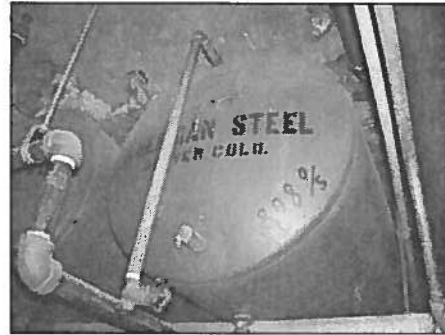
- The chiller system utilizes two American Steel expansion tanks.
- The boiler system utilizes one American steel expansion tanks.
- We were informed an additional expansion tank will be installed with the new domestic hot water boiler. The size and brand are unknown at this time according to the documentation we received.

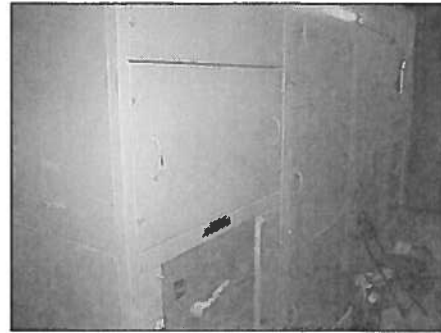
**Description:** All units were Westinghouse, Pow-R-Line switchgears for the buildings electrical services.

**Condition:** Good condition.

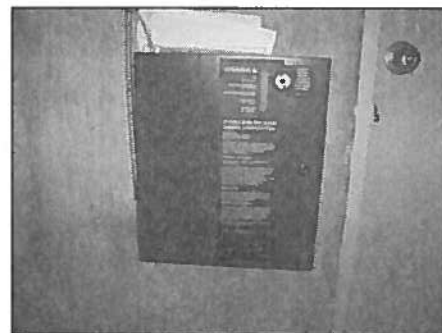
**Description:** There is one Edwards Systems Tech, EST-LSS4/36 fire panel and one Ademco 5-zone fire alarm panel.

**Condition:** Good condition, these units were installed in 2007.

- None, the remaining useful life of the fire and smoke notification panels should exceed the term of the Study.

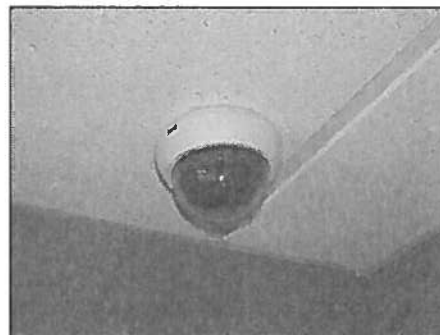
## K3. Video Surveillance System

**Description:** There are 11 cameras with a Sprite 2 digital recorder and monitor. We were informed the system can expand to support up to 15 cameras.

**Condition:** Good condition.

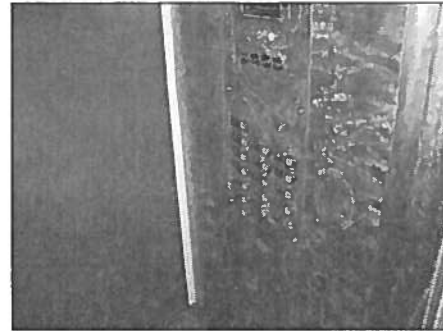
**Description:** The passenger elevator cab finished with stainless steel paneling.

**Condition:** Good condition.
